Braintree Town Office Building Energy Plan

Building Energy Plan

December 4, 2010

RE: Energy Audit Conducted October 2, 2010 on the Braintree Town Offices and Garage

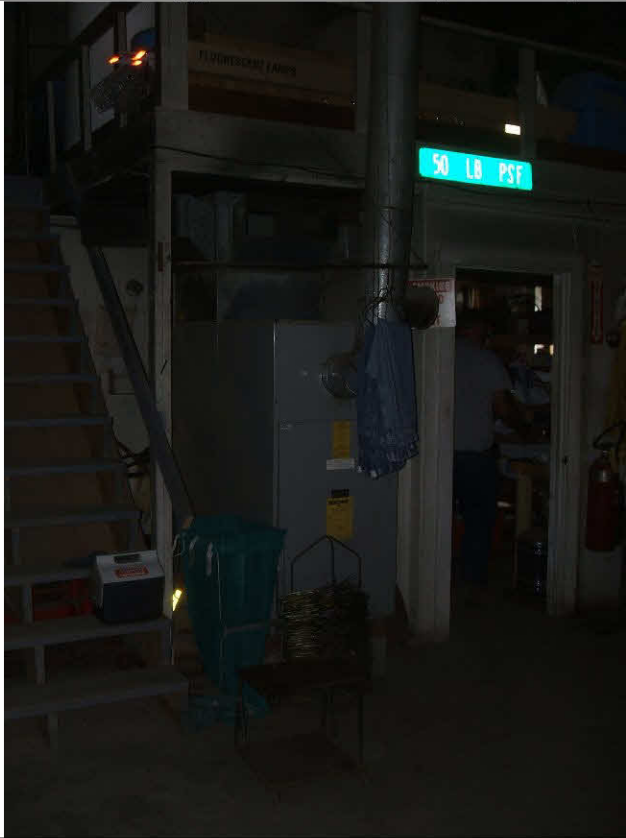
Finding: The existing furnace has a steady state efficiency of 80% and annual fuel utilization efficiency (AFUE) of 78%. I wondered about the heating distribution efficiency because there are no ducts to distribute heat for the main garage space but Tom Brown said the temperature distribution seems to be OK with the 2 ceiling fans going.

Recommendation: Install a programmable thermostat and program in a night setback of 55F. Replace the furnace with a unit that has an AFUE of 85% or better and a high efficiency blower motor when this furnace is at the end of life. The savings estimate below is based on both a new furnace and a night setback.

Implementation and timing: Install a programmable thermostat immediately and budget for a new furnace within the next 5 years.

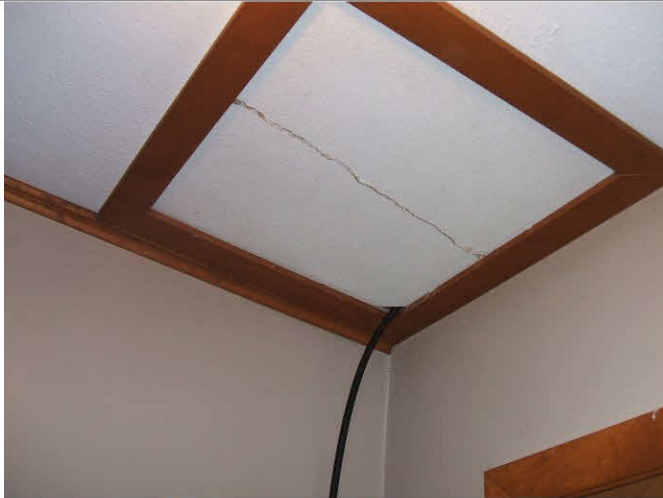
Broken attic hatch

Recommendation: Air seal the attic at the perimeter and at all other penetrations with spray foam. The goal is to block the air bypass that allows outside air into the strapping space below the batt insulation and to seal the leaks at the wall to ceiling connection. Add vent chutes at the eaves in preparation for increasing the attic R-value to R50 with additional blown in cellulose. The foam seal at the perimeter should seal to the bottom of the vent chutes so that outside air has no pathway to get beneath the insulation layer. Install a new attic hatch with weather stripping and at least 6" of rigid insulation attached.

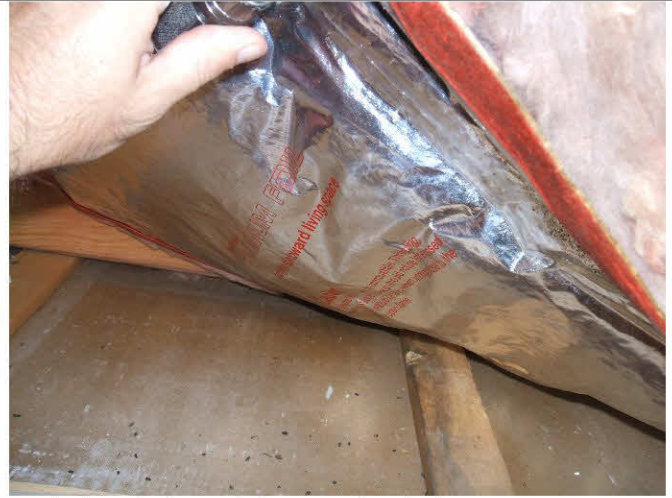
Attic insulation with strapping below

Finding: The attic insulation is insufficient (R19 fiberglass batt) and air leakage in the strapping space under the insulation degrades its performance. Air leakage into the attic was also found at the wall to ceiling connection. I believe the wood trim at the ceiling perimeter is hiding a gap between the sheetrock on the wall and the sheetrock on the ceiling. The attic hatch is a broken piece of sheetrock with no insulation or weather stripping. Air leaks are also common at the window trim boards. Finally, there is no insulation at the perimeter of the slab and heat is being radiated to the outdoors.

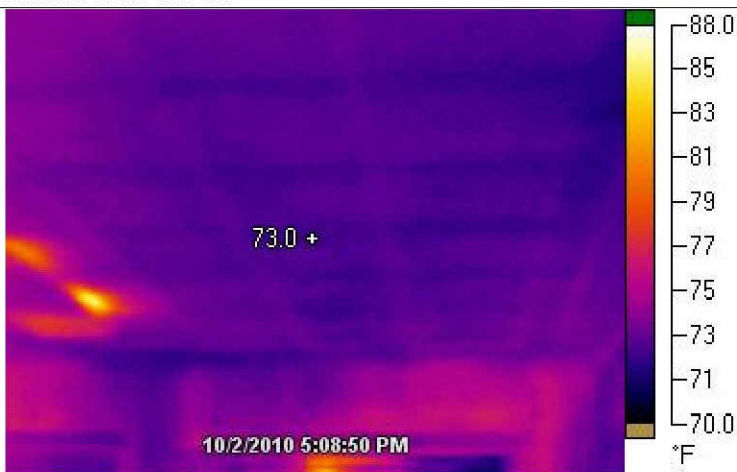
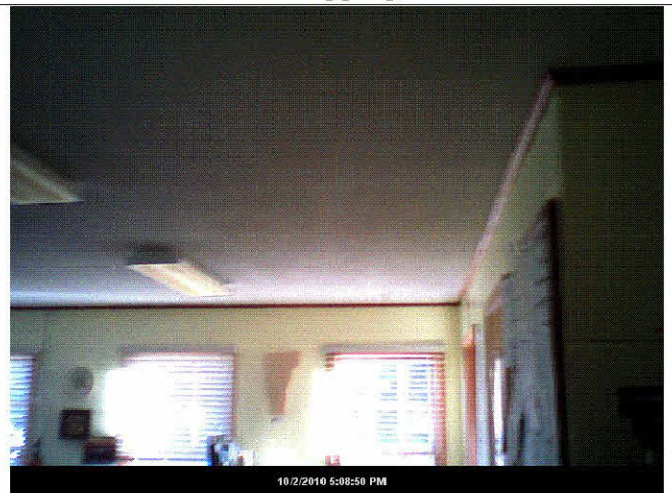
The ceiling got cold when depressurized, indication that outside air can travel under the insulation.

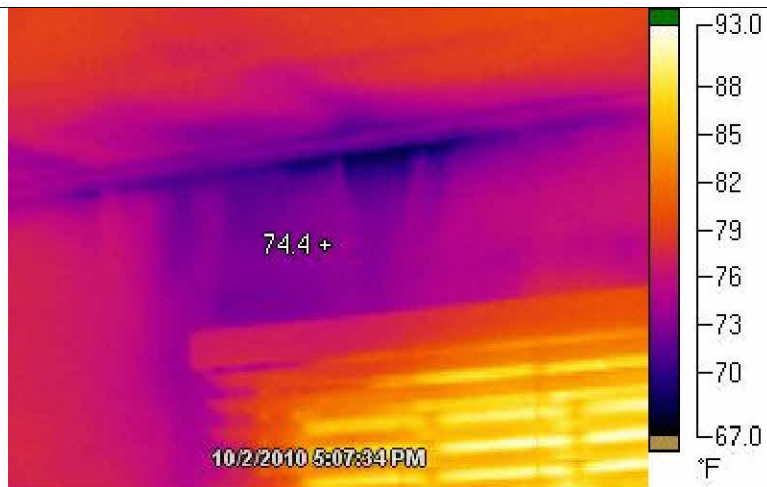
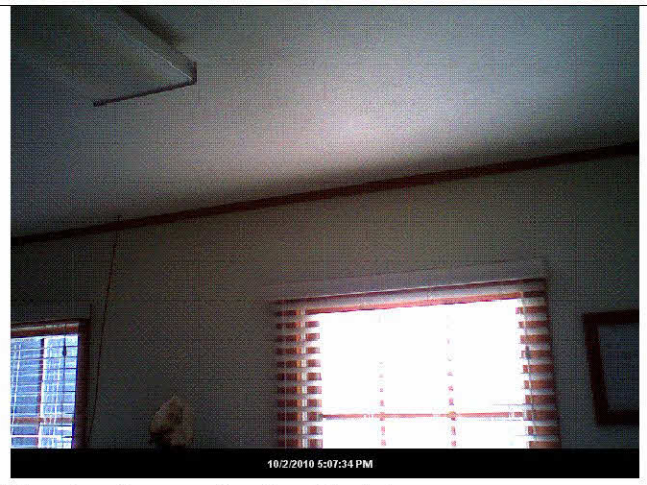
Air leakage at the wall to ceiling connection. I suspect that there is no mud or sheetrock tape behind the wood trim.

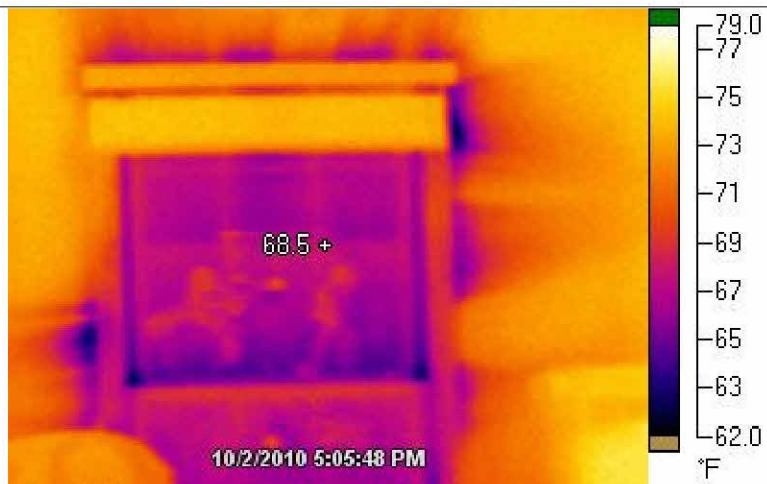
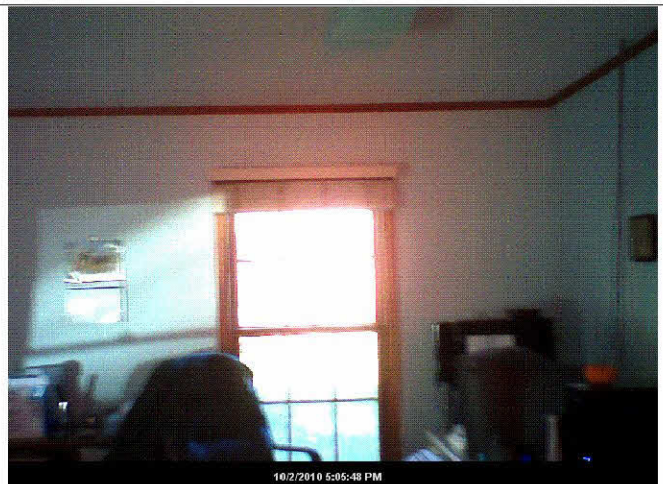
Air leakage at the window is shown by the dark spots that fan out from the window trim. Most

Remove the window trim boards and the fiberglass chinking between the rough opening and the window frame. Use one part foam to seal between the window frame and the rough opening and reinstall the trim boards.

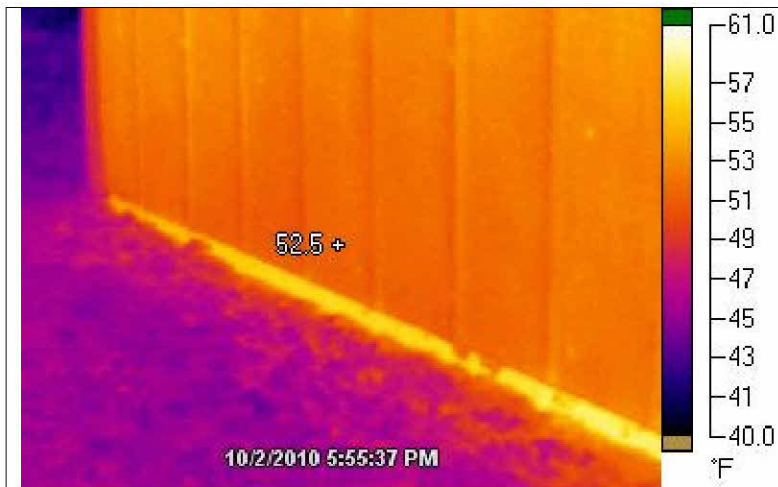
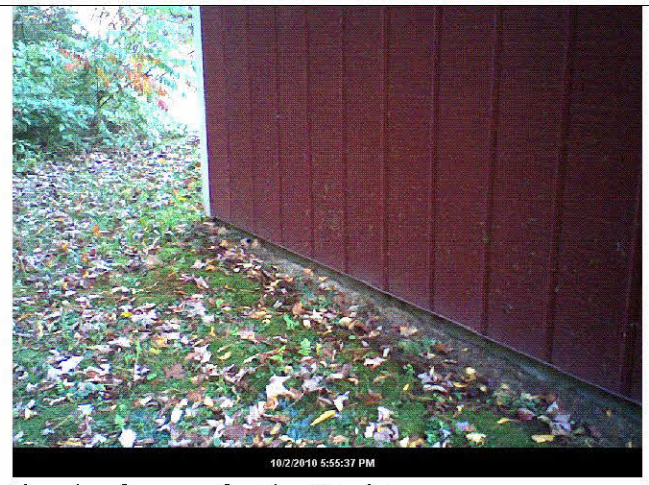
The exposed slab edge radiates heat to the outside.

If there is space so the siding will cover it, add at least 1 inch of rigid foam board to cover the edge of the slab. Dig down beside the slab and frost wall for 8-10" so the foam can be glued tight to the frost wall, then backfill against the rigid and cover the foam that is above grade with stucco for protection against sunlight. The rigid foam thickness should be narrower than the existing siding so water cannot get behind the foam.

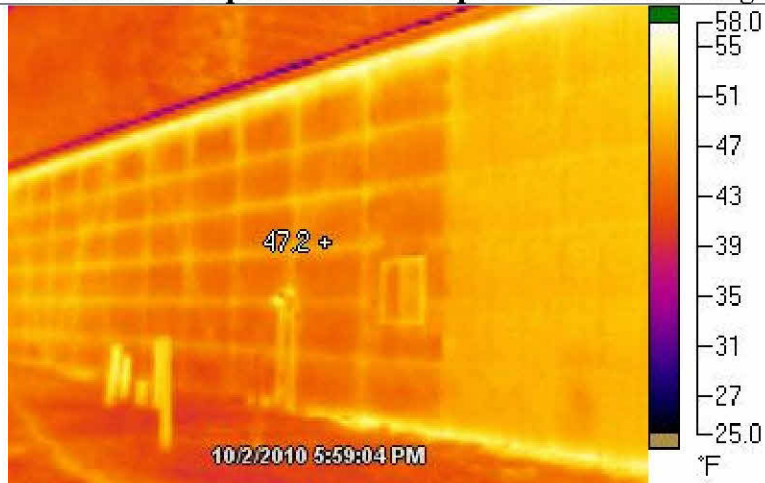
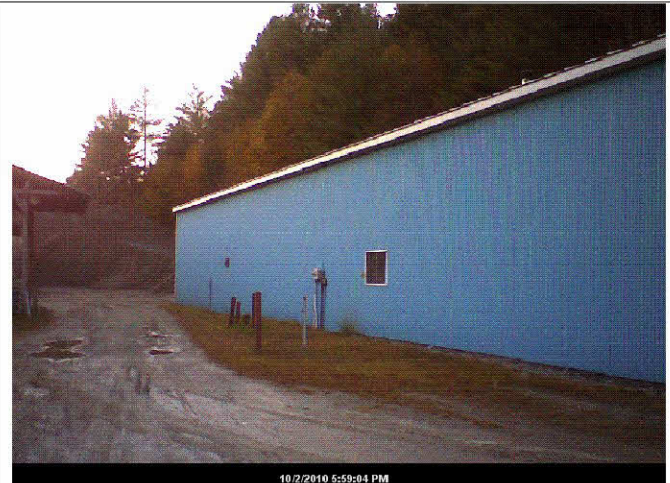
The horizontal strapping below the siding is easily seen in this infrared image. The strapping creates an air space that allows air to move around and through the fiberglass insulation, degrading its performance. There is a similar strapping layer on the inside also.

Finding: The wall cavities are about 8” thick comprised of wood posts with horizontal 2x4 strapping on either side of the posts to hold the metal siding and plywood interior. Fiberglass batts about 5” thick run up the middle of these walls but air can move easily around it because of the strapping on either side. The effective R-value of the wall is estimated to be about R9.

Recommendation: Add more insulation to the walls and make the walls as airtight as possible. This can be done in several ways but the simplest approach would be to remove the metal siding and existing insulation so closed cell spray foam can be installed from outside (to at least R21 value) against the back of the plywood. The spray foam is costly so this approach increases the payback term. Other methods could be employed at a lower cost but need to meet the same goals of increased R-value and airtight construction in order to be effective.
