## Bradford Town Garage Building Energy Plan

## Building Energy Plan

***RE: Energy Audit Conducted February 23, 2011 on the Bradford Town Garage.***

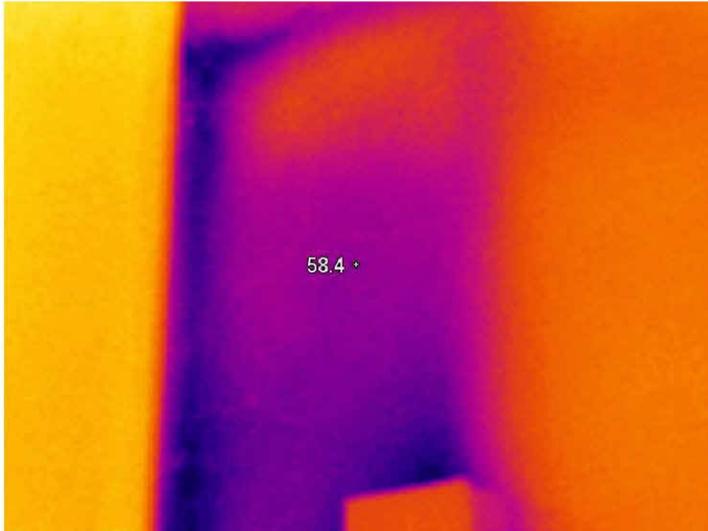
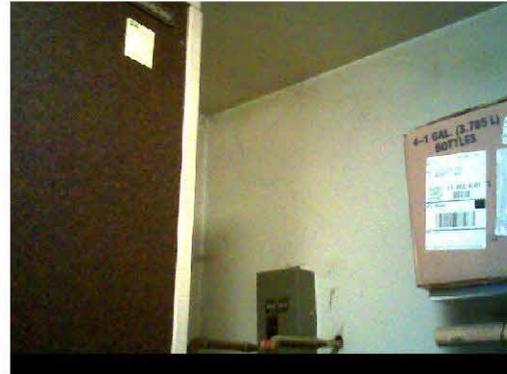
**IR003476.IS2**

The interior wall corner has missing or damaged insulation in the wall. It is not uncommon to find corner bays not as well insulated because there is more framing in the way.

Finally, remove the metal siding panels from outside the bathroom and install the missing insulation behind the corner bays in the bathroom. At the same time insulate any hot water lines found in the exterior walls with properly fitted polypropylene pipe insulation.

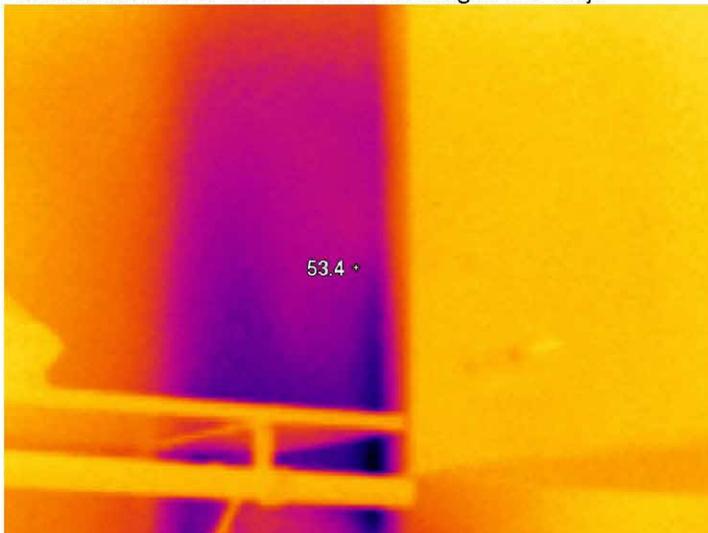
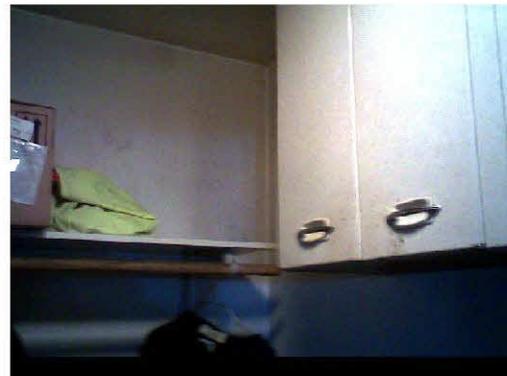
**IR003478.IS2**

The opposite corner of the bathroom has the same problem.

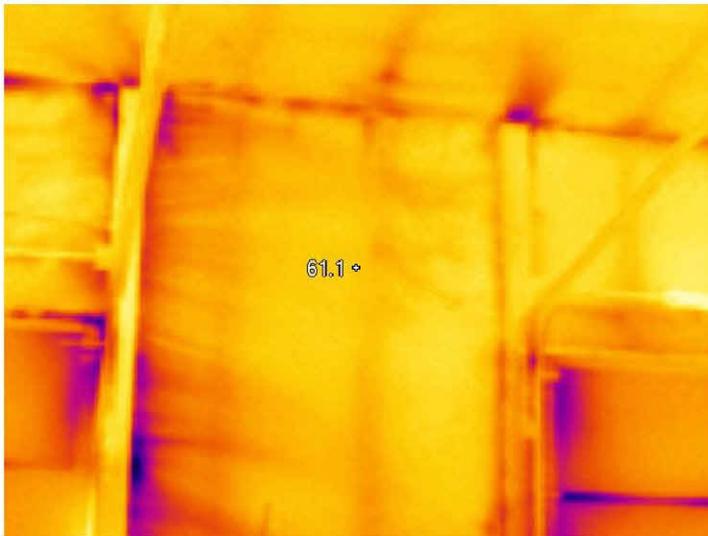
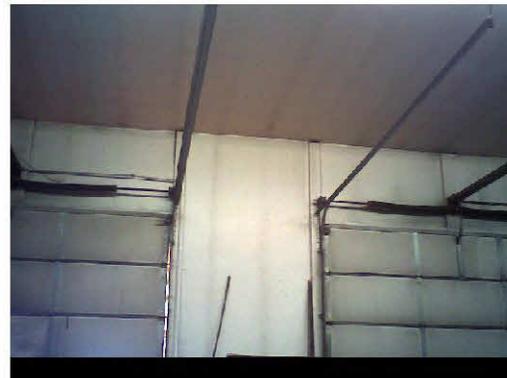
**IR003516.IS2**

Air leakage along the bay door and especially at the planks on either side of the door. Notice that not all the planks leak the same, close visual inspection will reveal which ones to fix first.

Re secure the planks on either side of the bay doors to the walls and air seal the planks with one-part foam for large gaps and caulk for gaps under 1/8" wide. These are significant air leakage sites that are easy to see and repair.

Adjust the bay door closers so the top of the door goes 100% vertical and meets the weather-stripping when closed. Check the weather-stripping on all sides of each door to make sure it is in good repair and in close contact with the door and check the rubber gasket at the bottom of the door for damage. Check the gasketing between each door segment to make sure it is in good repair, replace as needed. When the door is closed, and with the lights off, look at the door from all sides for daylight. If you see daylight the weather stripping needs to be adjusted or replaced. Given the number of large doors on this building it will be worth it in energy savings to check the doors each year for optimal air tightness. When it is time to replace a bay door replace it with a door that has 3" or 4" thick insulated panels so you get a higher total R-value out of the door, target R15 or better.

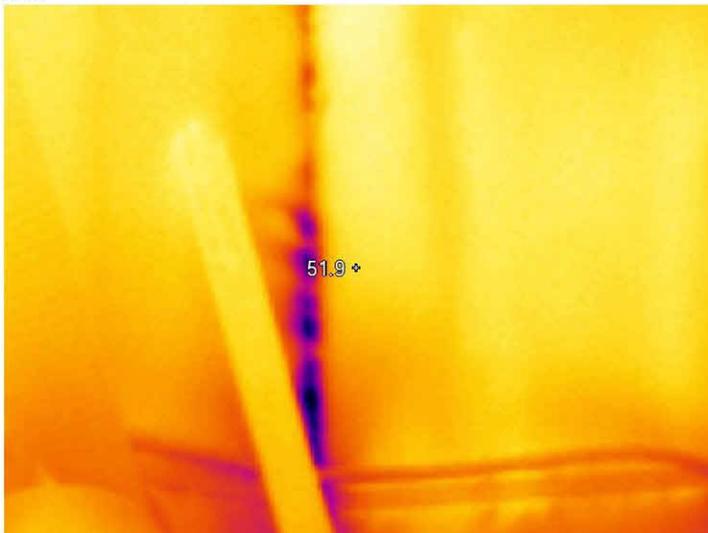
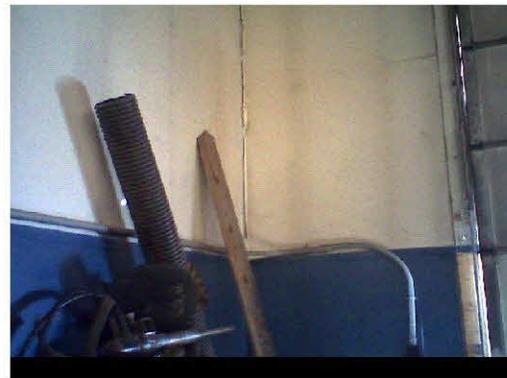
**IR003566.IS2**

The NE corner has been damaged by trucks and the wall has opened some air leaks.

At the NE corner of the building where the wall has been damaged. Seal the visible cracks and openings in the wall with one-part foam.

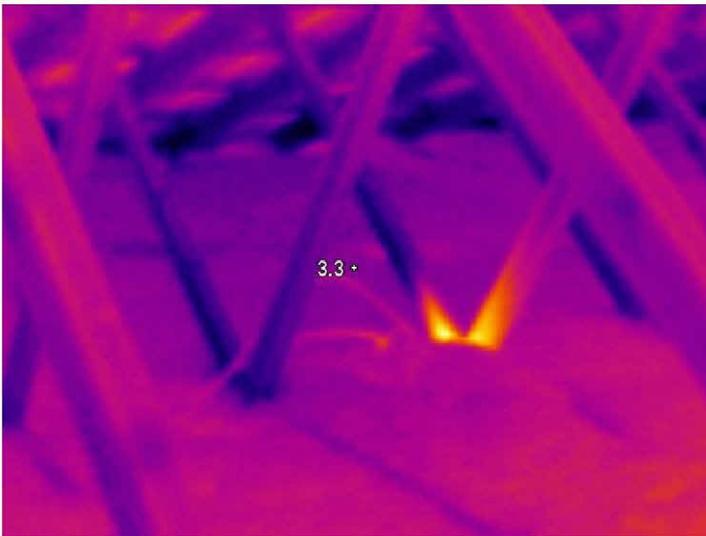
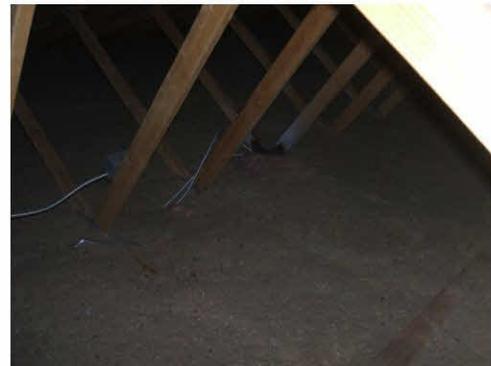
**IR003441.IS2**

This is a wiring penetration in the attic floor. In the visual image note the frost on the truss braces. This is warm air condensing moisture on the truss as it escapes.

In the attic pull back the insulation and foam seal around the isolated penetrations through the sheetrock ceiling and along the top of the gable end walls (shown above). Make sure the foam seals directly to the sheetrock.

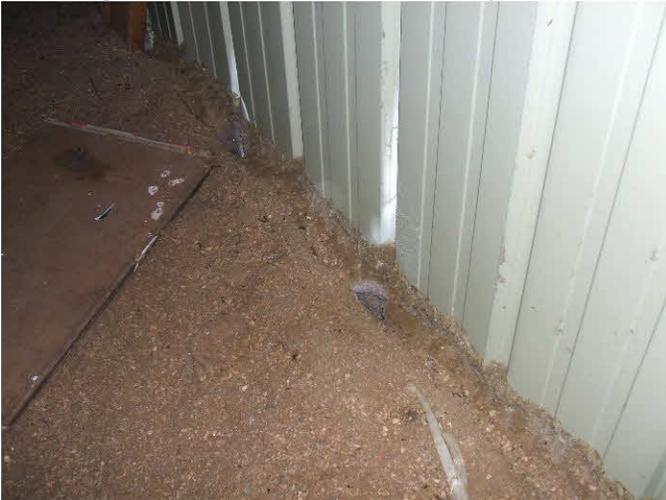
Holes through the insulation at the base of the gable end wall. There is frost lining the holes indicating warm air leakage. Infrared images did not indicate that the tops of the walls are open into the attic, I assume these are isolated leakage sites.

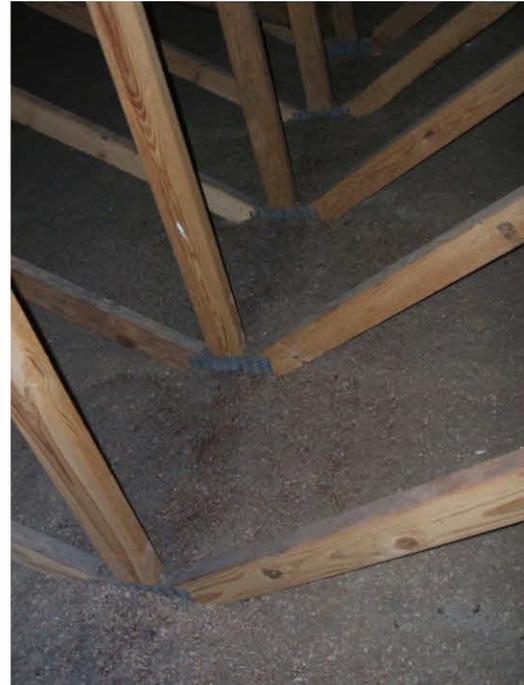
There is debris on the insulation that follows the ridge vent. This is sign that snow and rain can also get in through the ridge cap.

There is a minor problem with the ridge vent on the roof. It is not properly baffled so debris can blow in from outside and land on the insulation. The debris is not a significant problem, there is not much of it, but it is an indicator that snow and rain can come in also and it is best to avoid wetting the insulation. A roofer can recommend a better ridge baffle that will allow air flow but block water and debris.

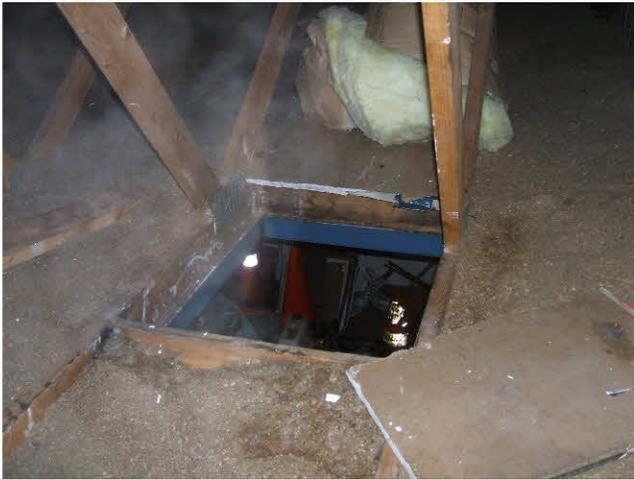
The attic hatch is a panel of broken sheetrock.

Install a new attic hatch with weather-stripping and at least 6" of rigid polyisocyanurate (foil faced foam board) insulation attached. Use 3/4" plywood and sheetrock for strength and weight so the hatch presses

down on the weather-stripping when closed. Use wide foil tape to cover and protect the edges of the insulation and then glue or screw the rigid foam insulation to the plywood so it remains affixed to the hatch indefinitely.

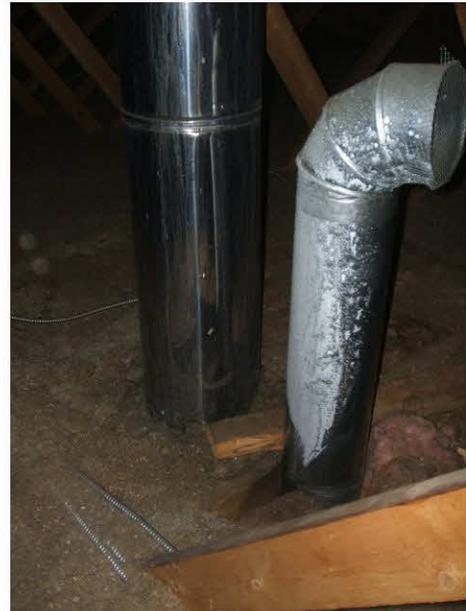
Similar to the truss brace above, warm air is keeping the bottom of this intake pipe warm and depositing frost on the cooler part above. This pipe needs to be foam sealed at the sheetrock.

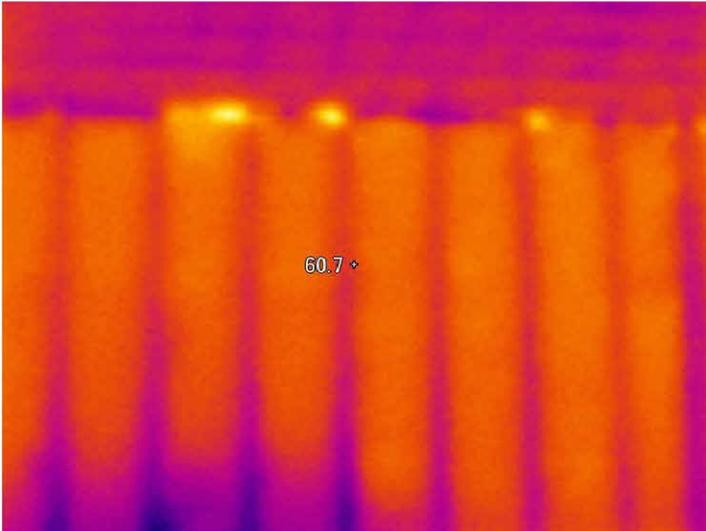
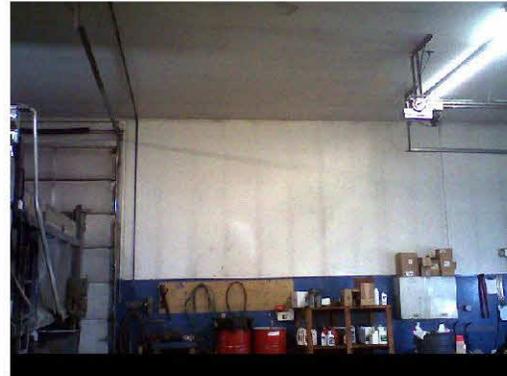
**IR003458.IS2**

The ceiling viewed under normal pressure. The strapping and truss chords can be seen as a grid pattern. Note that the framing pattern is faintly visible on the ceiling and walls in the visible light image, this is called shadowing and is caused by the exhaust from equipment. It is diagnostic in that every dark area is a location of heat loss, like having your own infrared image of the walls and ceilings.

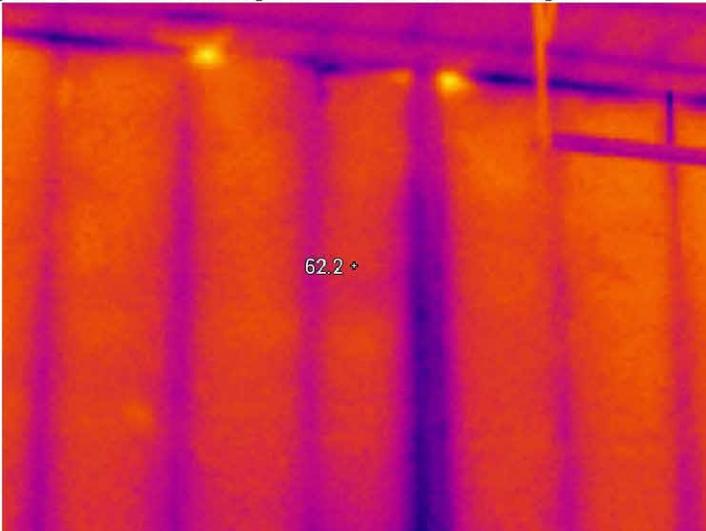
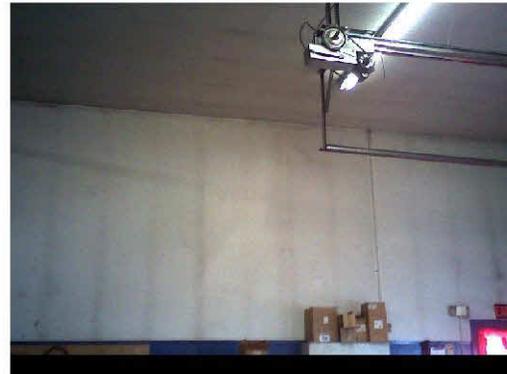
**IR003507.IS2**

The ceiling under depressurization. The ceiling looks about the same indicating that air leakage in the ceiling is minor.

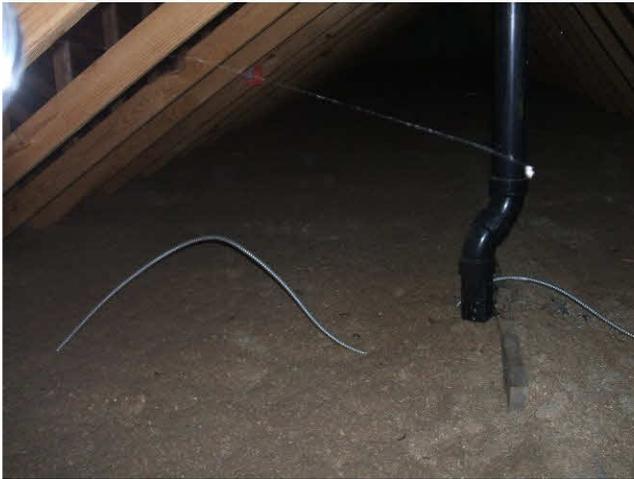
The insulation appears matted down by water. This could be caused by condensation on the roof deck "raining" down or slow air infiltration through the insulation from below. There are indicators of both conditions in this attic.

I recommend installing an additional R30 fiberglass batt insulation over the existing insulation perpendicular to the existing batt insulation. This work needs to be done carefully so the new insulation is cut and fit around the truss braces, inspect the installation as the job progresses to insure the proper fit. Use UNFACED fiberglass so water vapor does not get trapped between insulation layers. I am recommending fiberglass batt as the additional insulation because it is resilient to moisture. Blown in fiberglass or cellulose would be faster to install but will mat down over time in this attic. Complete removal of the insulation, air sealing, and reinstallation to make the ceiling airtight would reduce the amount of warm air that escapes and condenses but the cost is not justified in energy savings.

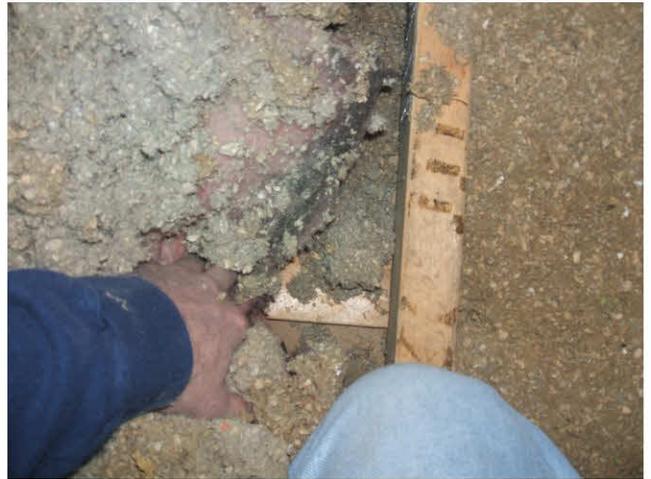
The fiberglass is dark on the bottom, an indication that at least some air is moving through the insulation.

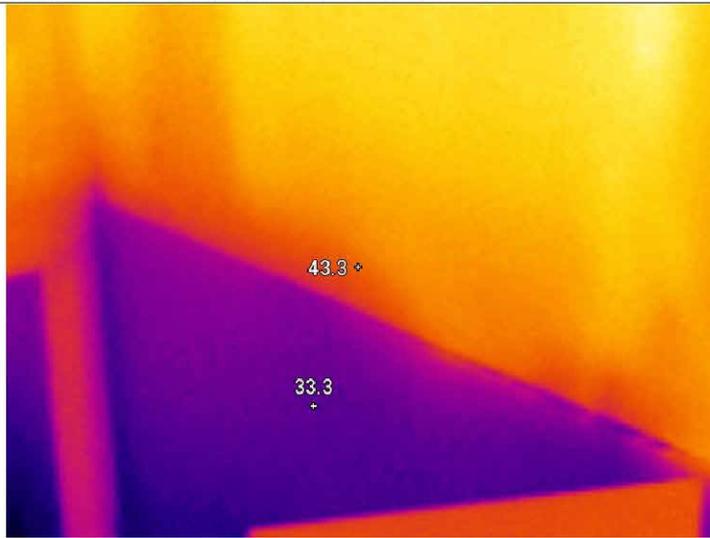
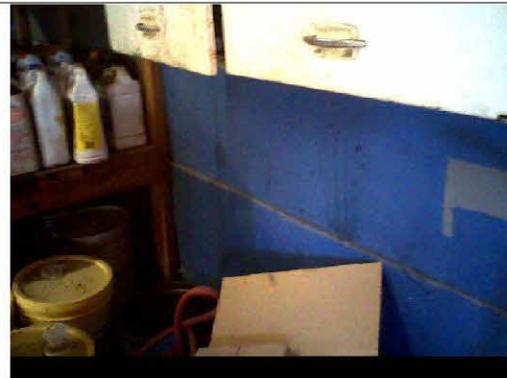
**IR003569.IS2**

The foundation wall is exposed 2' high all the way around the building. In the image you can see it reads a full 10° F cooler than the wall above.

Insulate the foundation wall from outside (preferred method):

1. From outside dig down into the soil around the foundation and expose 12" to 18" of the foundation wall. Wash off the soil and allow the walls to dry completely.
2. Glue at least 2" thickness of rigid expanded polystyrene (XPS) foam board (blue or pink board) to the wall by setting it in the bottom of the trench and going up to the top of the foundation. 3 or 4 inch thickness will save more but the largest payback will come from the first 2" of foam. Be cautious about the glue you select, get a construction adhesive that is formulated for XPS insulation, the other types will eat the foam.
3. Cover the above grade XPS insulation with metal sheeting (break metal), vinyl coil stock, or stucco.
4. Backfill the trenches in the soil.

1. Clear as much of the walls as possible. Remove shelving if possible.
2. Glue at least 2” thickness of rigid expanded polystyrene (XPS) foam board (blue or pink board) to the wall by setting it on the floor and going up 8-12” into the framed wall (since they are flush). 3 or 4 inch thickness will save more but the largest payback will come from the first 2” of foam. Be cautious about the glue you select, get a construction adhesive that is formulated for XPS insulation, the other types will eat the foam.
3. Since the insulation is inside it will not need to be covered but high traffic areas should have protective plywood put over the XPS to keep it from being damaged.
