Town of Bridgewater Road Erosion Inventory Report

In the spring of 2017, the Two Rivers-Ottauquechee Regional Commission (TRORC) conducted a road erosion inventory (REI) to evaluate hydrologically connected segments in the town of Bridgewater. This report highlights the road sites with the most significant hydrological impact due to erosion within the municipality.

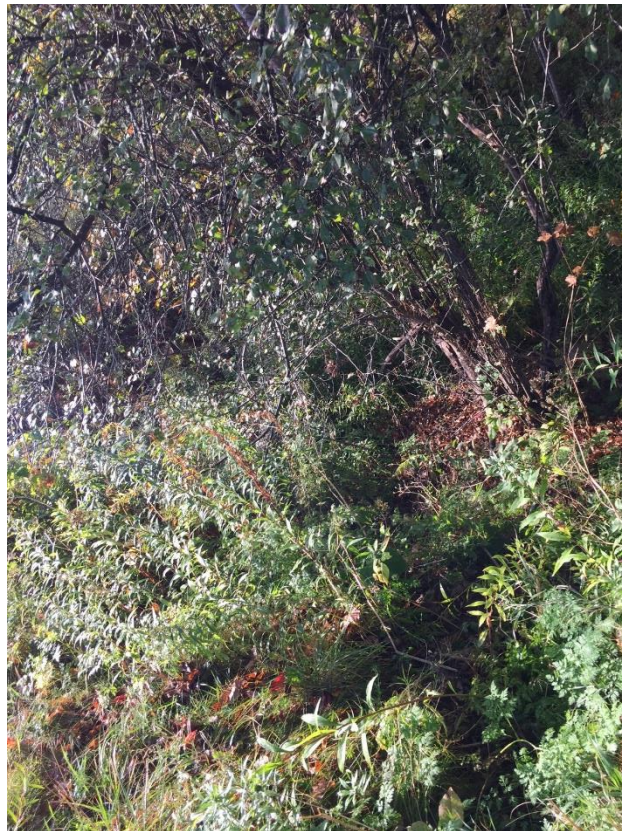
Road Segment Name & Segment ID Number:	Road Type:	Map Identification Number:
Bridgewater Ctr Rd 5753	Paved	2

Overall Segment Score: Does Not Meet

5. DRIVEWAY CULVERT:	5. DRAINAGE CULVERT:	Erosion Present	Type of Erosion
Fully Meets	Does Not Meet	Yes	3 bad outlets, 3 gully sites

Notes: Erosion at all culvert inlets

Culvert outlet. *Photo taken by TRORC staff.*

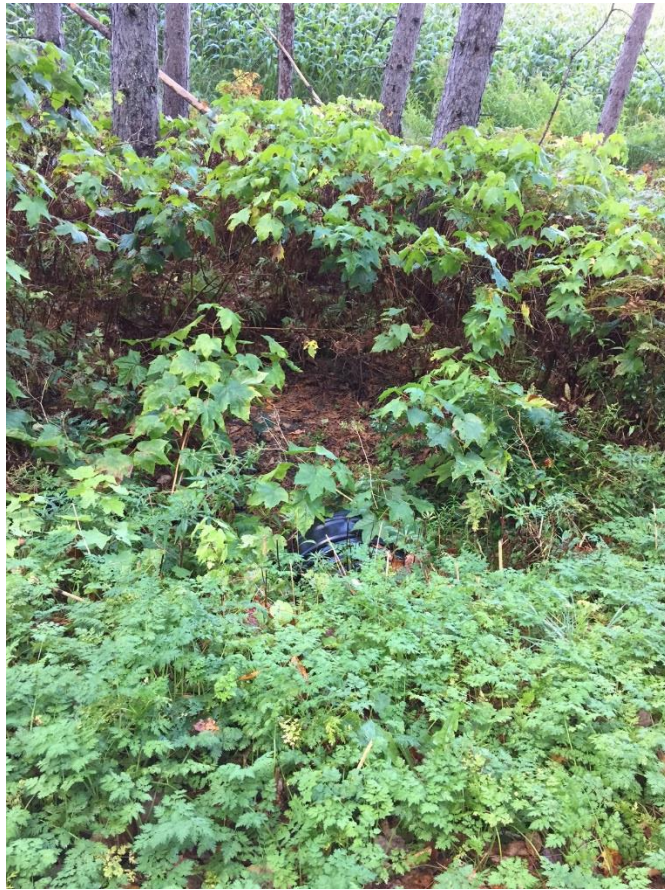
Road Segment Name & Segment ID Number:	Road Type:	Map Identification Number:
Bridgewater Ctr Rd 5754	Paved	3

Overall Segment Score: Does Not Meet

5. DRIVEWAY CULVERT:	5. DRAINAGE CULVERT:	Erosion Present	Type of Erosion
Fully Meets	Does Not Meet	Yes	1 bad outlets, 1 gully site

Notes: Large abutment and rip rap. One stream-road conflict.

Culvert outlet. *Photo taken by TRORC staff.*

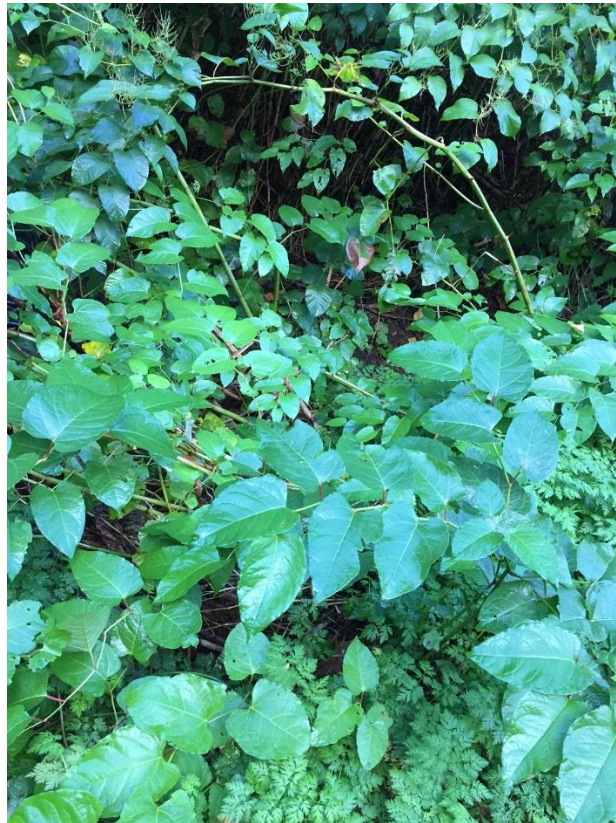
Road Segment Name & Segment ID Number:	Road Type:	Map Identification Number:
Bridgewater Ctr Rd 5755	Paved	4

Overall Segment Score: Does Not Meet

5. DRIVEWAY CULVERT:	5. DRAINAGE CULVERT:	Erosion Present	Type of Erosion
Fully Meets	Does Not Meet	Yes	2 bad outlets, 2 gully sites

Notes: Significant erosion at culvert inlets. One stream-road conflict.

Culvert outlet. Photo taken by TRORC staff.

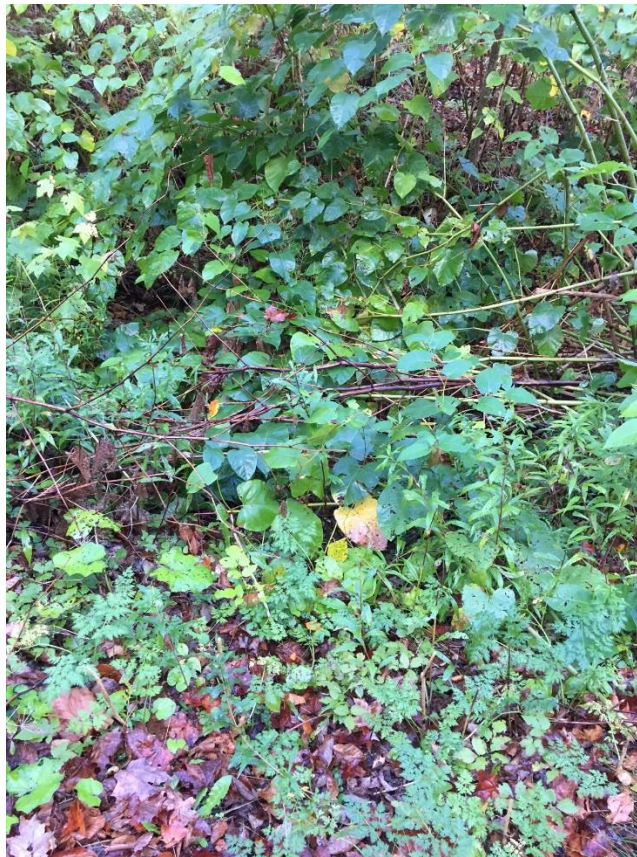
Road Segment Name & Segment ID Number:	Road Type:	Map Identification Number:
Bridgewater Ctr Rd 5756	Paved	5

Overall Segment Score: Does Not Meet

5. DRIVEWAY CULVERT:	5. DRAINAGE CULVERT:	Erosion Present	Type of Erosion
Fully Meets	Does Not Meet	Yes	1 bad outlet, 1 gully site

Notes: Ditches eroding. Stabilize!

Culvert outlet. Photo taken by TRORC staff.

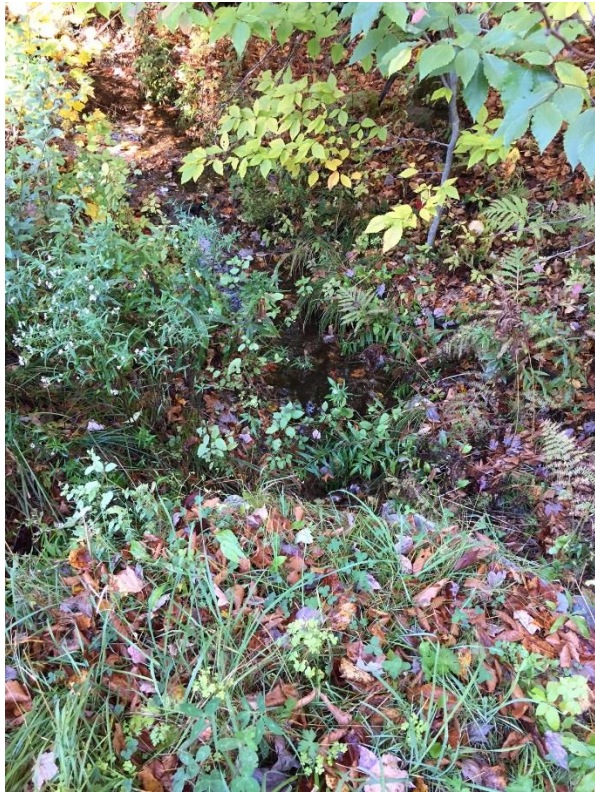
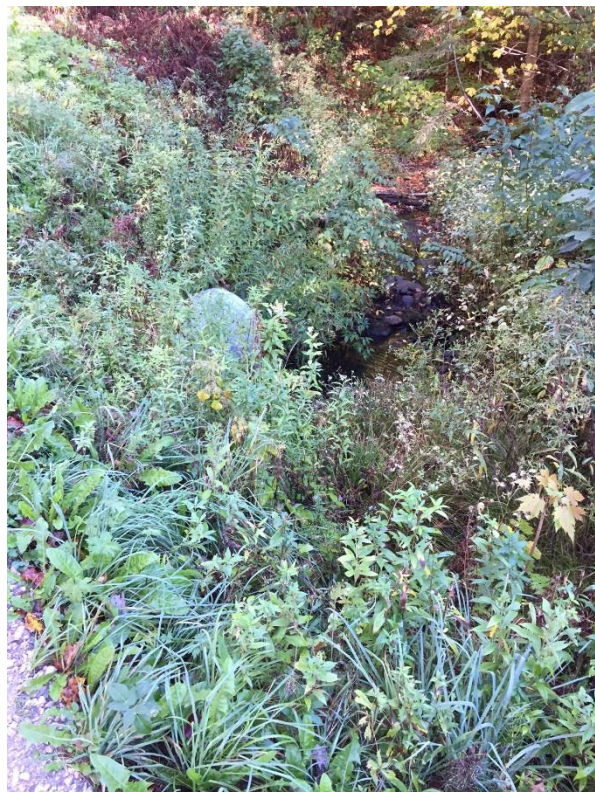
Road Segment Name & Segment ID Number:	Road Type:	Map Identification Number:
Bridgewater Hill Rd 12724	Gravel	6

Overall Segment Score: Does Not Meet

1. ROADWAY CROWN/TRAVEL LANE:	2. GRADER BERM/WINDROW:
Fully Meets	Does Not Meet
3. ROAD DRAINAGE:	4. CONVEYANCE AREA/TURNOUT:
Fully Meets	Does Not Meet

5. DRIVEWAY CULVERT:	5. DRAINAGE CULVERT:	Erosion Present	Type of Erosion
Fully Meets	Partially Meets	No	1 stream culvert

Notes: Conyeances bad. Perched.

Culvert inlet. *Photo taken by TRORC staff.*

Culvert outlet. *Photo taken by TRORC staff.*

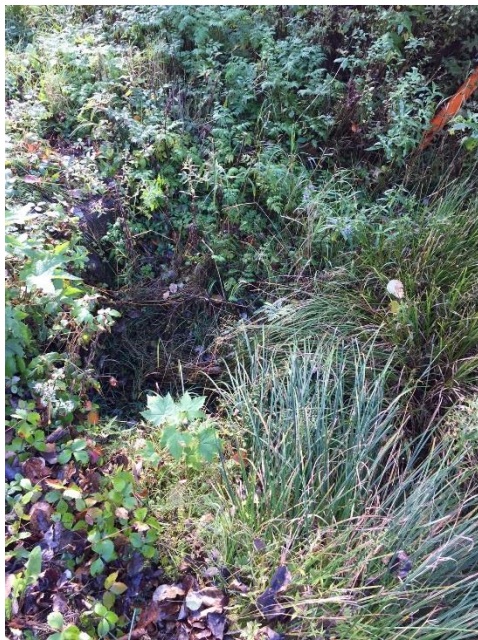
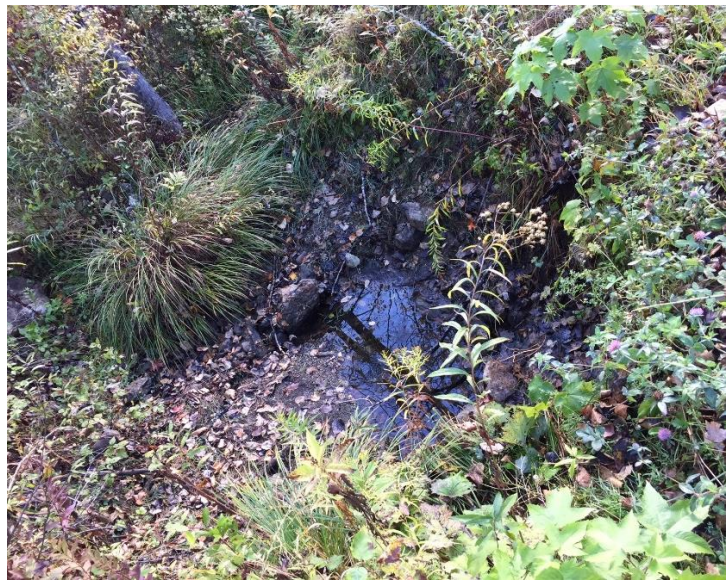
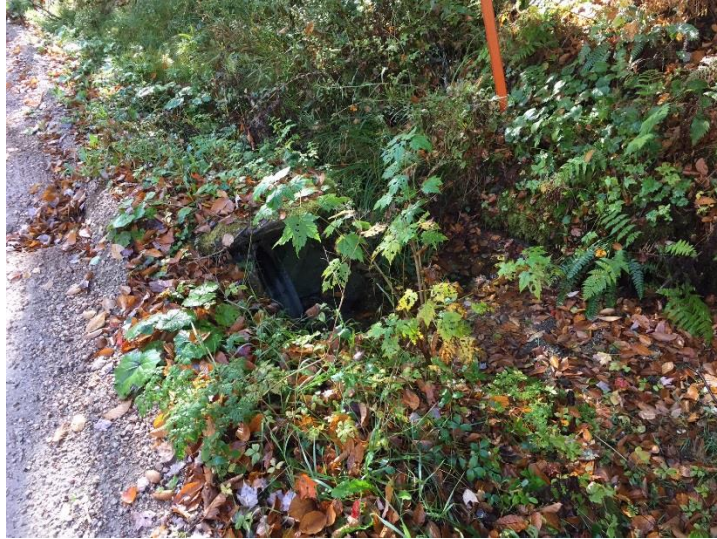
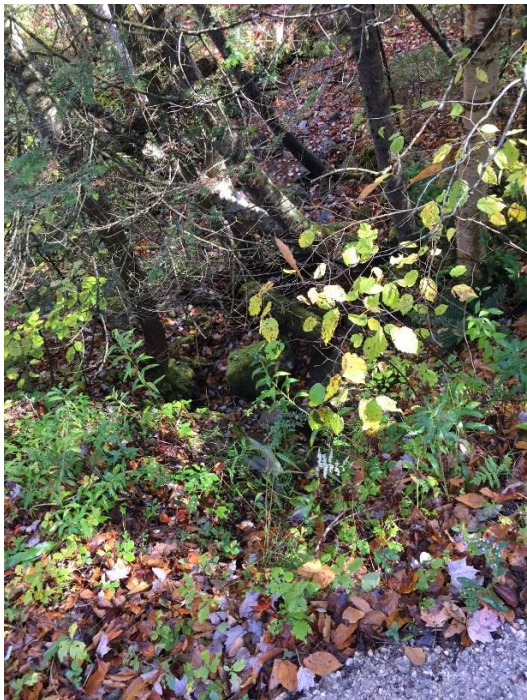
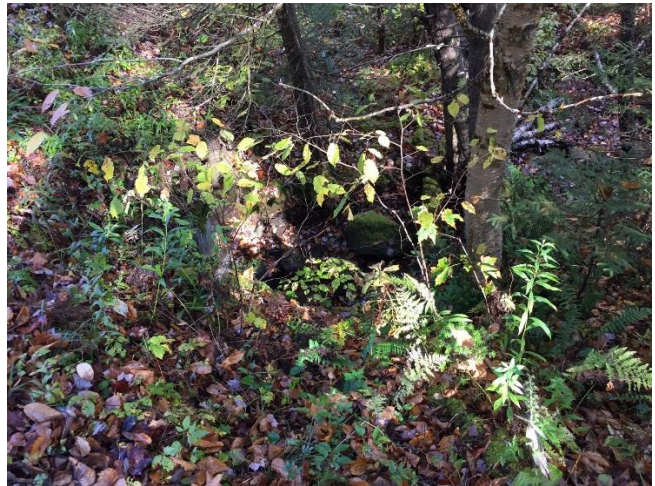
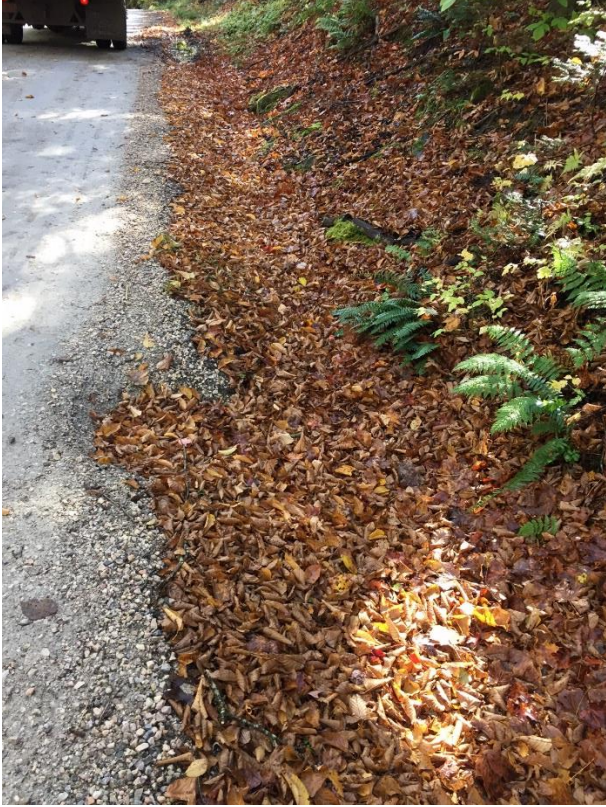
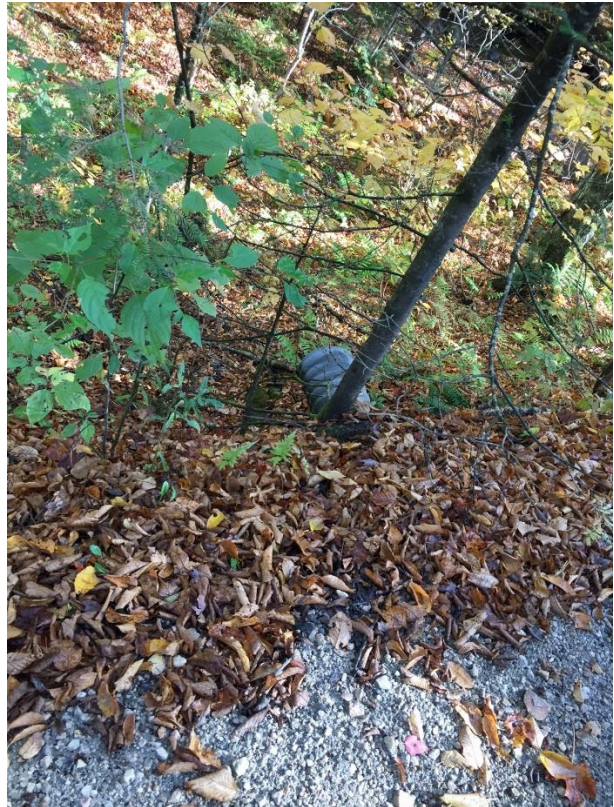
Road Segment Name & Segment ID Number:	Road Type:	Map Identification Number:
Chateauguay Rd 21317	Gravel	7

Overall Segment Score: Does Not Meet

5. DRIVEWAY CULVERT:	5. DRAINAGE CULVERT:	Erosion Present	Type of Erosion
Fully Meets	Does Not Meet	Yes	1 gully erosion, 2 bad outlets

Notes: Whole segment next to stream. One stream-road conflict.

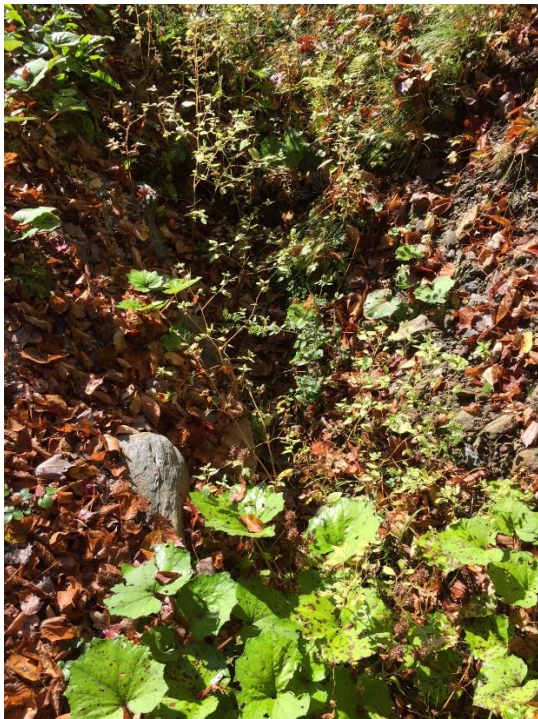
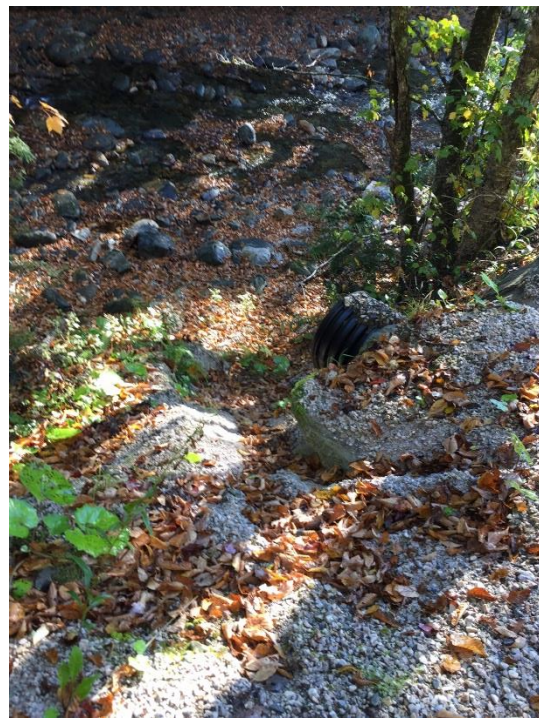
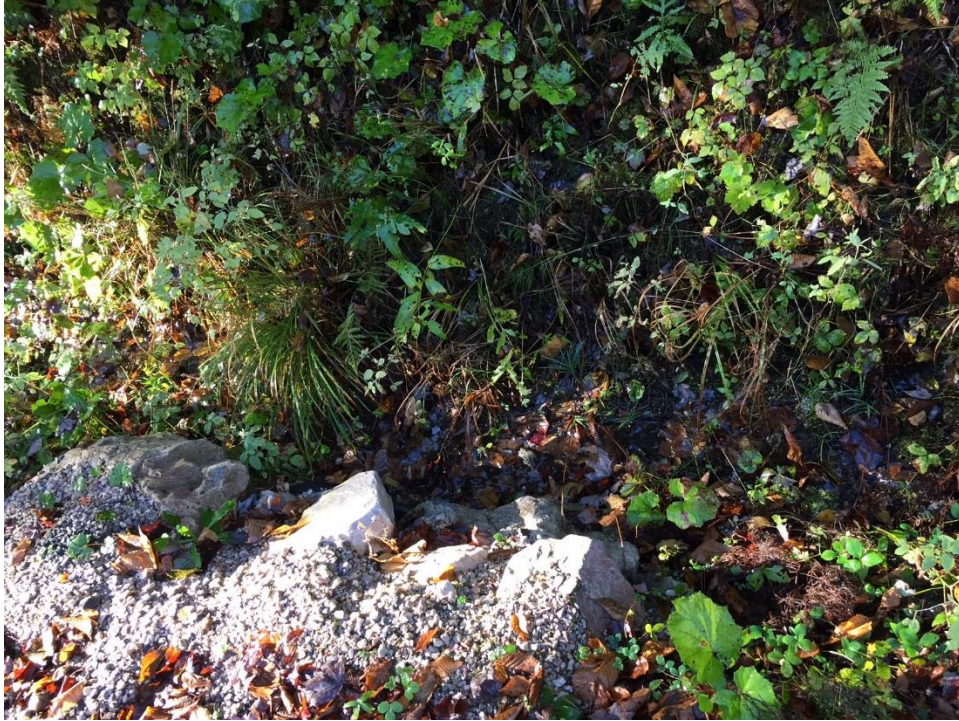
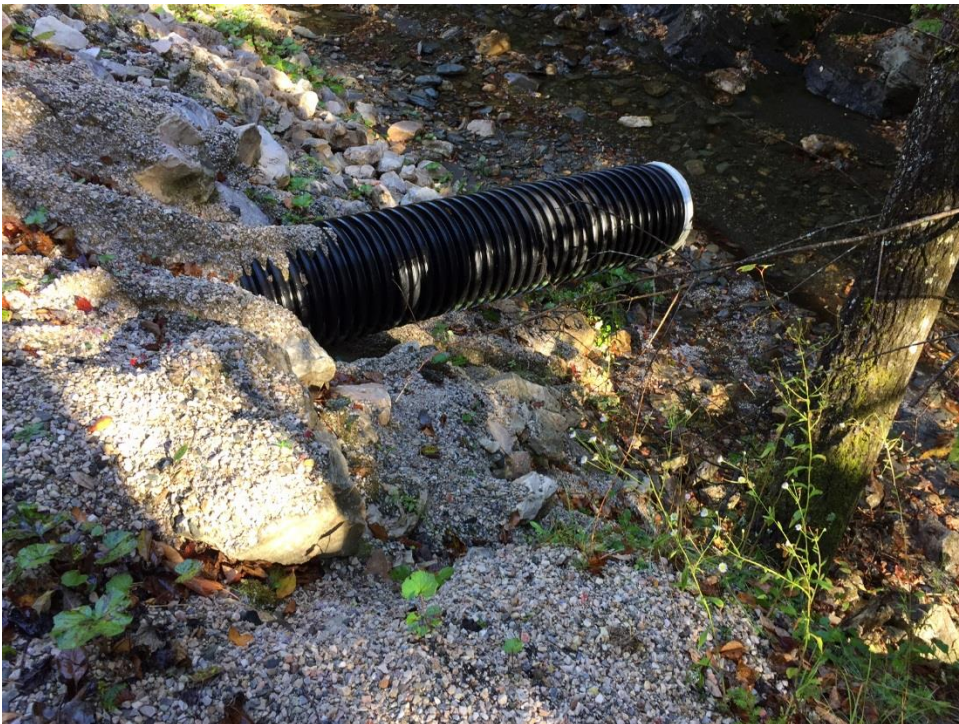
Road Segment Name & Segment ID Number:	Road Type:	Map Identification Number:
Fancher Rd 96368	Gravel	8

Overall Segment Score: Does Not Meet

5. DRIVEWAY CULVERT:	5. DRAINAGE CULVERT:	Erosion Present	Type of Erosion
Fully Meets	Does Not Meet	Yes	2 Gully erosion, 2 bad outlets

Notes: Both culverts need work. One way too long perched. Two stream-road conflicts.

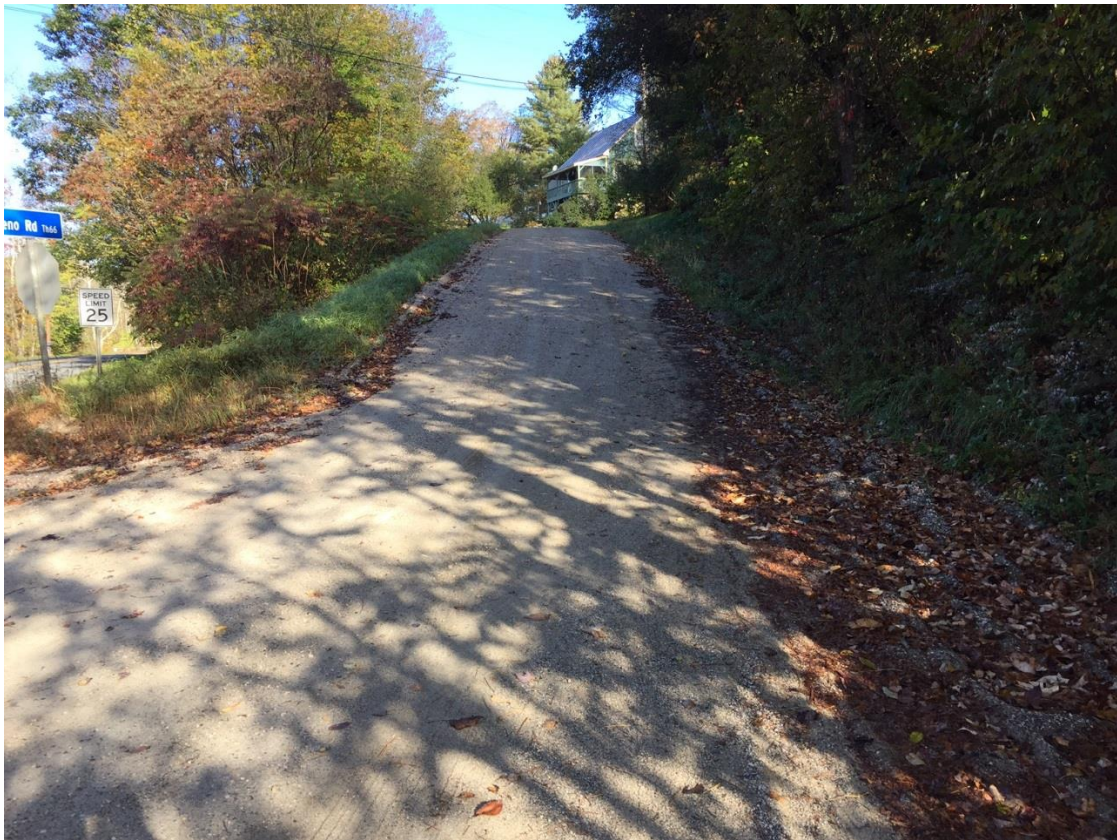
Road Segment Name & Segment ID Number:	Road Type:	Map Identification Number:
Geno Rd 101821	Gravel	9

Overall Segment Score: Does Not Meet

1. ROADWAY CROWN/TRAVEL LANE:	2. GRADER BERM/WINDROW:
Fully Meets	Partially Meets
3. ROAD DRAINAGE:	4. CONVEYANCE AREA/TURNOUT:
Partially Meets	Partially Meets

Notes: Ditches eroding and runoff in roadway.
