Brookfield Town Office/Library

Building Energy Plan

RE: Energy Audit Conducted April 13, 2011 on the Brookfield Town Office and Library.

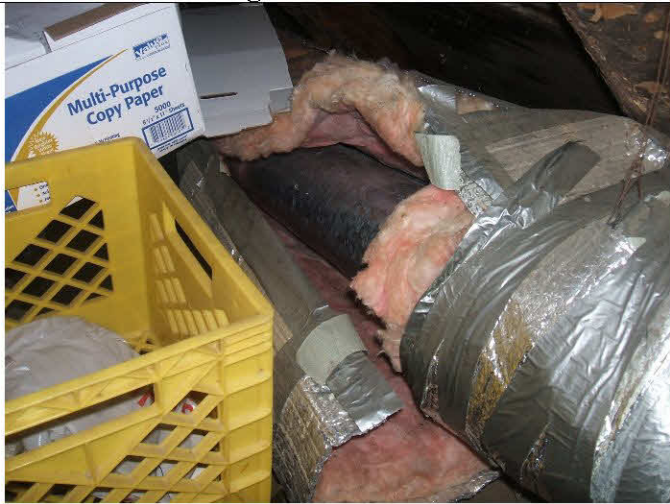
The existing ducts are poorly sealed and insulated.

The office and library furnaces had steady state efficiencies of 77.7% and 75.9% respectively. Judging by their age I expect their annual fuel utilization efficiencies (AFUE) to be in the 65% range. Plan to replace the office furnace with a new high efficiency furnace (92% AFUE or better) with an ECM fan motor as soon as possible. When the new furnace is installed, bring the combustion intake air directly to burner and remove the existing air intake to the boiler room and insulate and seal shut the opening. At that time, it would be appropriate to install a mechanical damper on the branch of the ducts that go to the library that is controlled by a programmable thermostat in the library so the library can be heated independently of the office space. Have an experienced HVAC technician or engineer review the present duct system to determine if it can be zoned properly or if a dump zone is needed for proper operation of the furnace. Remove the insulation on all the ducts in the attic so all seams on the ducts can be heavily coated with mastic and reinsulated and add balancing dampers at each supply so the air flow can be adjusted and balanced. Go heavy on the mastic to be assured the ducts are well sealed, the typical application is not sufficient. At the same time, have the HVAC technician review the return air on the office ducts to see if it is adequate. Two returns are covered in furnace room presently and the cabinet cover is sucked in indicating that the air handler is starved for return air.

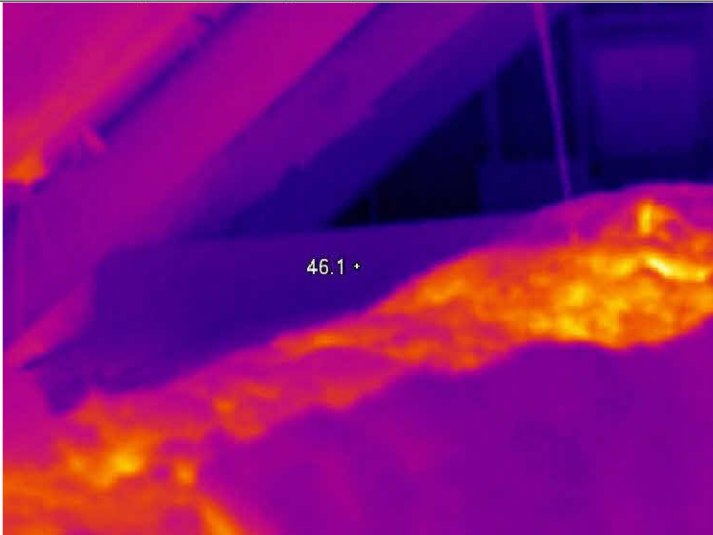
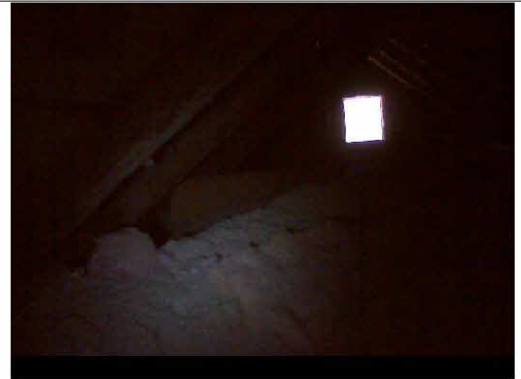
Heat from the ducts is being lost into the cold attics.

Air seal the office attic at the same time as the duct improvements described above. Move the existing fiberglass and cellulose to expose all the tops of the interior walls, dropped ceilings, and mechanical and electrical penetrations in the ceiling so they can be sealed with foam. Seal a rigid foam plug in place in the defunct chimney in the library attic. I recommend using a blower door during the air sealing work to check the progress of air sealing efforts. Home performance contractors should have their own blower door to check progress. After air sealing is complete reinstall the existing insulation and then cover the whole attic in about 8 more inches of cellulose.

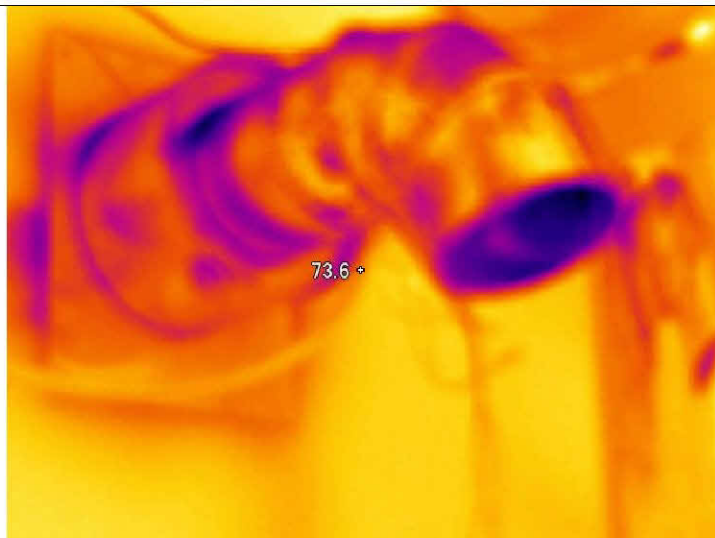
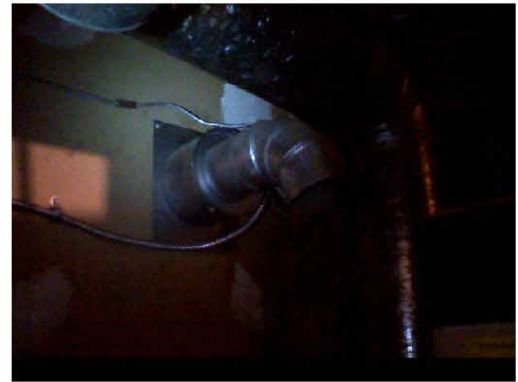
The outside air intake is large air leak that can be eliminated by ducting combustion air directly to the burner.

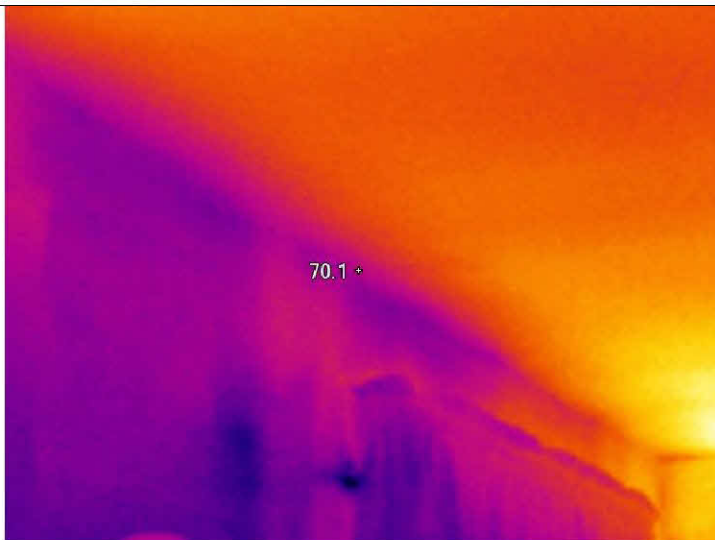
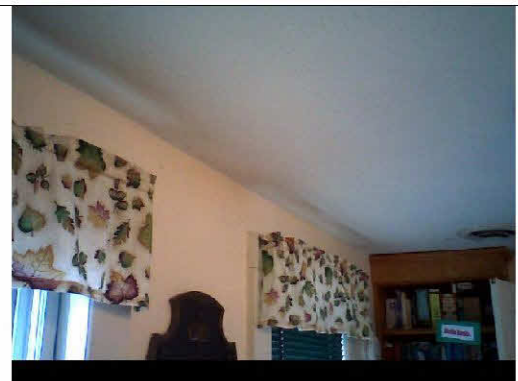
The library walls are uninsulated lathe and plaster walls.

The library walls are empty and have 4” of cavity space so they could be insulated with dense packed cellulose or open cell foam. I recommend insulating them from outside just before the clapboards are to be repainted (within the next 5 years) so holes drilled through the siding for the insulation can be patched easily.

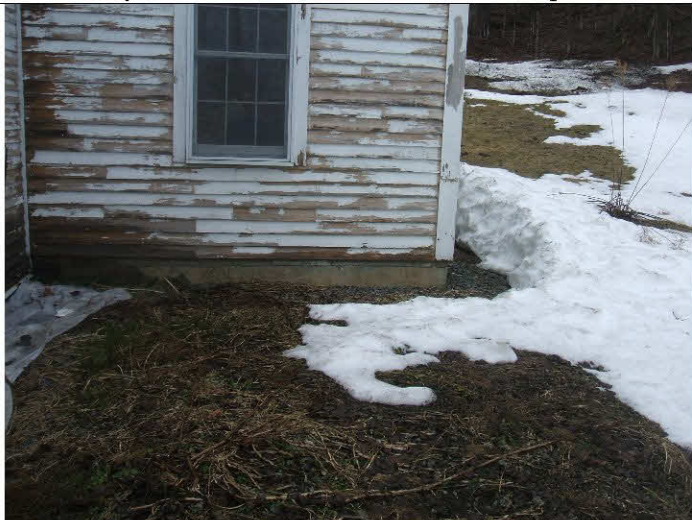
The clapboards are in need of repair and paint.

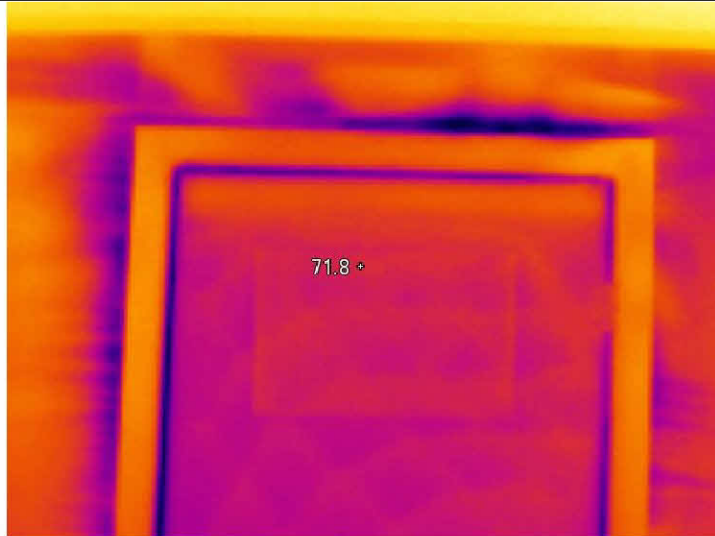
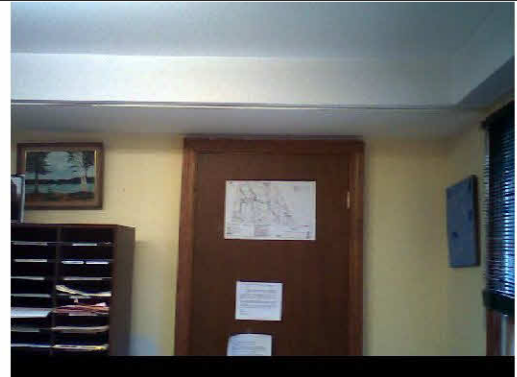
Air leakage around the trim of the attic door. The door also lacks insulation.

Insulate and weather strip the interior doors to the attic and basement by adding 2-3" rigid insulation to the back of the door and weather stripping the door and adding a door sweep at the threshold (see further on in this section for details on exterior doors). The attic door should also have the trim removed so the door frame can be foam sealed to the rough opening of the wall.

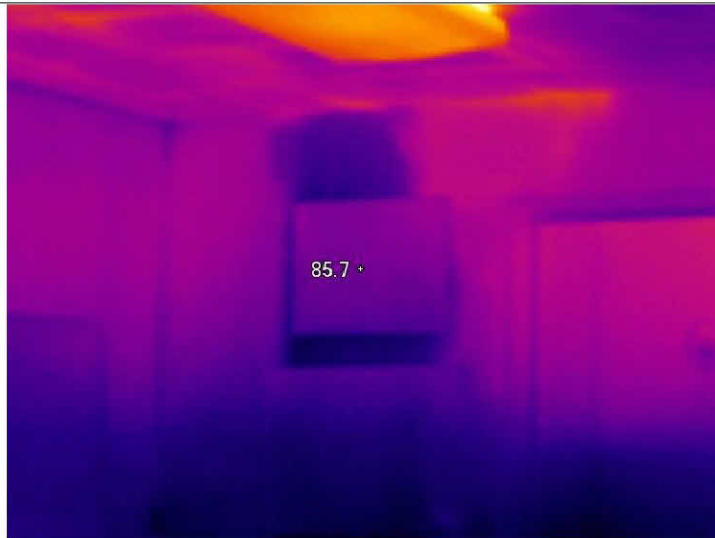
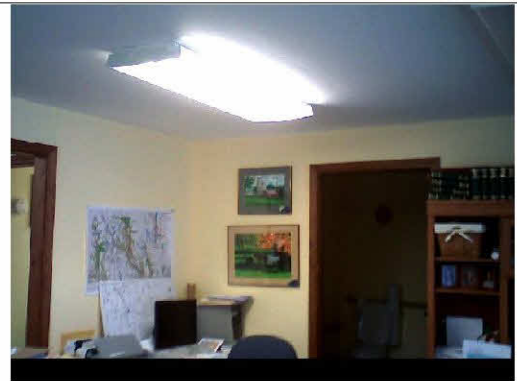
Cold air down into an interior wall from the attic above.

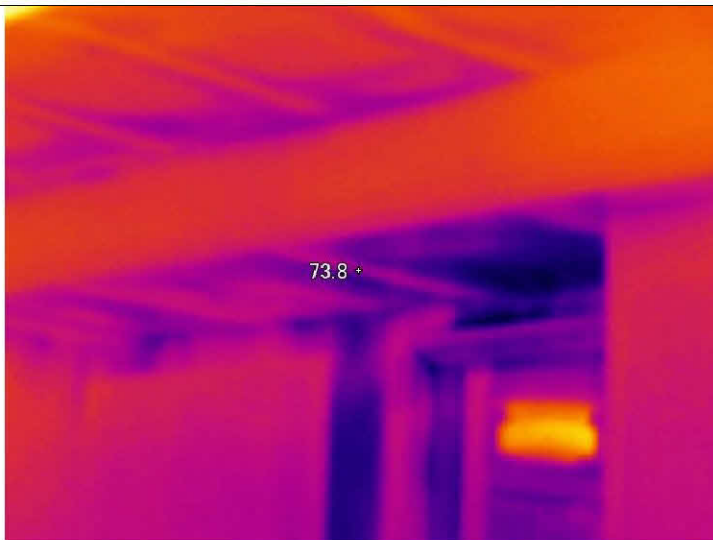
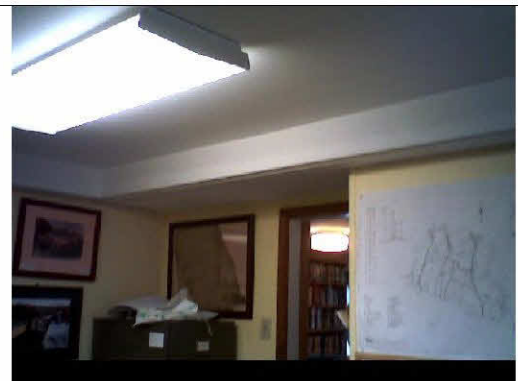
Cold ceiling bays and interior wall bays where the ceiling changes plane.

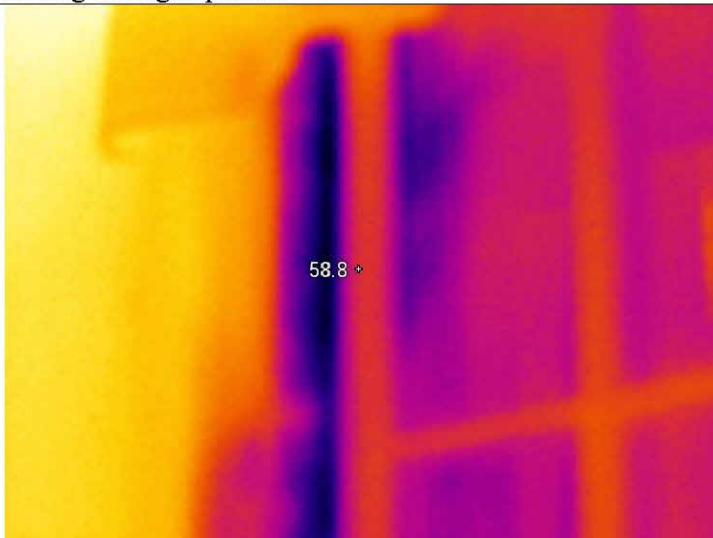
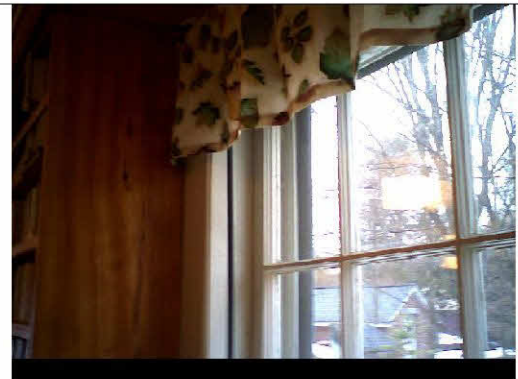
Air leakage at the jamb of a library window upper sash.

Most of the single pane windows with storm windows in the library are air leaky at all sides of each sash. Make the upper sash a fixed pane and caulk it in place. Weather strip the lower sash and the storm windows based on the recommendations below*:

1. Window sashes can be sealed at top, bottom and edges by installing v-shaped weather-strip. Top and bottom weather-strip can be installed on the window casing where the top and bottom sash close, with sash in place. To install side weather-strip, remove the window stops from one side of the sash, remove the sash, install v-shaped weather-strip on the window jamb with point of weather-strip pointing in and replace the sash. If sash is too tight to fit with new weather-strip, you will need to trim off a very small amount from one of the sash edges, leaving sash wide enough that they press out against and compress the weather-strip. Vinyl v-weather-strip is available from most building supply warehouses. Much longer lasting bronze v-strip is available from Architectural Resource Center: <http://www.aresource.com/cushion.html#start>

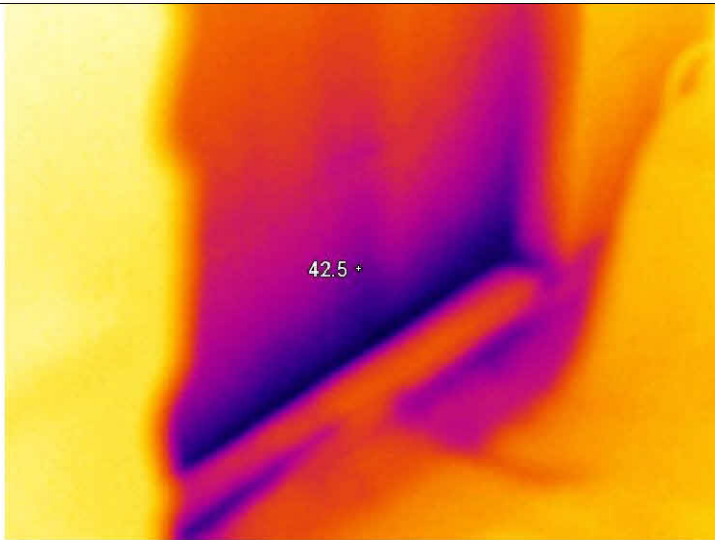
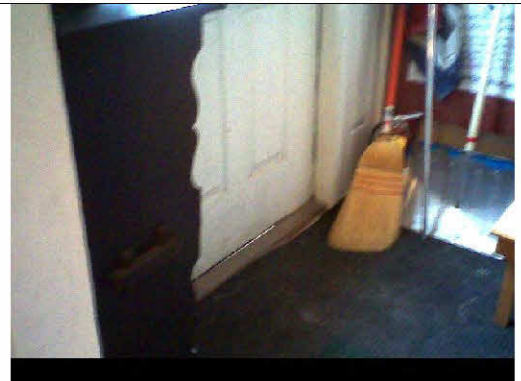
Air leakage at the missing door sweep of the library door.

Weather-strip the exterior doors at the head, jambs, and especially at the threshold with commercial grade weather-stripping (www.draftseal.com or Q-Ion available through The Energy Federation (www.efi.org)). When the door is closed you should not be able to see daylight light at the perimeter. Door thresholds also need to be added/replaced if they can be, if not, door sweeps should be added. Remove the wood trim and foam seal the perimeter of the side lights on the library door.

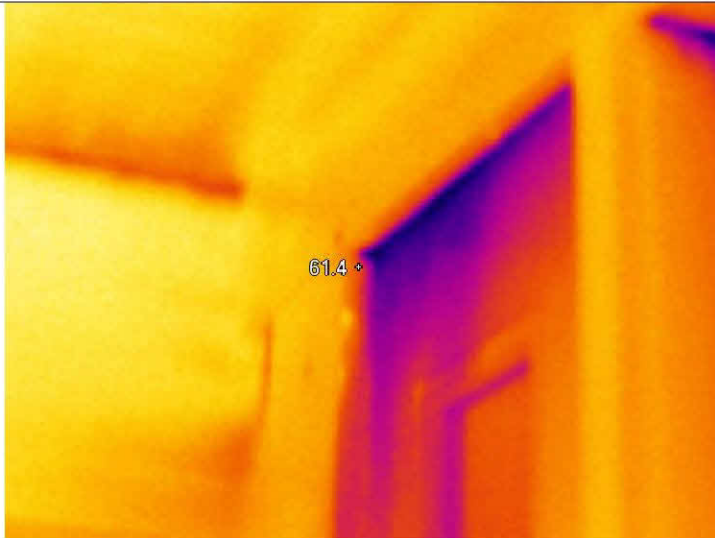
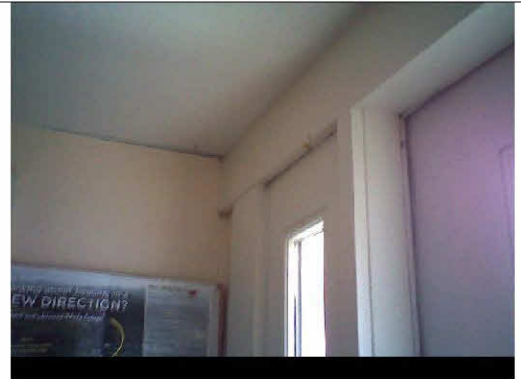
Air leakage around the door side light.

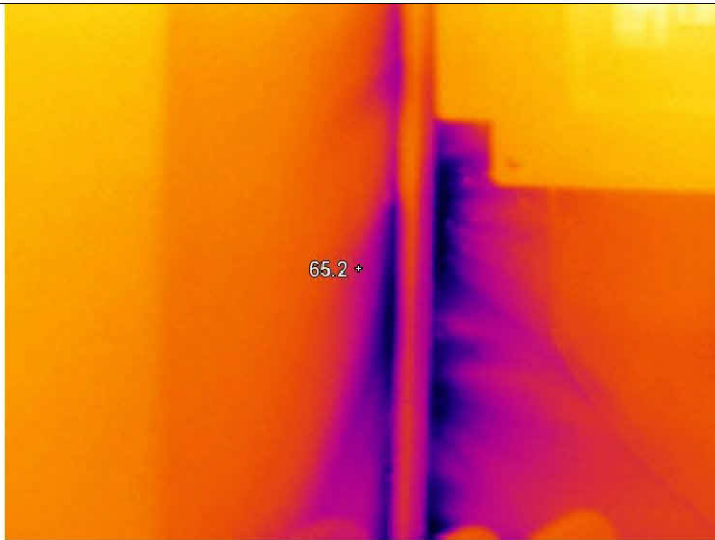
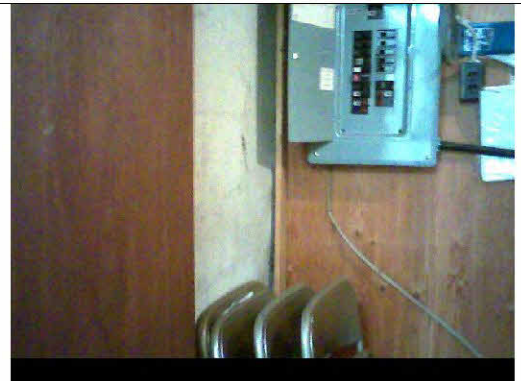
Air leakage in the corner of the boiler room.

Foam seal all the visible gaps and transitions in the sheetrock on the walls and ceiling of the boiler room.

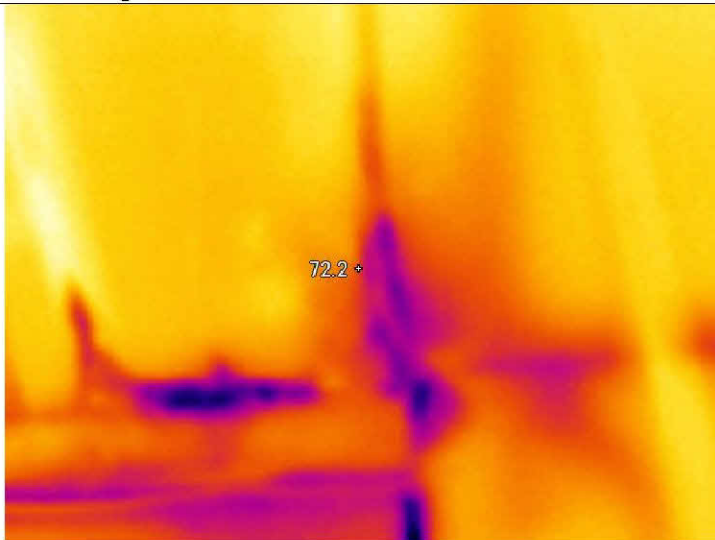
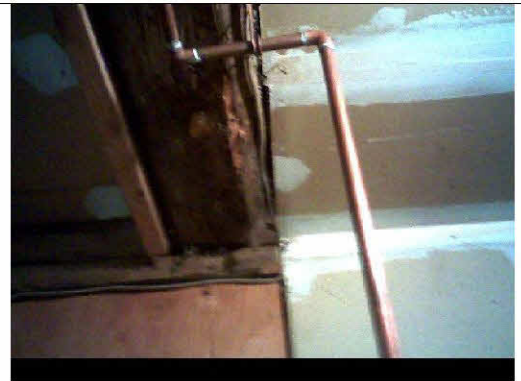
Air leakage in the ceiling of the boiler room.

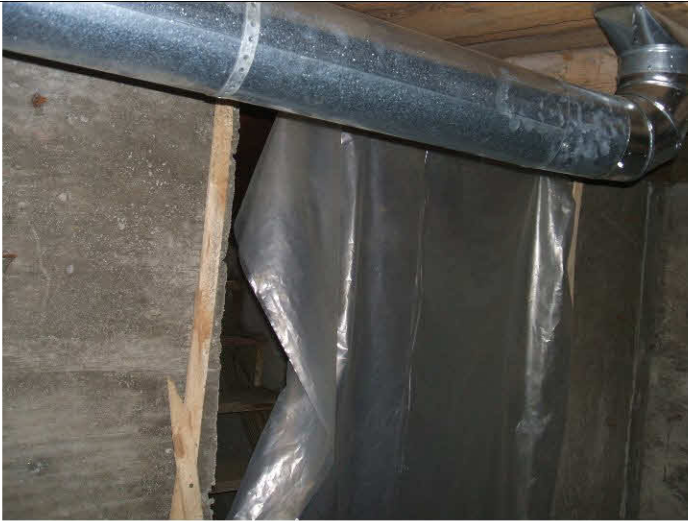
The basement bulkhead allows outside air into the basement.

If the library furnace is no longer used close the duct openings in the floor and insulate the basement ceiling with 2 layers of 2" rigid foam board staggered and foam sealed in place between the floor joists. Install an insulated and airtight doorway at the base of the bulkhead stairs. This is a major location for air infiltration and the whole building will benefit in reduced stack effect by sealing this entrance.

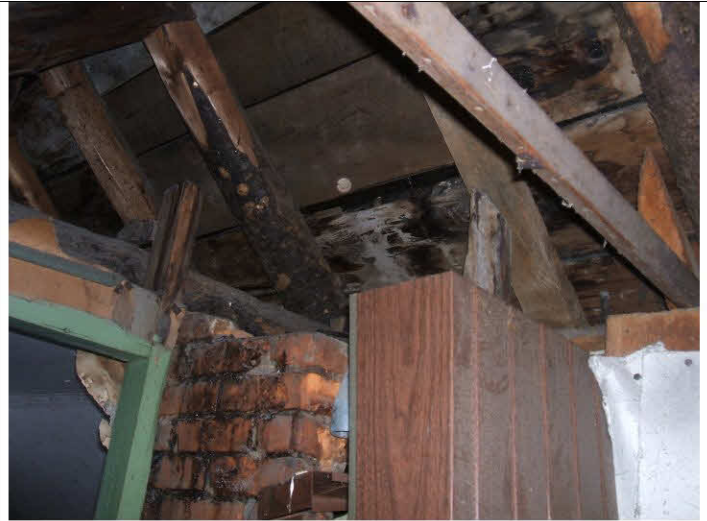
The top of a defunct chimney in the attic. It has a plug in it but I am not sure that it is air sealed.
