Stockbridge Town Garage Building Energy Plan

Building Energy Plan

December 17, 2010

RE: Energy Audit Conducted October 5, 2010 on the Stockbridge Town Garage and Fire Dept.

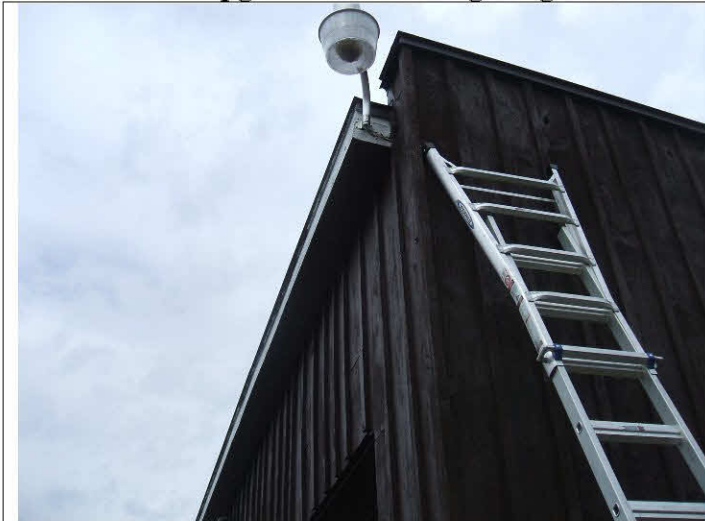
Finding: There are 2 outside lights on the garage and 1 on the salt shed on photo sensor controls. At least one is on all night, every night. In the winter, 2 and occasionally 3 may be on all night. The salt shed light is supposed to be off most of the time but occasionally it is left on. I was not able to confirm the wattage but I believe that they each have a 250 watt high pressure sodium (HPS) bulb.

Recommendation: Switch the outdoor HPS lights to an LED light with comparable light quality. Check the rated lumin output of the existing HPS light to find the best match in a LED replacement. Alternatively, you may consider using an incandescent flood light on a motion sensor for security so the lights do not have to remain on all night.

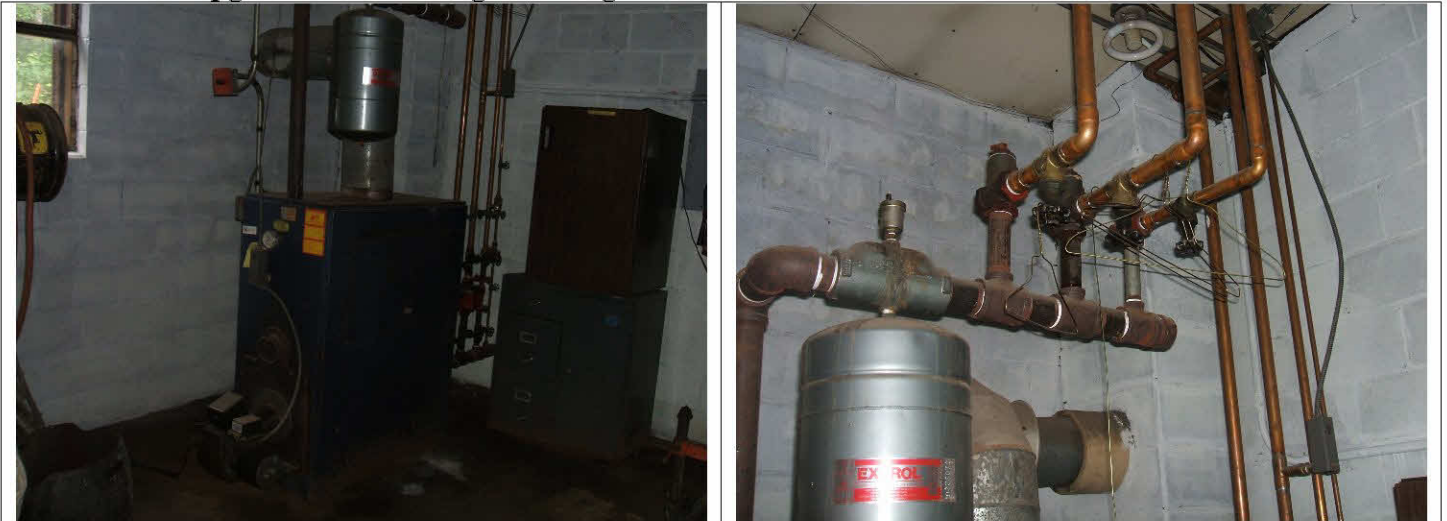
Finding: The existing boiler looks at least 30 years old and has a steady state efficiency of 74% and the heating distribution pipes are uninsulated. Those that work in the building comment that the boiler seems to always be on in the winter. This is in part because the boiler is inefficient and in part because the building cools too rapidly even when the massive doors are closed.

Recommendation: Install a programmable thermostat and program in a night setback of 55F. Replace the boiler with a unit that has an annual fuel utilization efficiency (AFUE) of 85% or better. The new boiler should also have an outdoor air reset control to increase efficiency even further. Install an intake air duct direct to the burner so no indoor air is required for combustion. This eliminates the potential for back drafting even if the big exhaust fan is on and is safer for improving the air tightness of the building shell. Insulate the distribution pipes so the modines and radiators receive higher temperature water. Finally, I recommend installing programmable thermostats with “2 hour occupied” overrides in each of the 3 zones of the building. Dave keeps the building set at 60 F all the time now so the energy savings from programmable thermostats will be slight. However, 2 hour occupied setting allows anyone to come in and increase the temperature just while they are there and then the thermostat reverts back to the preset limits after 2 hours. These thermostats will reduce the number of times that the thermostat is accidentally left too high.

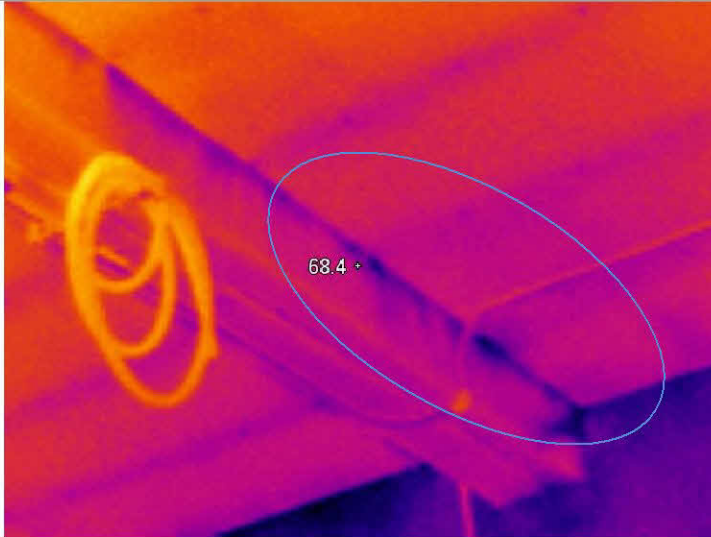
Broken attic hatch

Air leakage at the top of the beam.

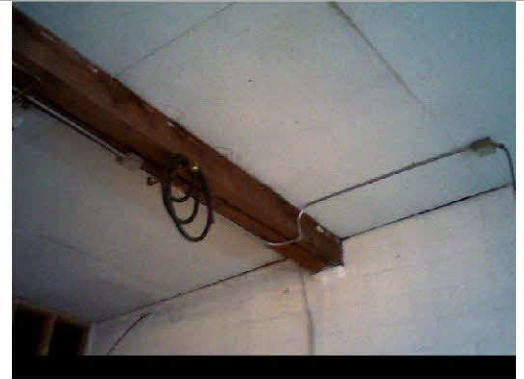
Attic insulation with strapping below

Air leakage at the wall to ceiling connection. Air is able to get around the fiberglass into the vent space above it.

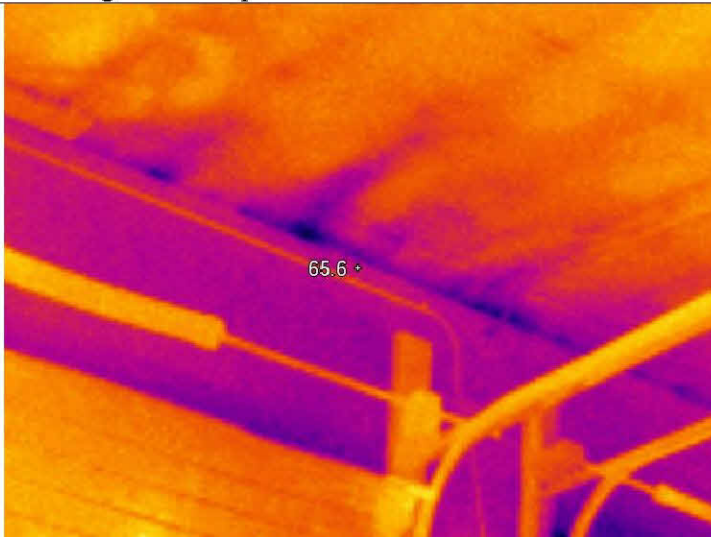
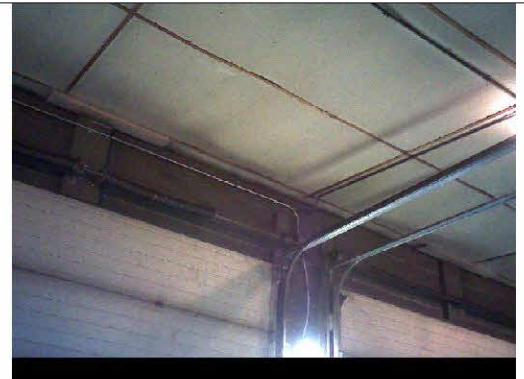
Air leakage in this building is higher than average and is found mostly around the bay doors, through the ceiling, and at the wall to ceiling connection. I believe that warm air can get through the seams in the ceiling and into the vent space above the fiberglass. There is also significant air leakage through the ventilation fan dampers, around the man door that is in the bay door, and through the wall opening to the old chimney.

Next, address the air leakage through the ceiling. This is not an easy task but the goal is to make the ceiling an airtight barrier that keeps warm air trapped inside. One idea is to inject the ceiling bays with densely packed cellulose through holes in the ceiling. This would work to address air leakage and add needed R-value to the roof system. The downside is that it is not without risk. Cellulose is a good product that I often recommend for walls but it isn't a good product for unvented roofs. It has the slight potential to accelerate moisture damage in this application.

I think the best options are: 1- Pull the ceiling down and install closed cell spray foam (to at least R50) against the roof deck, making sure the foam seals to the top of the walls on all sides. Then reinstall the ceiling. 2- install 5" of rigid polyisocyanurate foam board (R7 per inch) from inside onto the ceiling taking care to foam seal the rigid to the walls and every beam or penetration in the ceiling. Cover the rigid with sheetrock and then mud and tape the seams with at least 2 layers of mud. The mud doesn't have to be pretty, it serves to make a continuous air barrier that spans all the joints in the rigid foam. Foam seal the sheetrock to the perimeter and at all penetrations through the ceiling. This system allows the roof to remain vented but now blocks all the pathways warm air has to the vent space above the fiberglass. 3-Wait until the roof membrane needs to be replaced and add rigid insulation to the roof from above. This strategy takes advantage of the opportunity to improve insulation while the crew is there for other work so the work is more cost effective. This is not without complication because to do it right the roof venting has to be eliminated and the rigid insulation has to be air sealed to the walls below but it can be done when the roof membrane is up. Unfortunately, over half the membrane was replaced just a couple years ago so a new roof may be several years away.

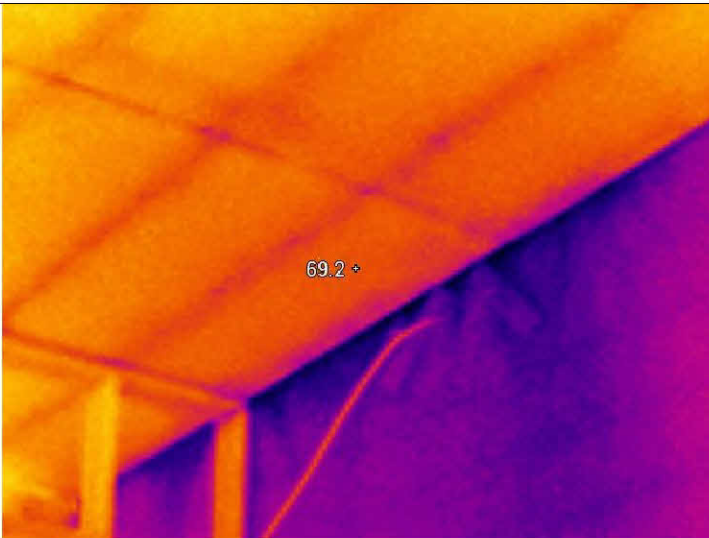
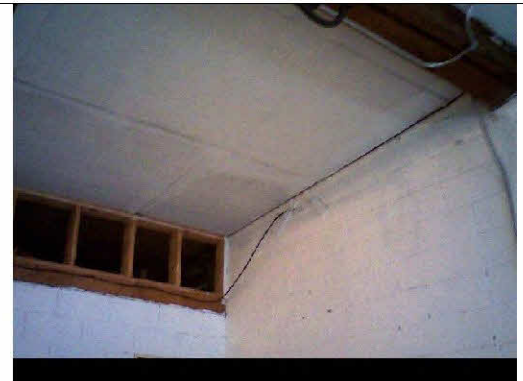
Air leakage at the wall to ceiling connection on an end wall.

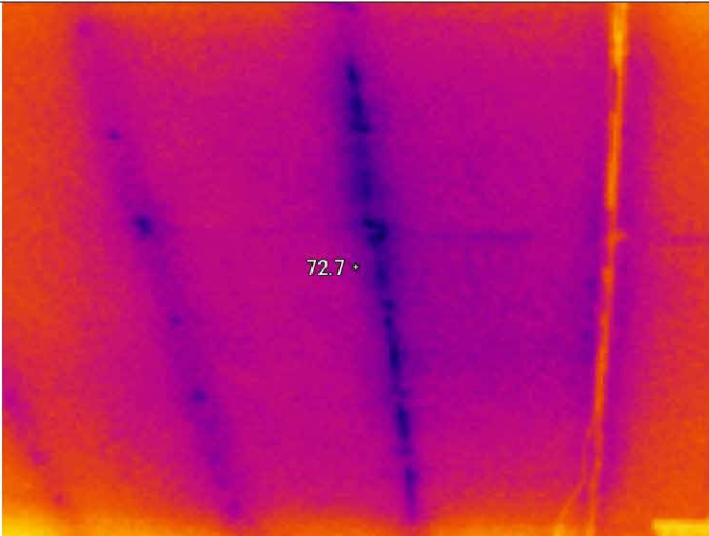
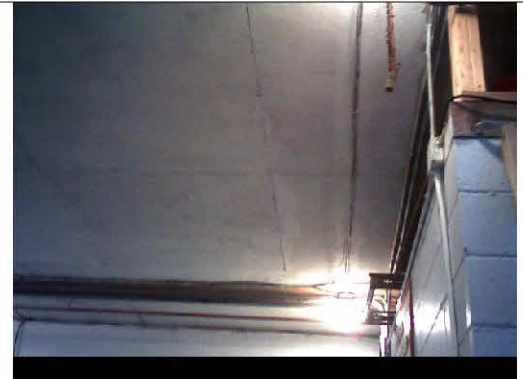
Air leakage through the panel joints on the ceiling.

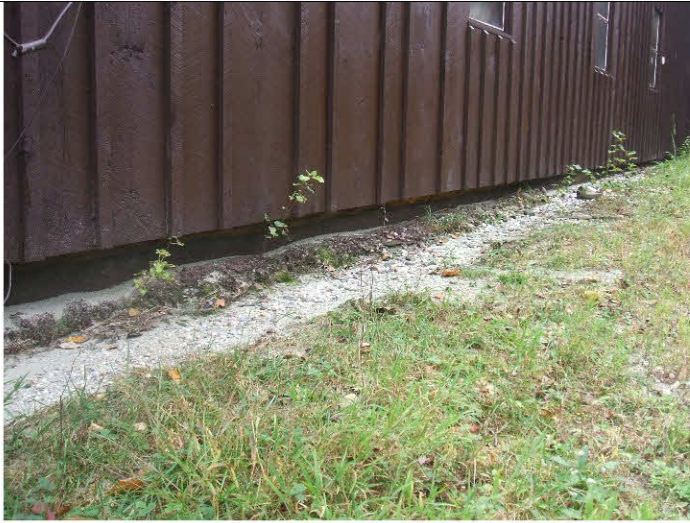
The exposed slab edge radiates heat to the outside and should be insulated like the rest of the wall.

Recommendation: First, fix the easy stuff. Block and foam seal the opening to the old chimney, install an insulated and weather-stripped door on hinges to cover the vent fan when not in use, and weather strip the man door and the bay doors. Most of the bay doors leak at the top and sides but the first bay door leaks at the bottom also. Adjust the door closers so the top of the door meets the weather-stripping when closed. Check the weather-stripping at the sides to make sure it is in good repair and in close contact with the door and check the rubber gasket at the bottom of the door for damage. When the door is closed and with the lights off, look at the door from all sides for daylight. If you see daylight the weather stripping is not tight to the door. At the same time pull the fiberglass chinking around the wooden man door on the south side with one-part foam (Good Stuff by Dow or Purfil), it makes a much tighter seal between the door frame and the wall. Finally, insulate the slab edge with as much thickness in rigid foam board as can be tucked under the existing siding. Dig down beside the slab and frost wall for 8-10" so the foam can be glued tight to the frost wall, then backfill against the rigid and cover the foam that is above grade with stucco for protection against sunlight. The rigid foam thickness should be narrower than the existing siding so water cannot get behind the foam. Do not bother to install rigid where there is finished driveway tight to the building.

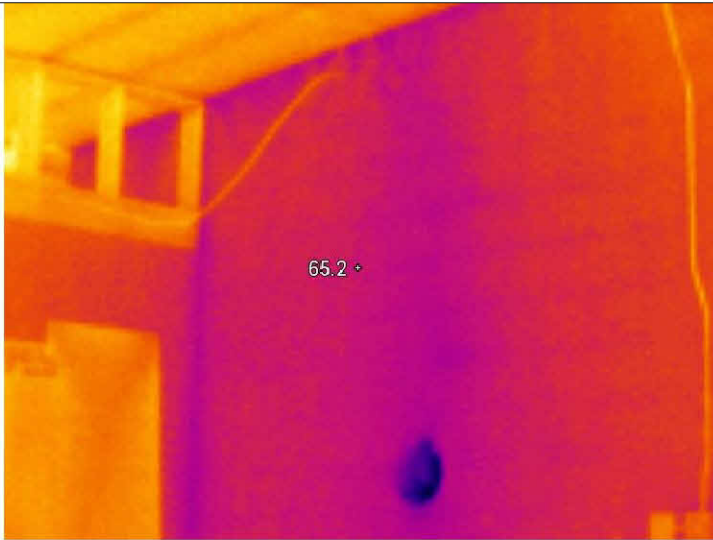
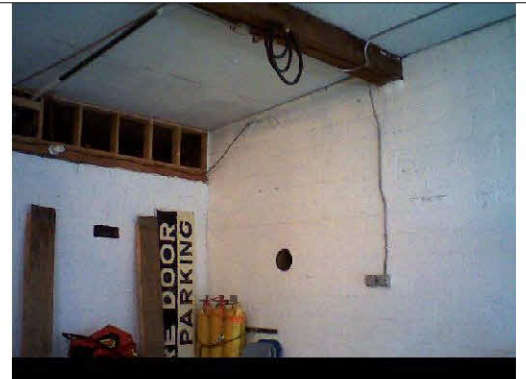
The open hole to the old chimney.

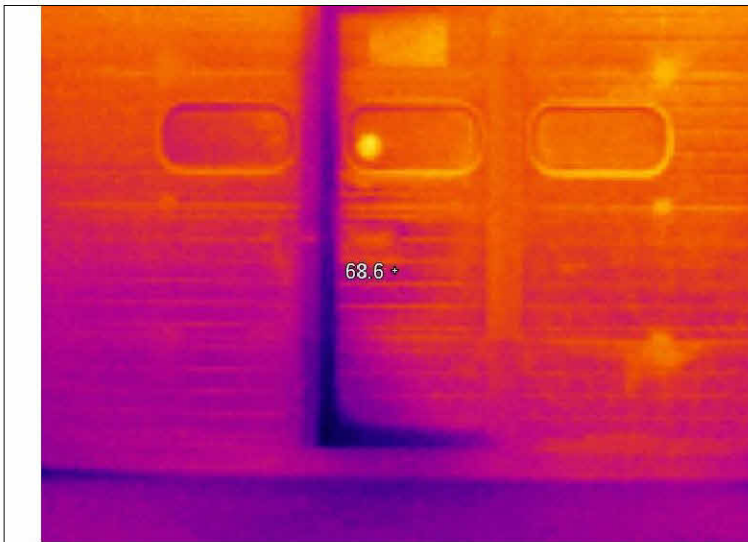
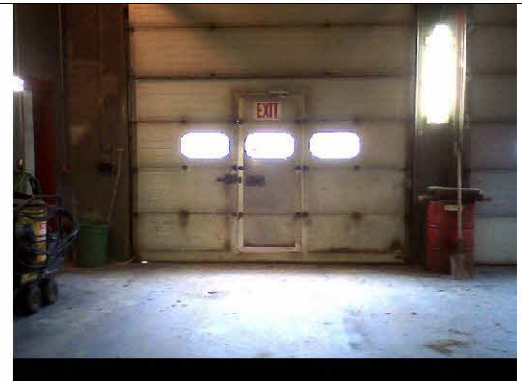
Air leakage around the door.

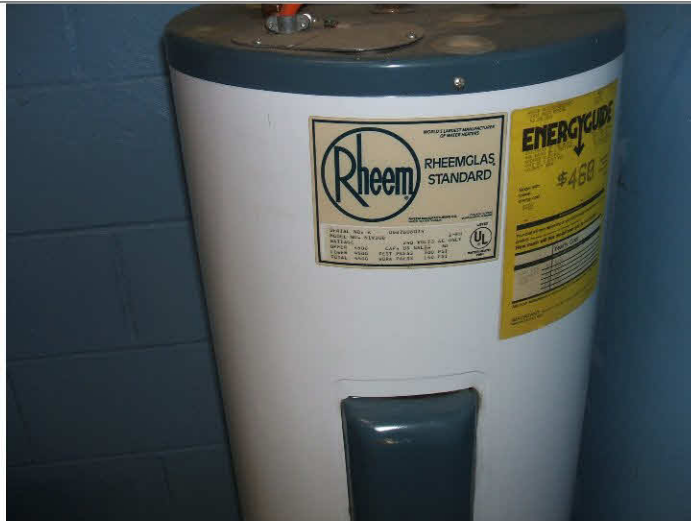
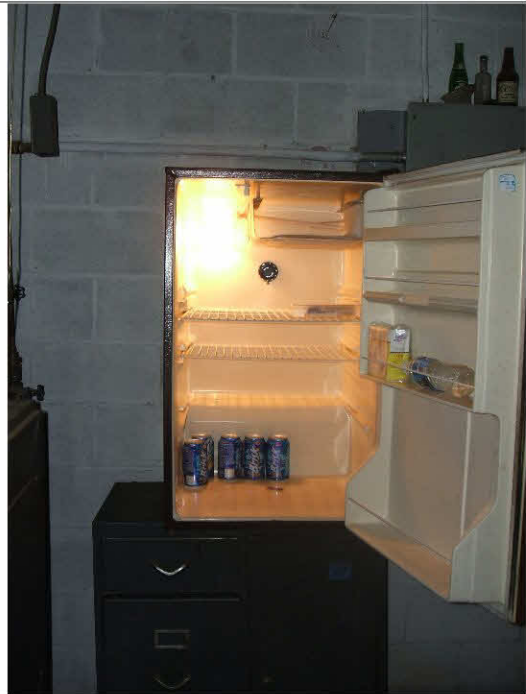
Finding: The 43 gallon water heater is on standby year round even when consumption is low, primarily for hand washing. There is a second refrigerator that is nearly empty but running.

Recommendation: Replace the water heater with an electric on-demand hot water heater to supply hot water for hand washing and other limited uses. Consolidate food items so they can all be stored in one refrigerator and disconnect the other.
