Vershire Town Garage Building Energy Plan

Building Energy Plan

November 16, 2010

RE: Energy Audit Conducted September 16, 2010 on the Vershire Town Garage

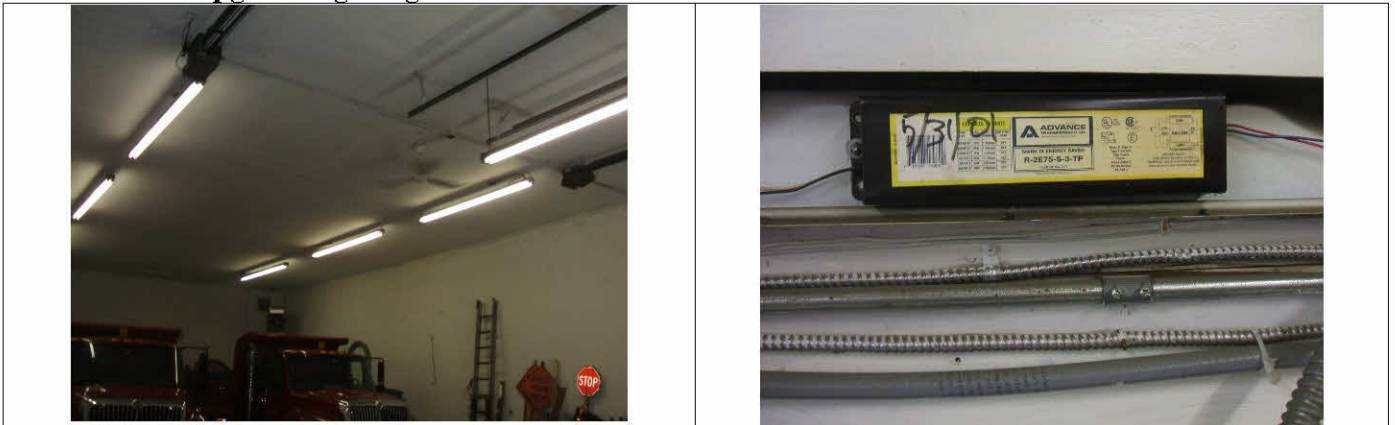
1. ECM#1 – Upgrade lighting

Finding: Most of the existing lights are T12 fluorescent fixtures with magnetic ballasts.

Recommendation: Replace the existing light fixtures with T8 lights with electronic, low ballast factor, ballasts. The main lights on the ceiling can be replaced with tandem 4' units rather than 8' lights. The 4' T8 bulbs are easier to obtain and have a longer life than the 8' T12 bulbs so they will need to be replaced less often. Heating costs will increase slightly with this measure because T8 lights will give off less heat than the T12 lights.

Implementation and timing: This measure can be implemented immediately, the lights are surface mounted and easily replaced. Implementation costs may be higher if the existing wiring is not code compliant. Cramer electric provided budget pricing for the upgrade, contact Reg Cramer at 802-333-3298 for more information on the installation.

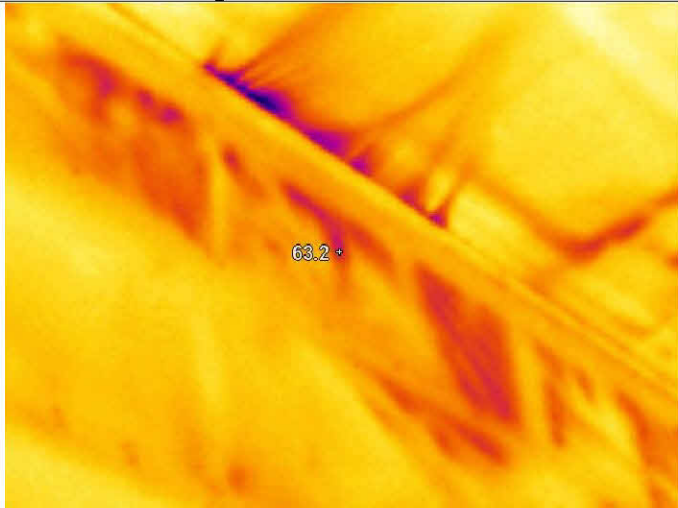
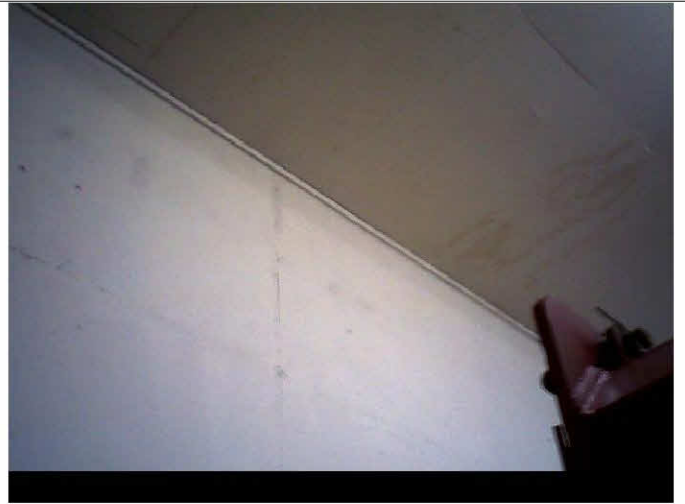
IR014999.IS2- Infrared image
9/16/2010 6:20:33 AM

Finding: The wall cavities are about 8” thick comprised of wood posts with horizontal 2x4 strapping on either side. Fiberglass batts about 5” thick run up the middle of these walls but air can move easily around it. The effective R-value of the wall is far less than the R-value rating of the batt, R13 at best. The walls have a 2” to 4” gap at the bottom and are open into the attic at the top. In many places the insulation has sagged and fallen inside the walls. All of these characteristics combine to make it easy for warm air to enter the walls, rise to the top, and exit into the attic where it hits the cold roof and condenses moisture.

Recommendation: Air seal the top and bottom of the walls and add more insulation to the walls. This can be done in several ways but the simplest approach would be to remove the metal siding and existing insulation so closed cell spray foam can be installed from outside (to at least R21 value) against the back of the plywood. The spray foam is costly so this approach increases the payback term. Other methods could be employed at a lower cost but need to meet the same goals of increased R-value and airtight construction in order to be effective. Please note that as air tightness increases there may be a need for mechanical ventilation, see notes under “Health and Safety” above.

Implementation and timing: If an addition or renovation is planned within the next 5 years this upgrade should be coordinated with it. This measure involves the removal and reinstallation of siding which would be a low cost proposition if a construction crew was already on site for other work. However, the air sealing portion of this work should not wait and is explained further in ECM#6 below.

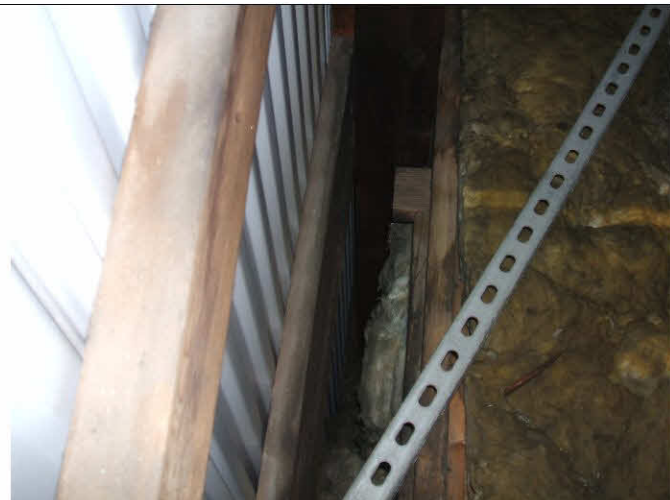
Looking down into the top of the wall from the attic

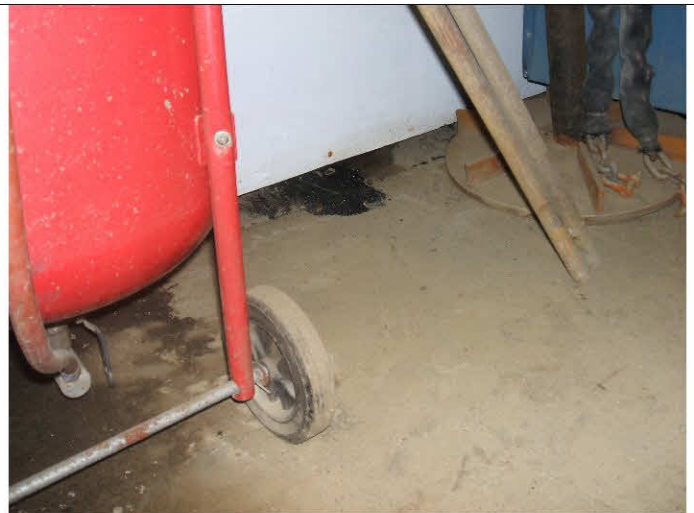
4" air space at the bottom of the wall where cold air pours in

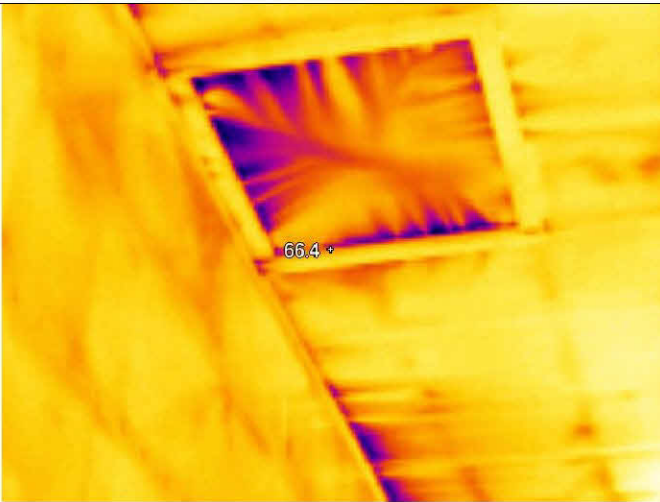
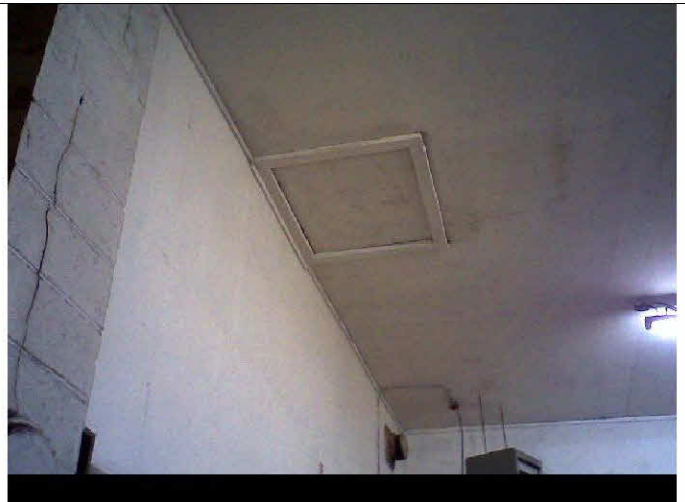
IR014987.IS2- Infrared image of the attic hatch and leaky wall to ceiling connection.
9/16/2010 6:18:25 AM

Finding: The attic was once insulated with about 6" of fiberglass batt insulation, even then that wasn't enough insulation. Now, that batt is only about 3" thick because it has been "rained on" by condensation from the metal roof for many years. The effective R-value of the ceiling system is probably less than 7. Too much warm air is getting into the attic and condensing moisture on the metal roof panels.

Recommendation: Because of the condensation the solution cannot simply be to pile more insulation on top of the existing insulation, it will be damaged after the first winter. The solution must also address the air leakage into the attic. The existing fiberglass needs to be removed and I recommend a 2" layer of closed cell spray foam across the entire attic to air seal it. Then, cover the foam with about 11" of cellulose for a total R value of R50. The attic hatch needs to have rigid foam glued to the top of it to the same R-value as the attic and then it needs weather stripping that t perimeter so it seals tightly when

closed. Please note that as air tightness increases there may be a need for mechanical ventilation, see notes under “Health and Safety” above.

Implementation and timing: This measure should be implemented as soon as possible. Access is good in the attic and the condensation needs to be stopped.

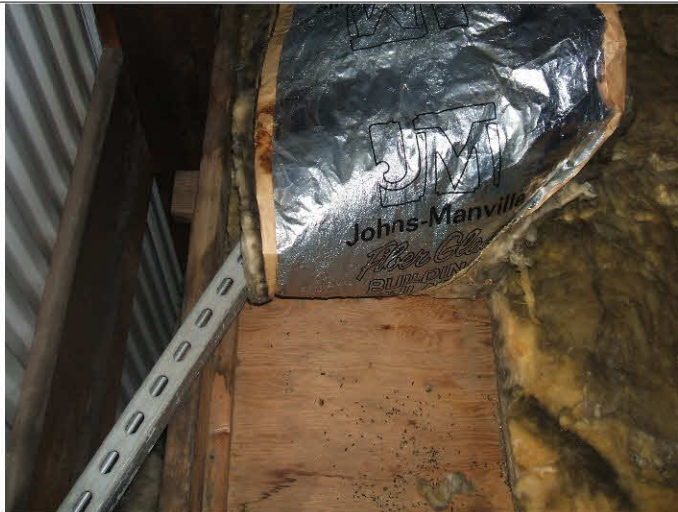
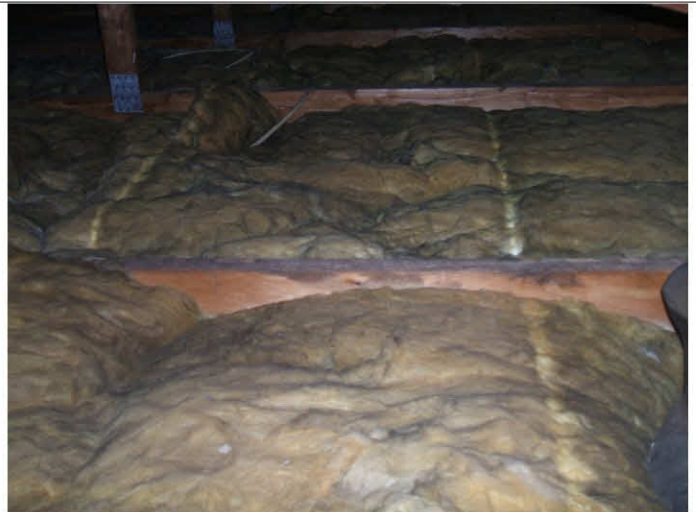
The lines are water lines below the roof purlins.

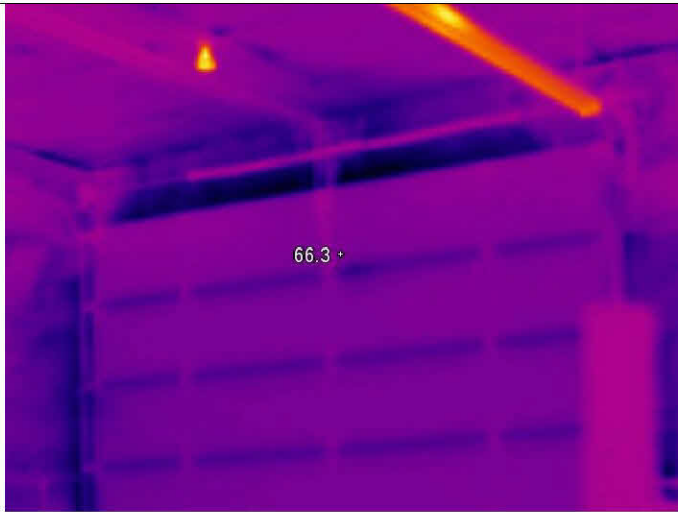
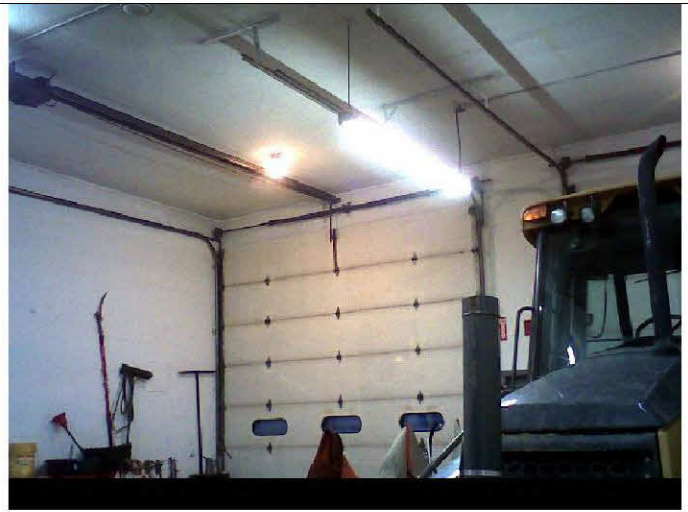
IR014963.IS2
9/16/2010 6:14:36 AM

Finding: The front man door leaks at the perimeter and the top and sides of the bay doors leak.

Recommendation: Replacing doors is generally not a cost effective energy saving measure and should only be done when the door is at the end of its structural life as the front man door is. The most energy efficient door is fiberglass with a solid insulated core and bulb weather-stripping on top, bottom, and jambs. Ideally the latch should engage the door frame at more than one location. If a metal door is required, choose a door with an insulated core and the inside metal is thermally broken from the outside metal. If the door requires a window, choose a window with the smallest necessary area that is double

pane, fiberglass framed, low-conductivity edge spacers, and is gas filled. The new door frame should be foam sealed to the rough opening.

The bay doors leak at the top because the top panel of the door doesn't come in full contact with the weather stripping when the door is closed. With some adjustment it should close better. The weather-stripping needs to be refit around the door so it is in maximal contact when the door is closed.

Implementation and timing: Economically this measure doesn't make sense unless it can be done very inexpensively and timed with other work. Replacing the man door has to be done anyway so it makes sense to put in a well insulated door. The weather stripping on the bay doors needs to be checked every year and replaced every 5 years. The sad part is, even with perfect weather stripping, one of those bay doors open for 5 minutes exhausts all the heat in the building.

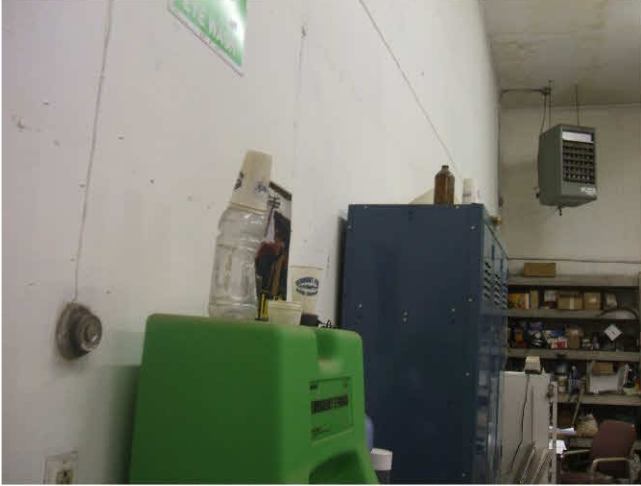
The thermostat in relation to the Modine heater.

Finding: Both of the modine heaters came on every 3-4 minutes, ran for about 1.5 minutes and then shut off. This was on a day when it was 44 F outside. What do these heaters do on a really cold day? Alan Lyford said the heater over the bathroom was more prone to short cycling than the other one. Both heaters are less than 10 years old.

The thermostats are located at about 5' high on either side of the garage on walls that are not very airtight. It is possible that with ceiling air leakage, heat stratification, and drafty walls the thermostats are only momentarily satisfied and call often. Other possible reasons for the short cycling are that the units are oversized for the garage or they are way out of tune. With the building so air leaky and poorly insulated it is hard to know exactly why the Modines are short cycling but it is important that they stop because they never reach their rated efficiency that way.

Recommendation: Complete the attic repairs and air sealing as soon as possible to see if the short cycling stops because the building heat is not lost so quickly. the problem may go away after the building is improved. Have the units checked by a technician to make sure they are operating properly and install a second ceiling fan to help reduce heat stratification. Remove the thermostats from walls and mount new programmable ones on a piece of rigid insulation to separate them from the drafty walls (if the walls are not getting reinsulated soon). If none of these measures has an impact on the short cycling then have their sizing verified with a heat load calculation done by an HVAC engineer.

Implementation and timing: Some of the smaller tasks such as a tune up and new thermostats should be done immediately but I don't recommend doing the full scope of work on the Modines until we know the building shell is much more efficient.

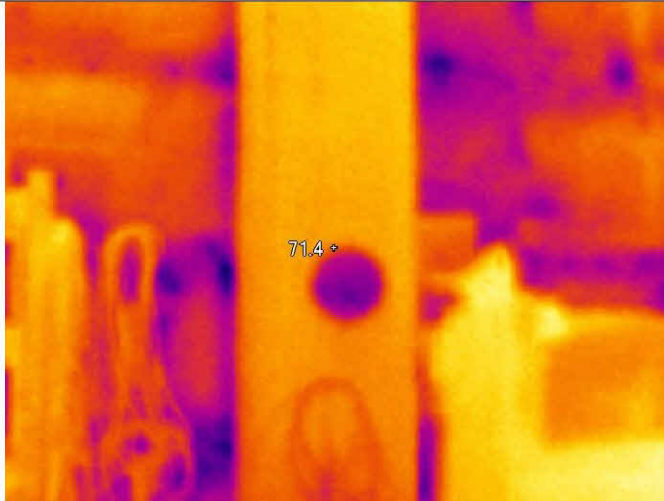
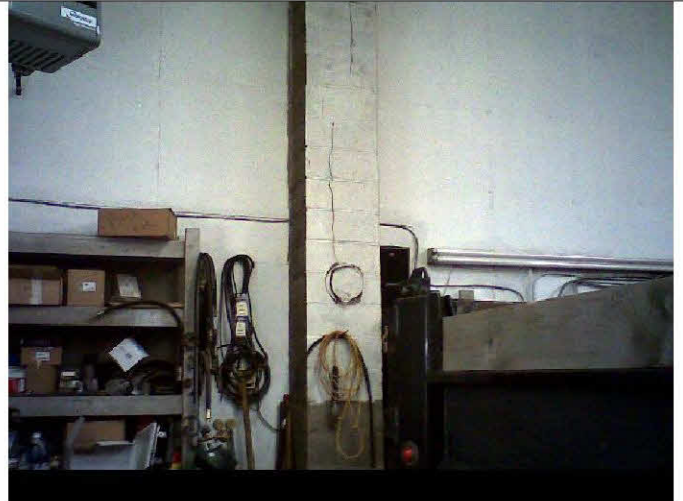
IR014984.IS2
9/16/2010 6:17:40 AM

Finding: As mentioned previously the walls leak at the top and the bottom and are a direct path to the attic. Not mentioned previously are the old chimney openings that need to be sealed shut and the hose penetration through the wall that needs to be blocked in the winter. The air leakage in these walls is excessive and it contributes to the condensation problem in the attic.

Recommendation: Foam seal the tops of the walls from the attic and the bottoms of the walls at the floor around the entire perimeter of the building. I recommend the foam sealing be done by a professional but it can be done with kit foam by anyone. Block and foam seal the old chimney and the old flue through the wall. Remove the hose and create a winter cap for the hose opening in the wall. Please note that as air tightness increases there may be a need for mechanical ventilation, see notes under “Health and Safety” above.

Implementation and timing: Air sealing should be done immediately IF the walls are not going to be reinsulated in the near term. It is not difficult to access the areas that need to be fixed and it will have a significant impact on heating. If ECM #2 is going to be completed in the near term most of the work will be accomplished and only the old flues and the hose opening will need to be addressed.

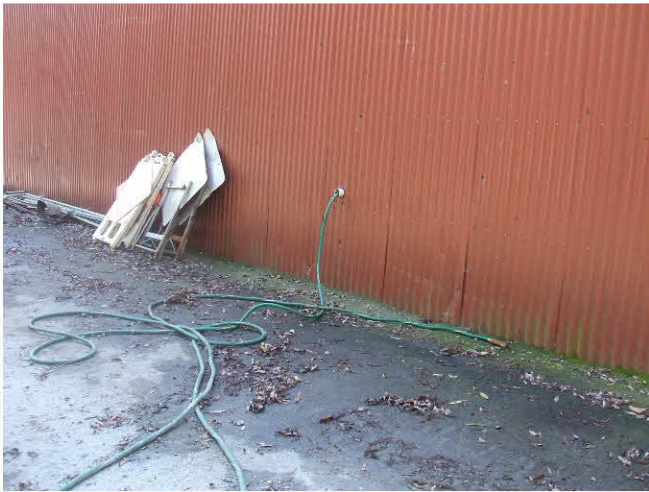
The hose pipe in the wall
