Woodstock Town Hall Building Energy Plan

Building Energy Plan

January 17, 2011

RE: Energy Audit Conducted October 30, 2010 on the Woodstock Town Hall.

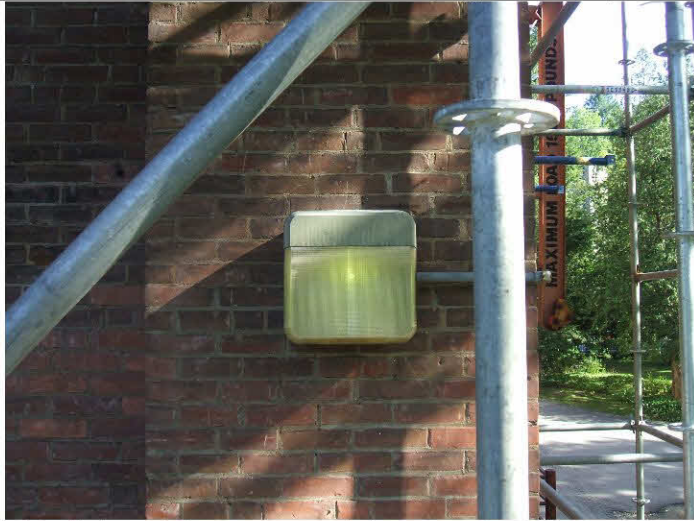
This light and the one around the corner both were on in the daytime.

There are 2 outside lights that I found on in the daytime both times I was on site. I found a timer that controls these lights and it appears to be set for 4pm to 11pm but the override switch may be working because the lights were on at 2:04 pm. Verify the switch and timer are working and adjust the timer seasonally so the lights do not stay on in the daytime.

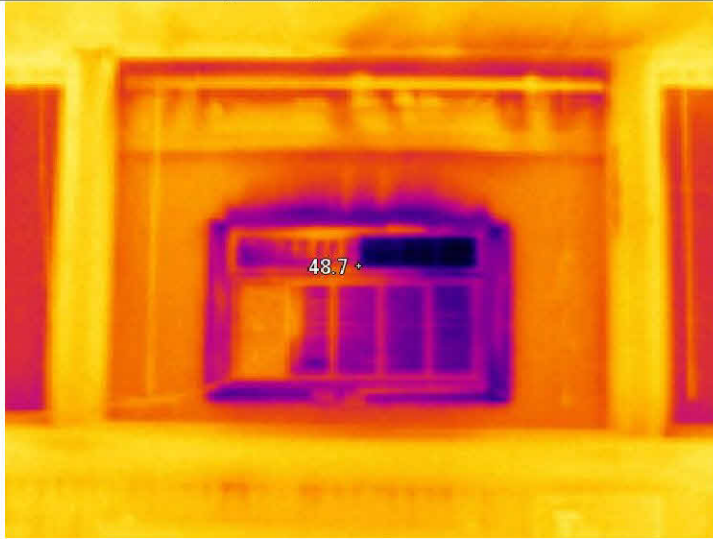
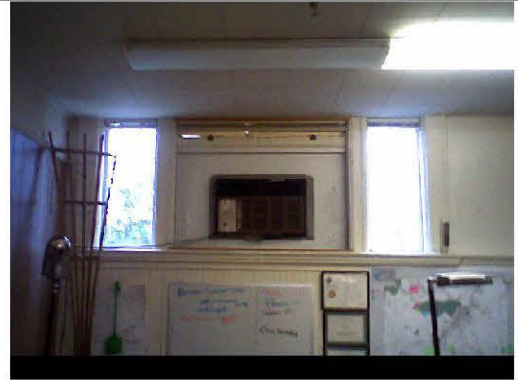
Air leakage around and through the AC unit.

1. Seal the large air leak through the basement conduit with foam from a can. Weather strip and insulate the attic hatch above the stage with rigid foam board that is at least 4" thick. Remove AC units from windows sooner in the fall and install them later in the spring to reduce air leakage when the heating system comes on. There is a large air leak at the stage ceiling that can be addressed at the same time as other work but if not, should be foam sealed immediately.

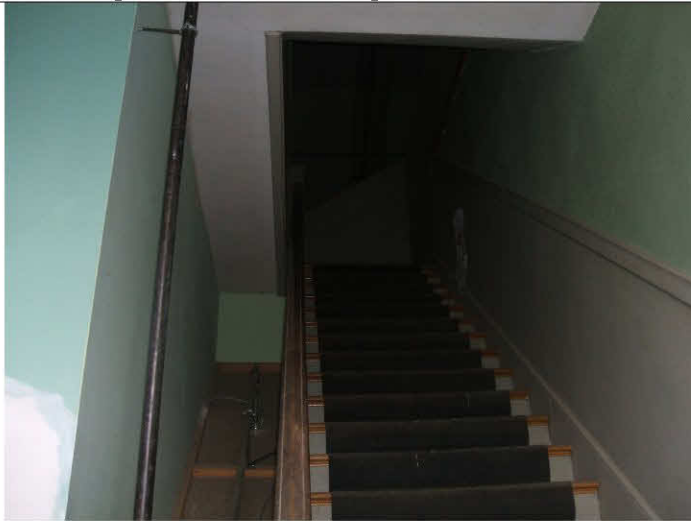
The hallway to attic needs to be separated from the heated space that surrounds it. The easiest way to do this may be to install an insulated and weather stripped door where the stairs pass through the flat ceiling rather than to try to insulate the walls and stairs.

4. Install an insulated and weather stripped hatch at the plane of the ceiling in the hallway that goes to the attic. Currently the hallway is treated like cold space but it is not insulated in the walls or floor so as to separate it from the rest of the building. The best compromise is to make this hallway a semi conditioned space by separating it for the cold attic with a hatch. At the same time insulate and air seal over and around the elevator shaft in the attic with spray foam and cellulose.

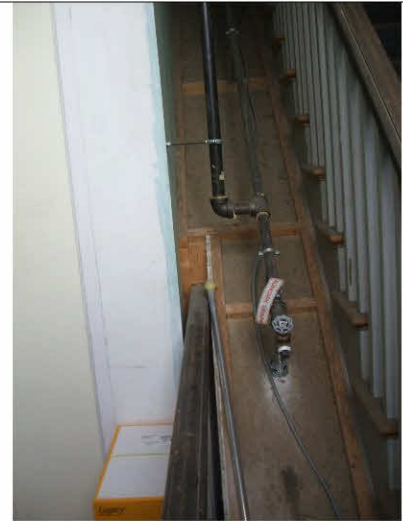
This hallway is a difficult space to separate from the rest of the building because at one time it was just part of the heated space. A ceiling was put in by the stairwell in an attempt to separate it that should be insulated if it is meant to separate the attic from the rest of the building.

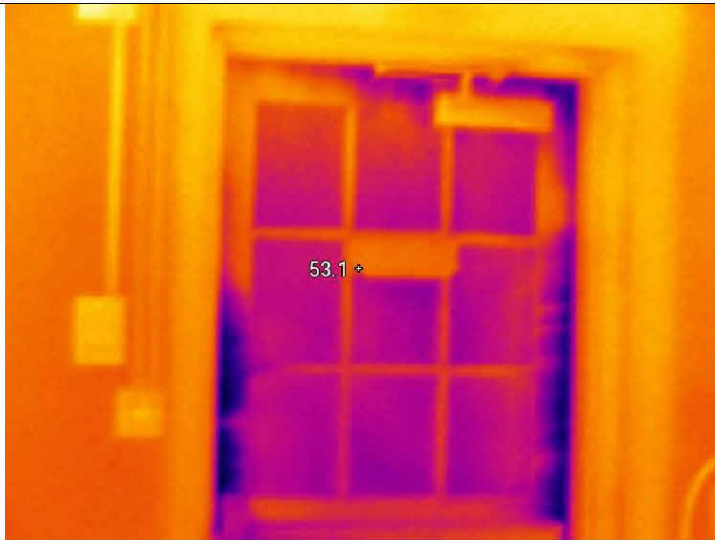
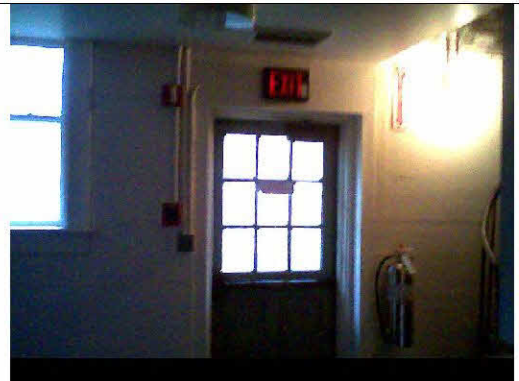
Typical exterior door with air leakage around it.

2. Weather-strip the exterior doors at the head, jambs and especially at the threshold with commercial grade weather-stripping. Don't forget the door to the boiler room which is especially bad and "interior" doors that open into cold spaces such as the emergency stairs, the attic, and the basement under the theatre.

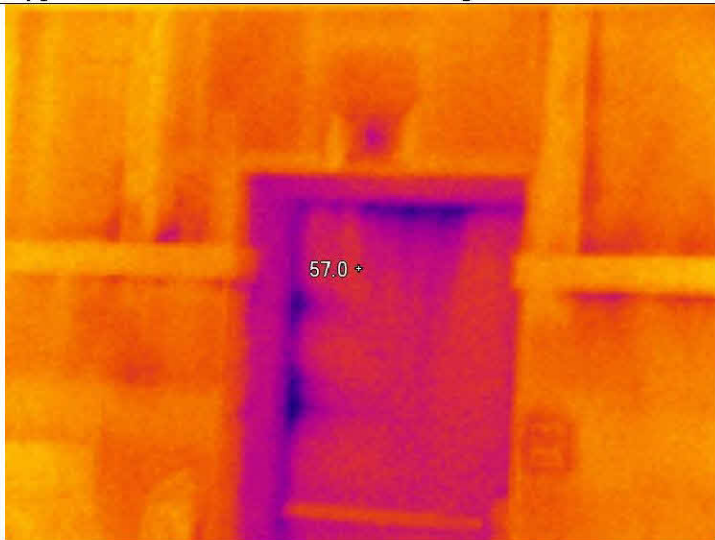
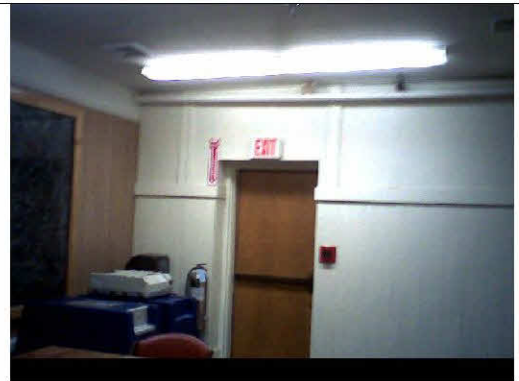
The door to the emergency stairwell door showing air leakage. This might be viewed as an “interior” door.

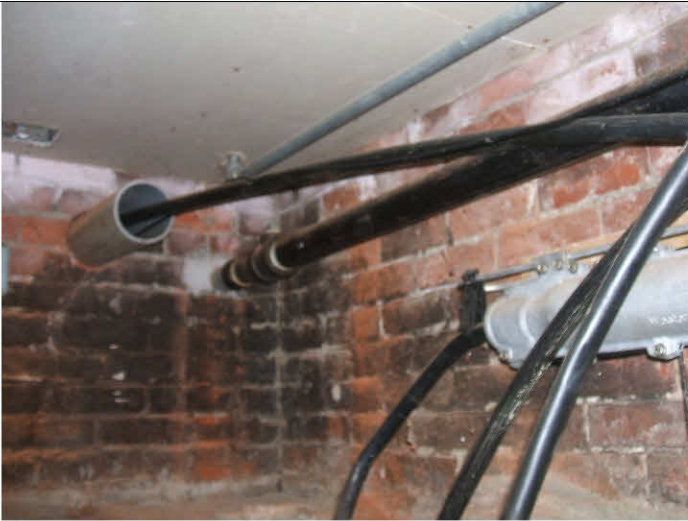
Basement conduit that is open to the outside. This is at the front of the building.

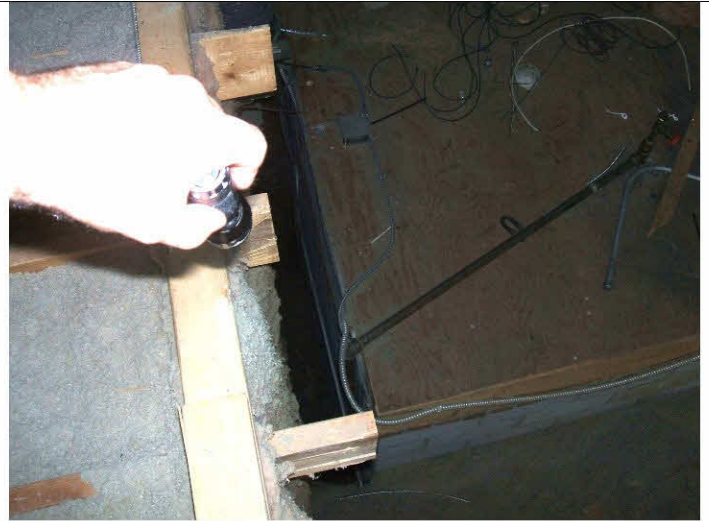
The elevator shaft is not insulated at the top and sides in the cold attic.

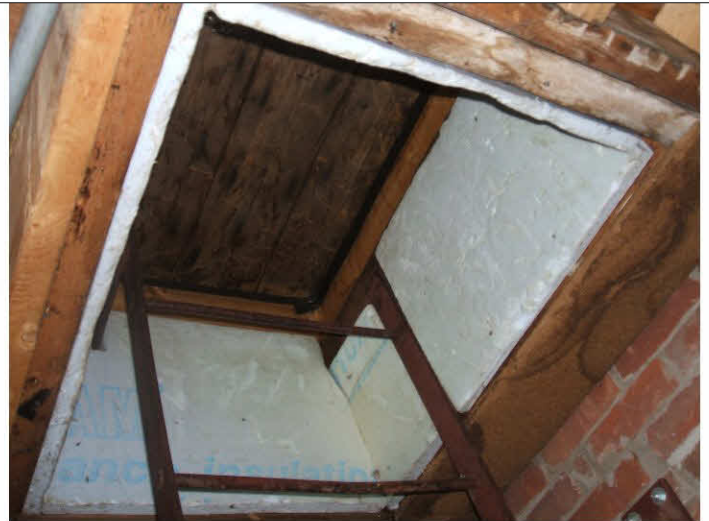
The stage ceiling hatch is not weather-stripped or insulated.

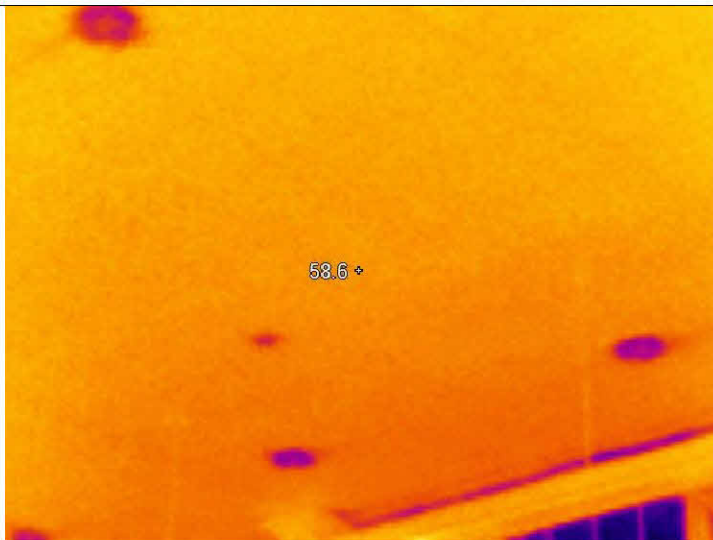
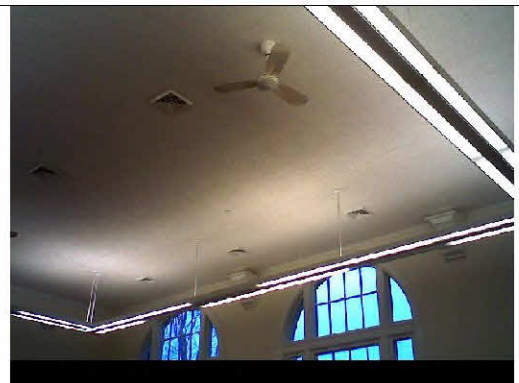
AC openings that are cold under depressurization.

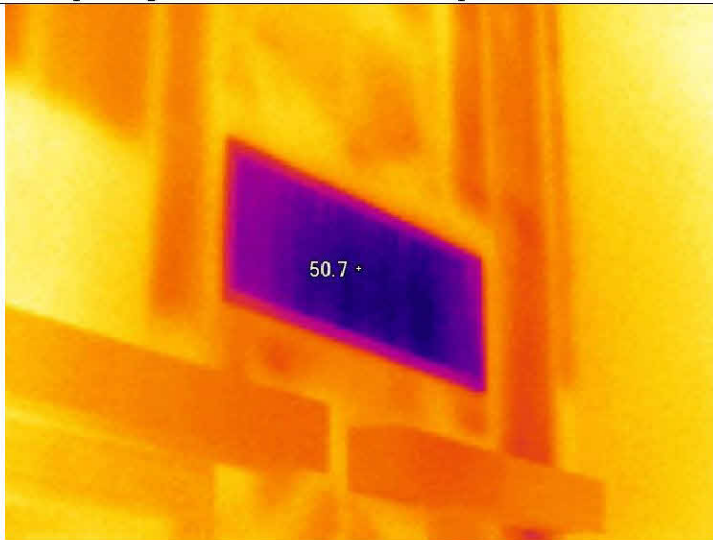
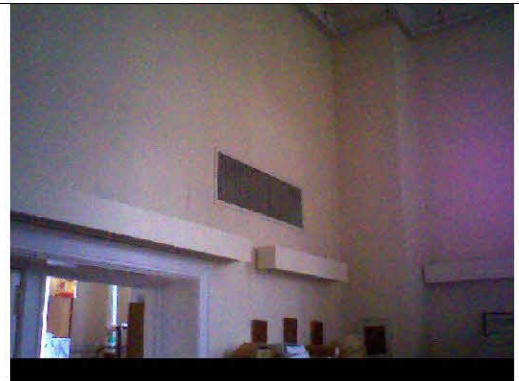
This return grows cold under depressurization because air is being drawn in from the cold attic. Under normal conditions warm air would exit through this path when the system is off. Note also the cold interior wall bays around the return. This is an air pathway to the attic above.

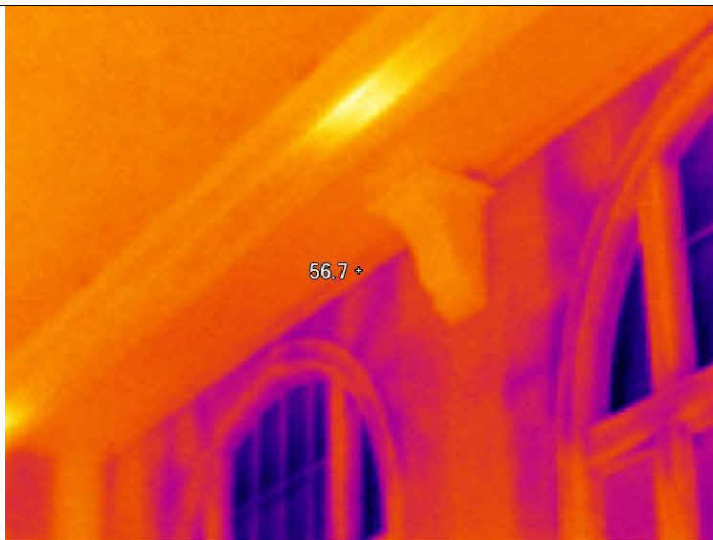
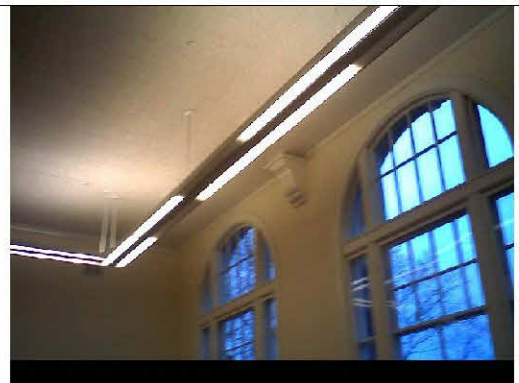
Under depressurization the cavities behind the plaster grow colder indicating that air able to travel behind the plaster.

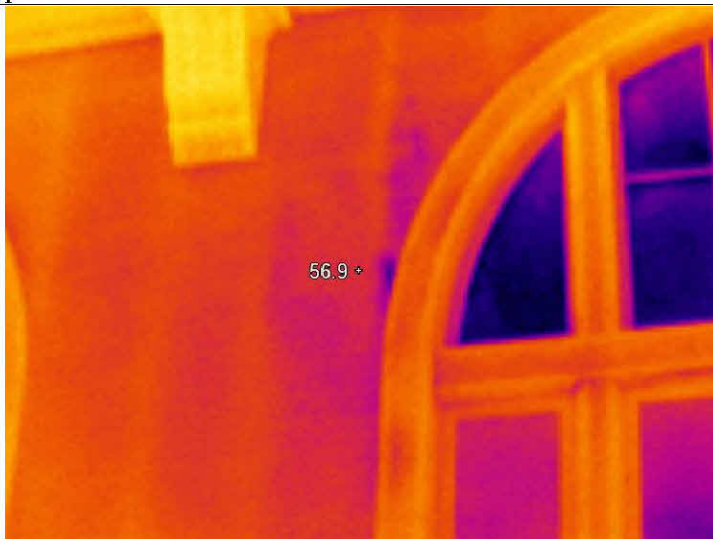
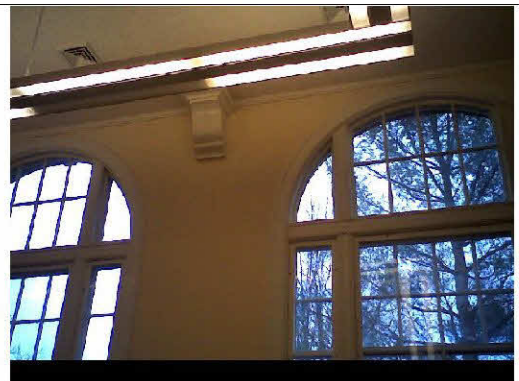
The infrared image of the walls shows the wood framing behind the plaster as the warmest objects. This indicates that there is no insulation behind the plaster and this is true of most of the walls.

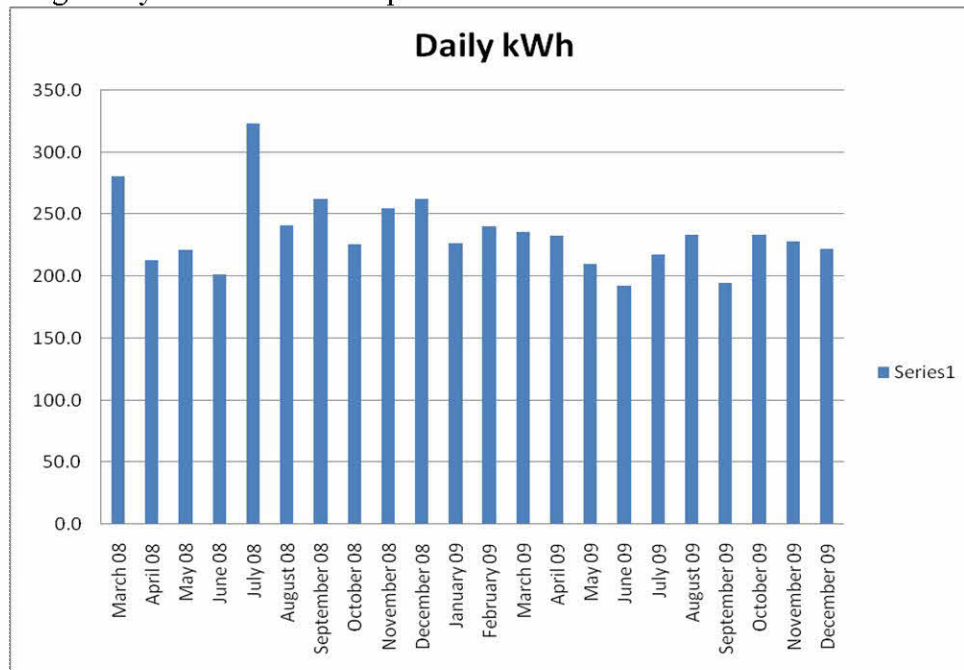
Electric power consumption is between 200 and 250 kWh/day all year long. The day to day base load is about the same regardless of the season. This is probably due to the year round use of the theatre and air conditioning in the warmer months.
