Chelsea Public School Building Energy Plan

Building Energy Plan

December 13, 2012

RE: Energy Audit Conducted November 21 & 29, 2012 on the Chelsea Public School

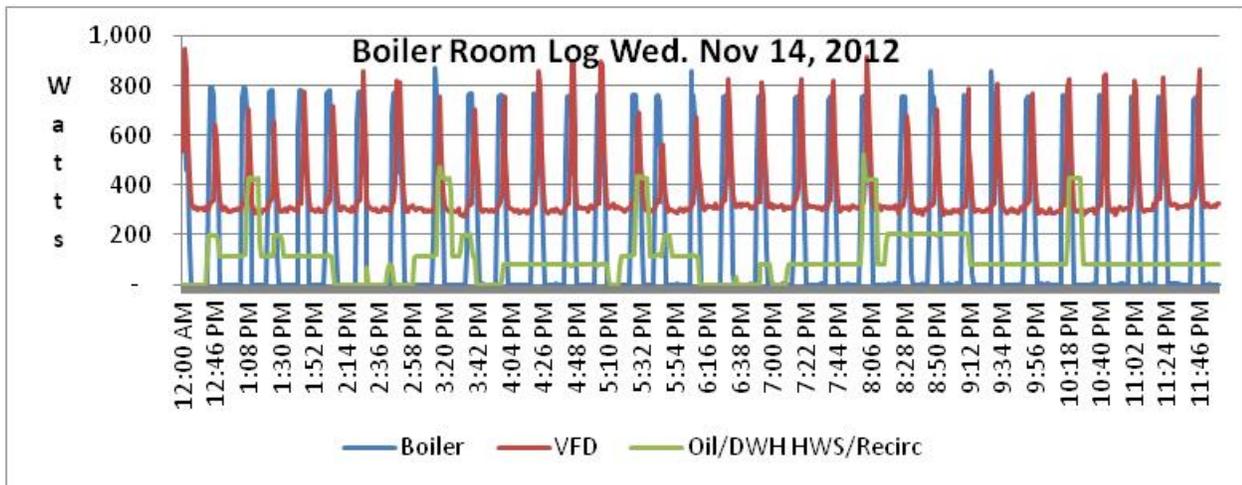
1. All heating equipment should be kept off during unoccupied times when outside temperatures are above 30° F. Following is a graph of heating equipment operation from noon to midnight when outside temperatures were in the low 30's.

There is little or no difference between the occupied and unoccupied operation. The boiler fires for 6 minutes every 22 minutes. Half of the firing time is a purge cycle so the burner fires for only 3 minutes.

2. A low night setback should be implemented. Try 40 or 45°, though the building will rarely if ever drop this low. In order to protect coils in the unit ventilators allow the VFD pumps to run below 30°F outside air without the boilers. Fire the boilers only on a call from a room thermostat.

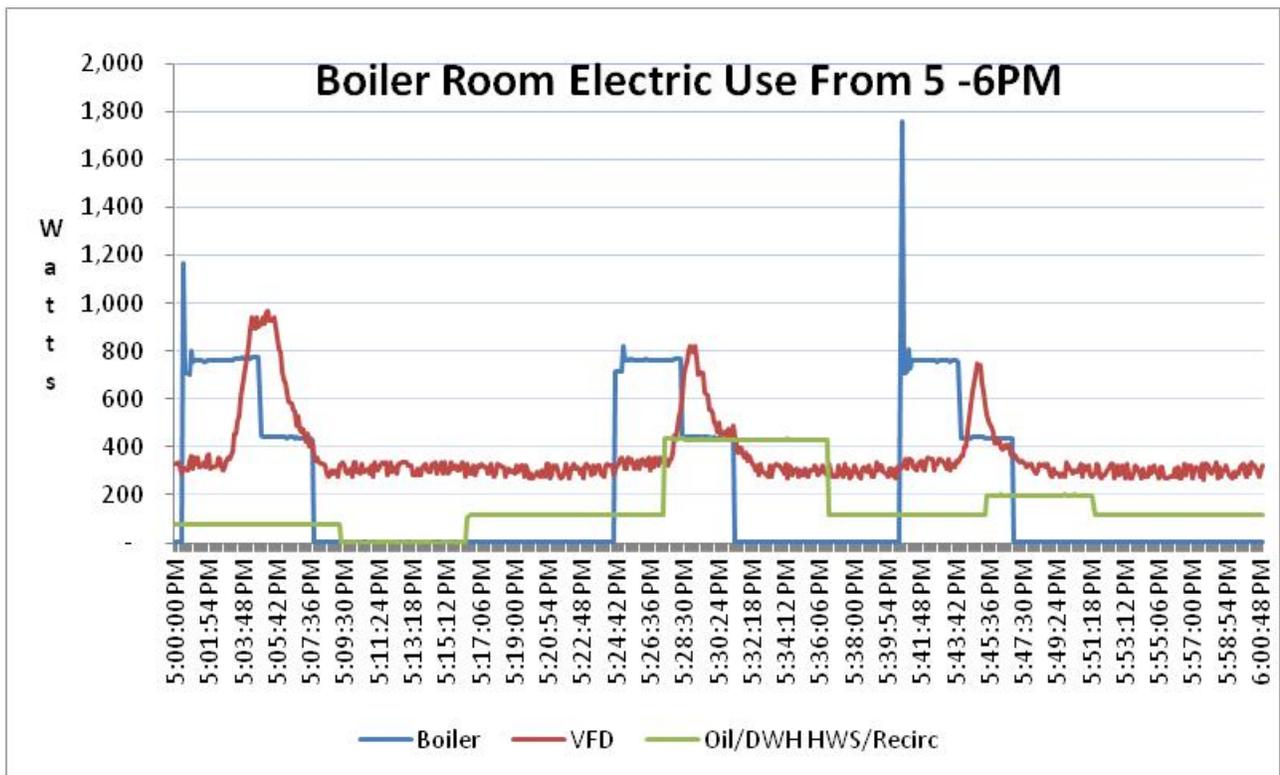
This is very inefficient operation. Though the stack test showed a combustion efficiency of 88% the overall efficiency at this load is probably less than 60%. (The spike is the start up load of the burner.)

3. The boilers are substantially oversized. To alleviate some of the low load short cycling of the burner reduce the firing rate (nozzles) of both boilers to the minimum the burner will accept.
4. The domestic hot water recirculator pumps run during unoccupied hours. Add these to a programmable controller.

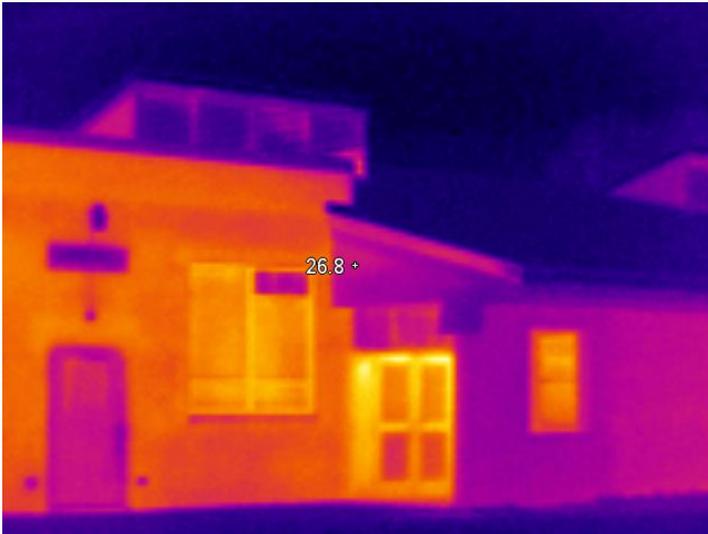
a. IR014284.IS2

A minor control change that can be made immediately is to turn the unit heater in the back vestibule way down or off. It is very warm in that small space and the metal and glass door with sidelights has very little R-value. See images below.

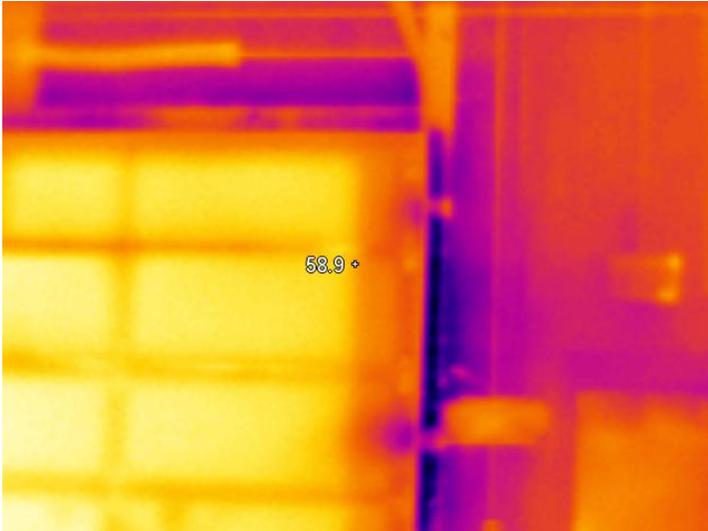
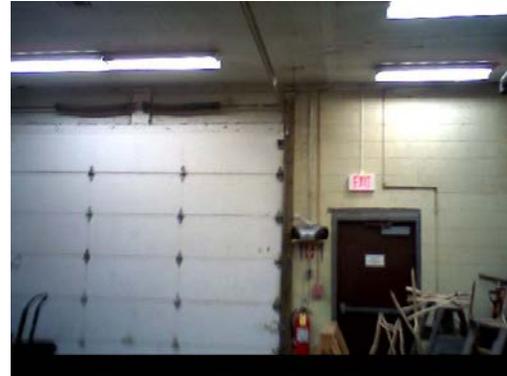
a. IR013891.IS2

It is not a surprise that this overhead door leaks at the perimeter. It is hard to make these type of doors tight. What is surprising is...

The images above show the worst doors and those should be made a priority. Some of the old classroom exterior doors are well weather-stripped and will only need to be checked. Weather-strip the exterior doors at the head, jambs, and especially at the threshold with commercial grade weather-stripping (www.draftseal.com or Q-Ion available through The Energy Federation www.efi.org) or replacement

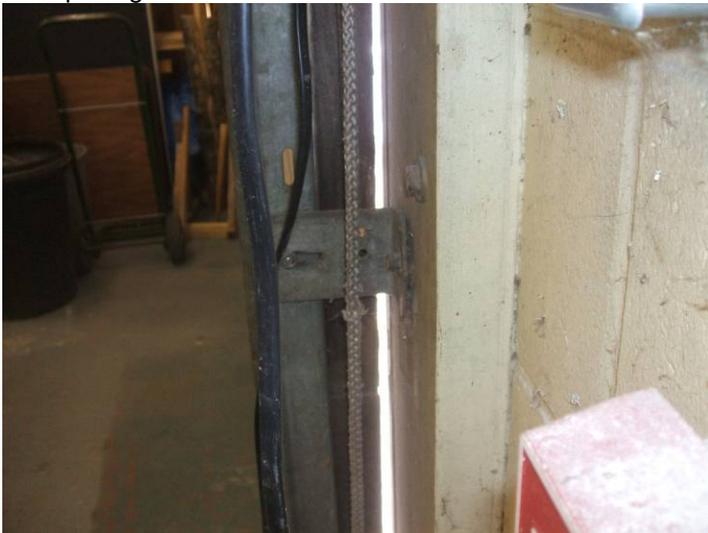
b.

...that there are NO weather seals on the bay door. The shop man door is also missing weather seals.

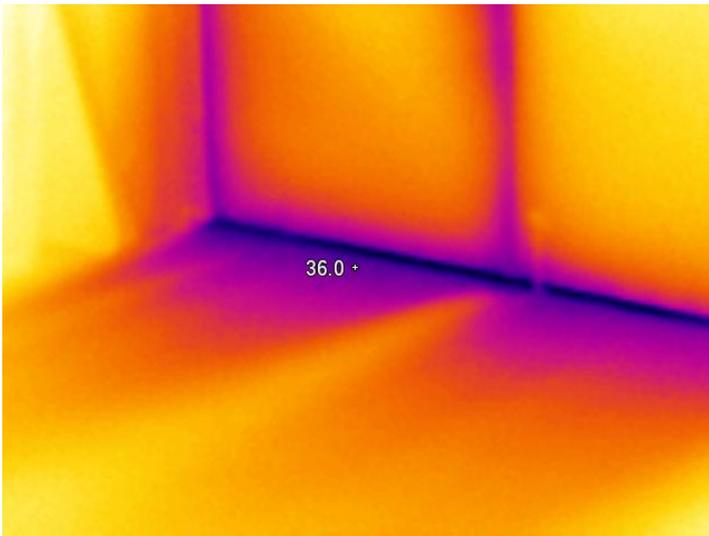
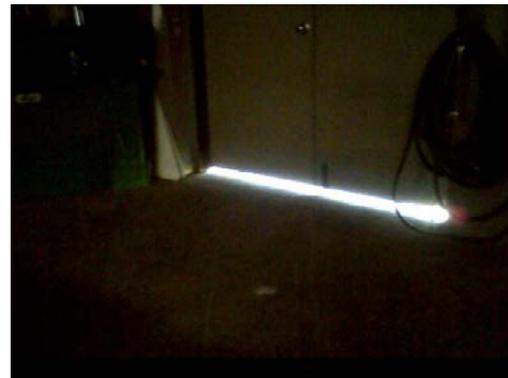
c. IR013904.IS2

Air coming under the boiler room doors.

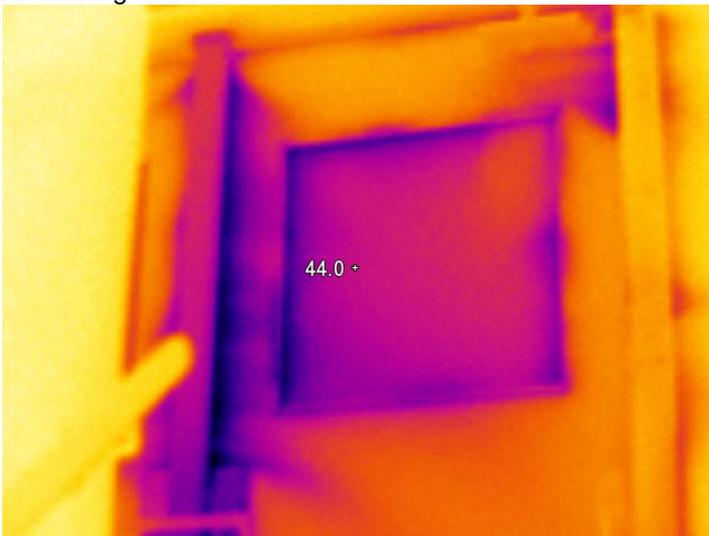
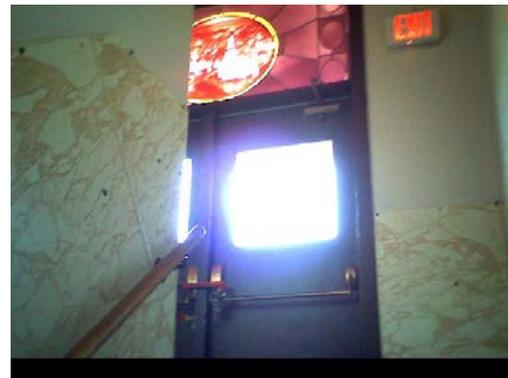
d. IR014036.IS2

Air coming through the front doors and at the door trim.

The front door is unique in that it leaks not only through the doors but also where the door trim meets the wall. Carefully caulk all the seams between the door trim and the wall including around the fixed pane window over the door. It would also be good to install a permanent interior storm window over this window to increase the R-value.

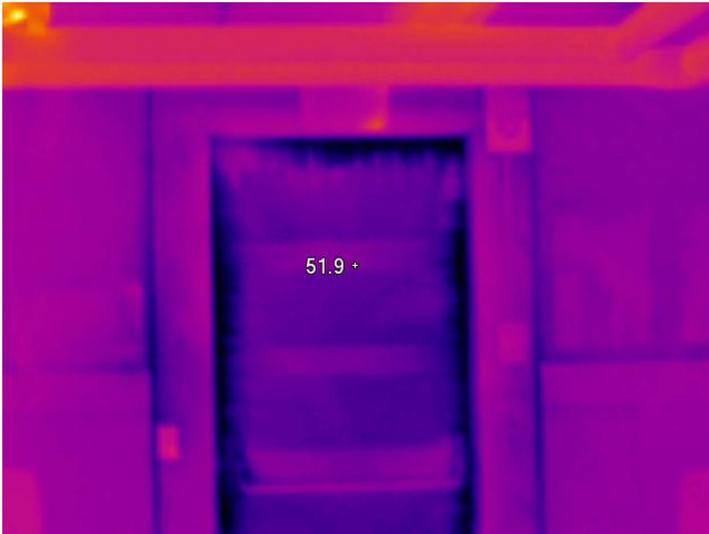
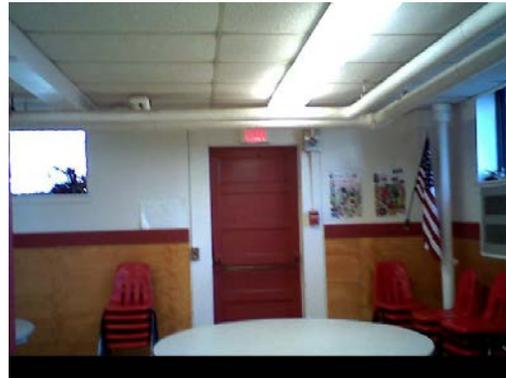
e. IR014048.IS2

Air coming through the cafeteria door.

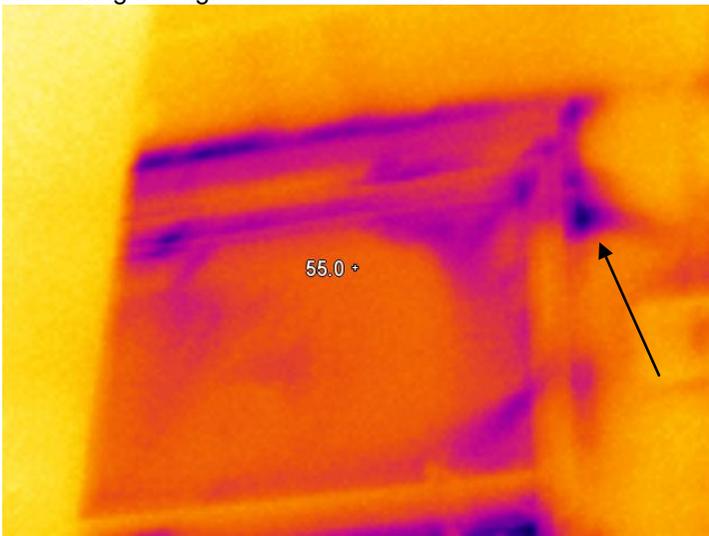
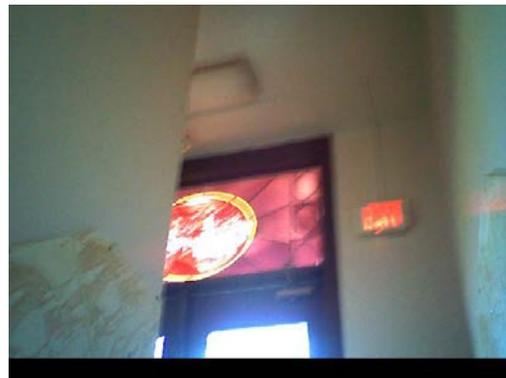
f. IR014035.IS2

The trim surrounding the decorative window above the front door is leaky.

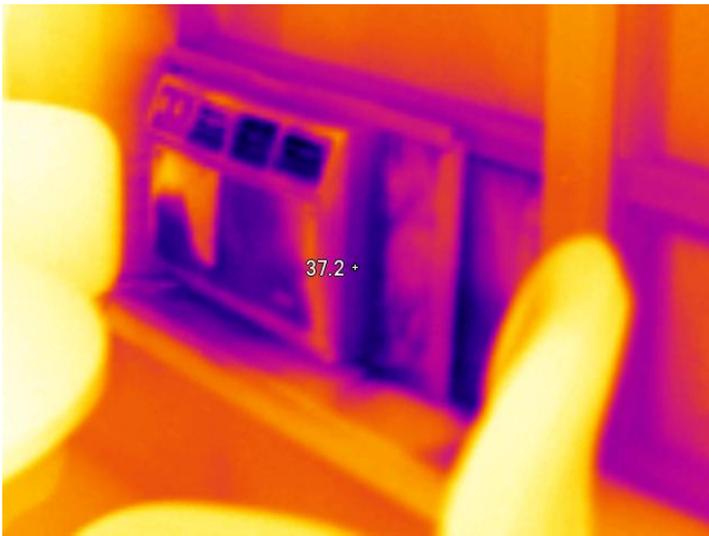
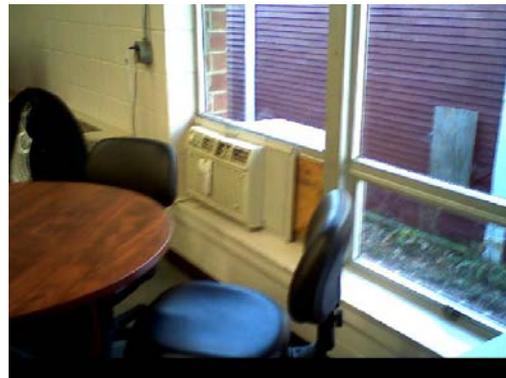
g. IR013977.IS2

Air leakage around and through an AC unit.

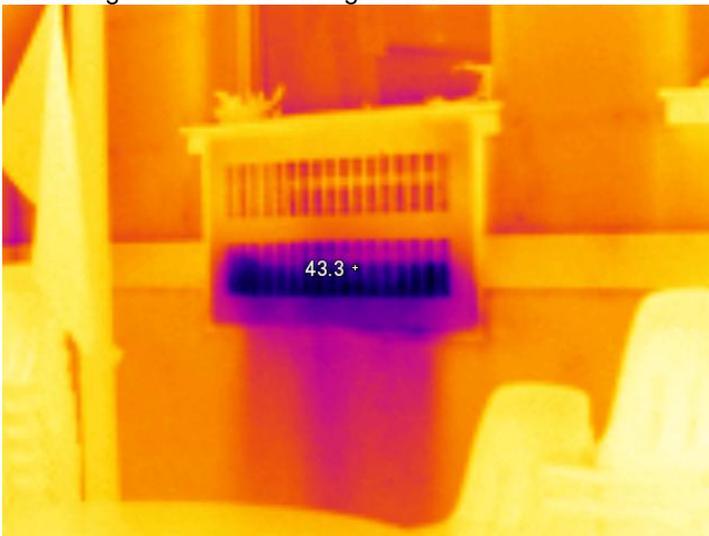
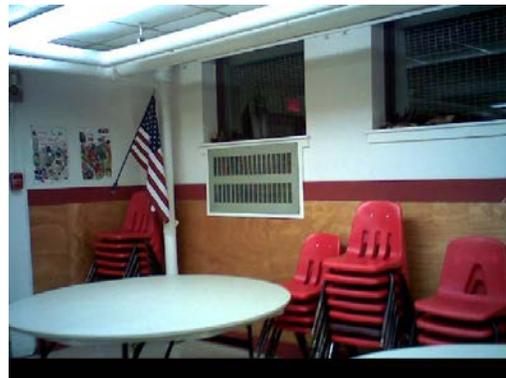
h. IR014225.IS2

Cold air pouring in through a typical relief damper (this image was taken under normal pressure). These are designed to only open with excessive indoor air pressure but it is clear that they cannot stop dense outside air.

All of the unit ventilators had leaky dampers. As these were recently renovated the contractor should be notified to readjust the linkage arms or replace seals with more flexible ones as needed to obtain a tight fit. At the same time remove the inside grills and foam seal the relief damper housings (not the damper itself) to the walls with gun foam. Ask the mechanical contractor if heavier or better flap dampers can be installed to keep cold air out.

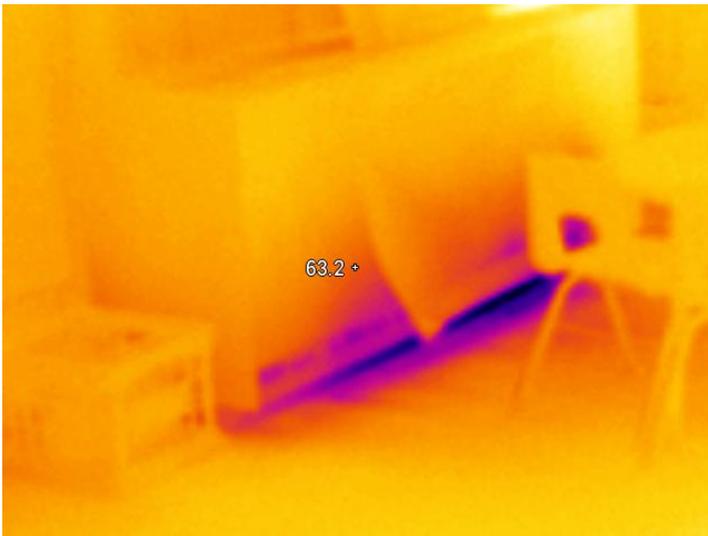
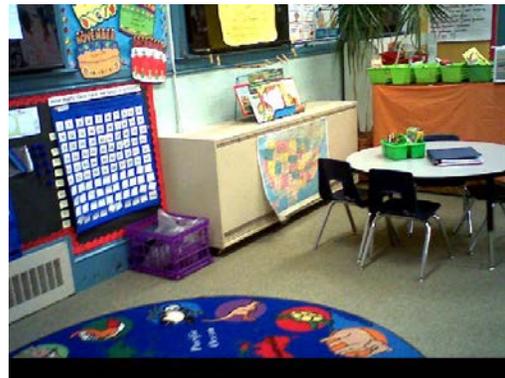
i. IR014234.IS2

Air leakage under a typical unit ventilator. They all looked this way.

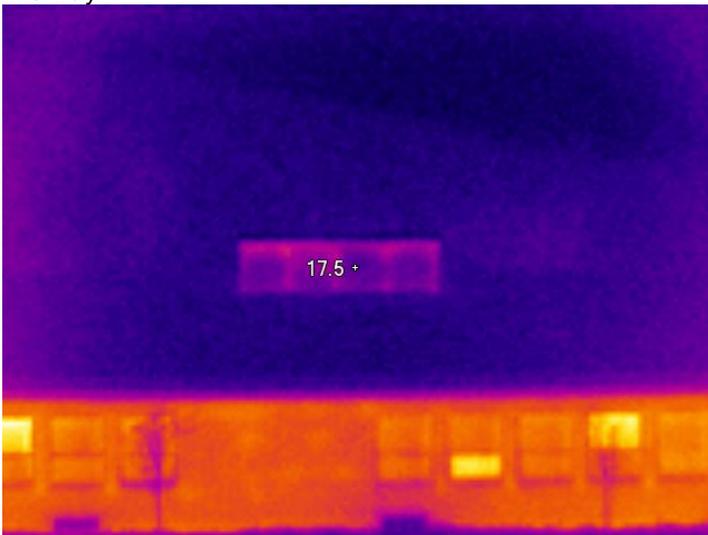
j. IR014291.IS2

In 2007 the roof of the 1978 building was insulated and all these vents should have been sealed closed. Some were, like this one.

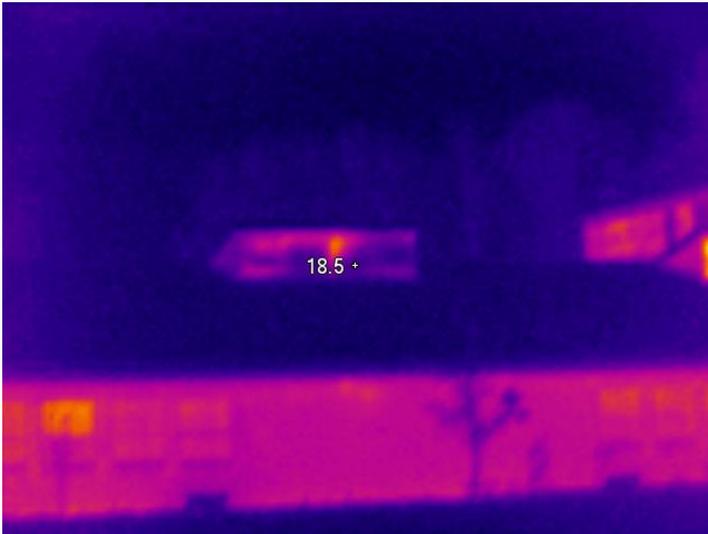
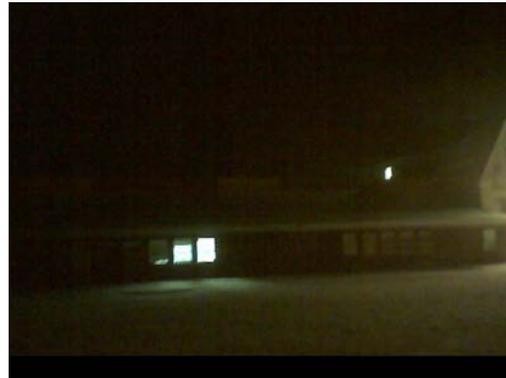
k. IR014292.IS2

This one was not completely sealed.

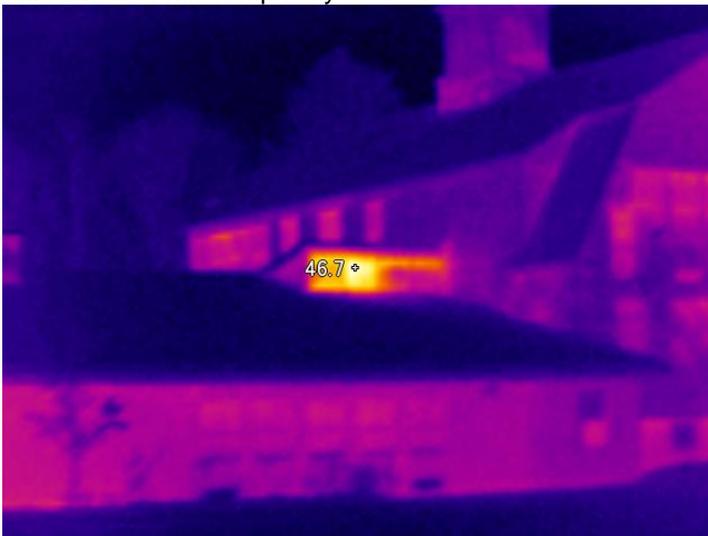
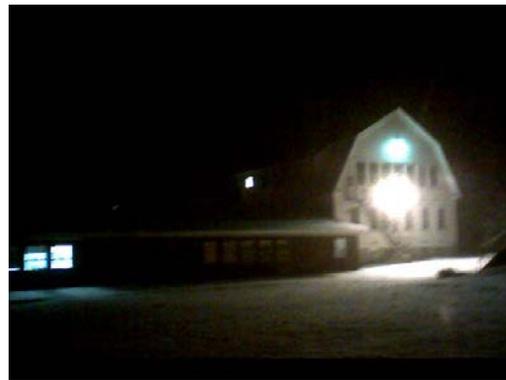
I. IR014298.IS2

And this one seems to have been missed. Infrared images inside showed that air leakage through the dropped ceiling got progressively worse as I got closer to the connection between the 1978 and 1912 buildings. This is the reason.

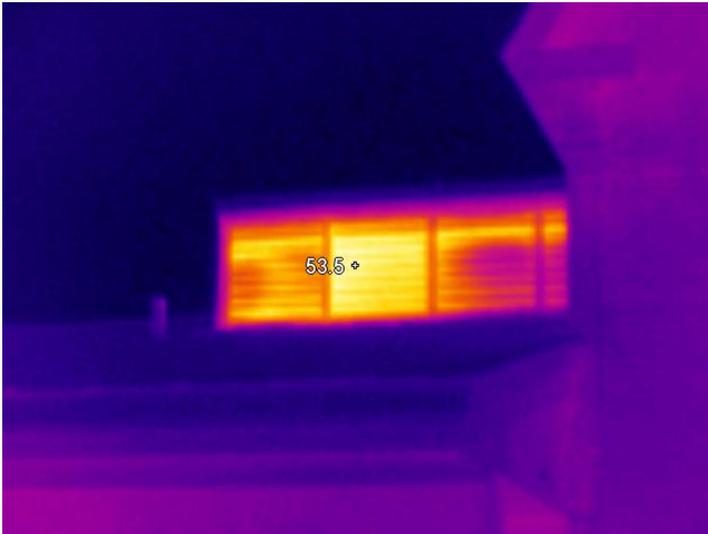
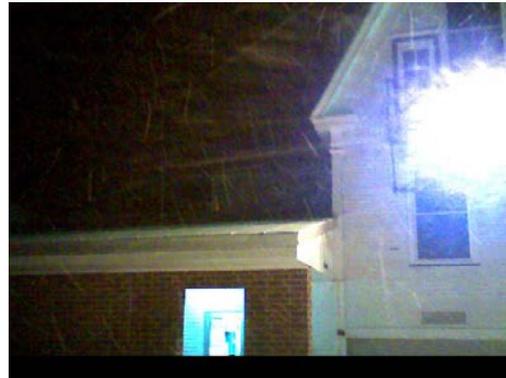
m. IR014307.IS2

Another view of the same vent.

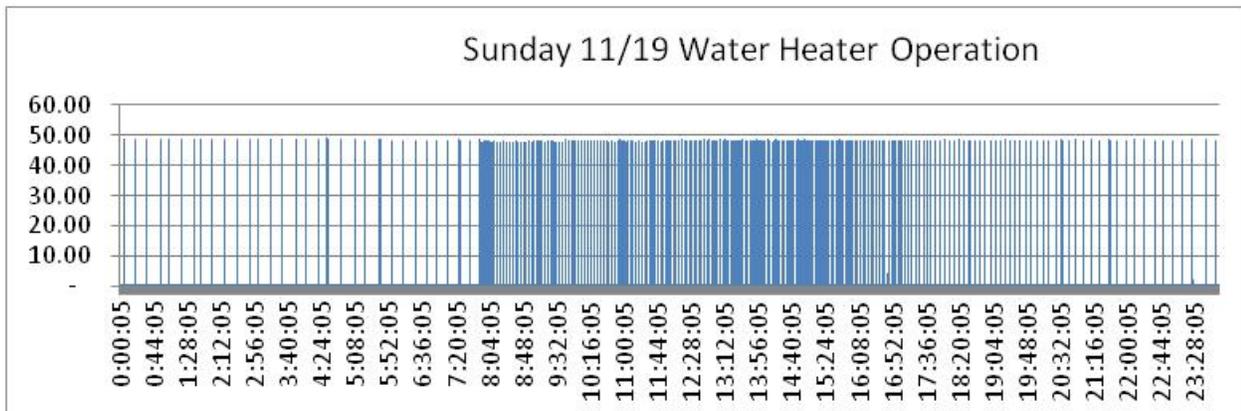
There are two large electric water heaters serving the kitchen. One of them does not operate because it has a failed breaker and the other cycles on for 40 seconds every three minutes at 12kW during occupied hour. At night and weekends it cycles at 10 minute intervals maintaining 120°F water.

Above is the kitchen water heater operation on Sunday, November 19th. There was no dishwasher use at on that day.

We recommend extending the boiler indirect heater loop to the kitchen to handle this load. There will be some inefficiency in operating the boiler in warm weather but probably not enough to warrant keeping the electric heaters. They add about 4kW to the peak demand.

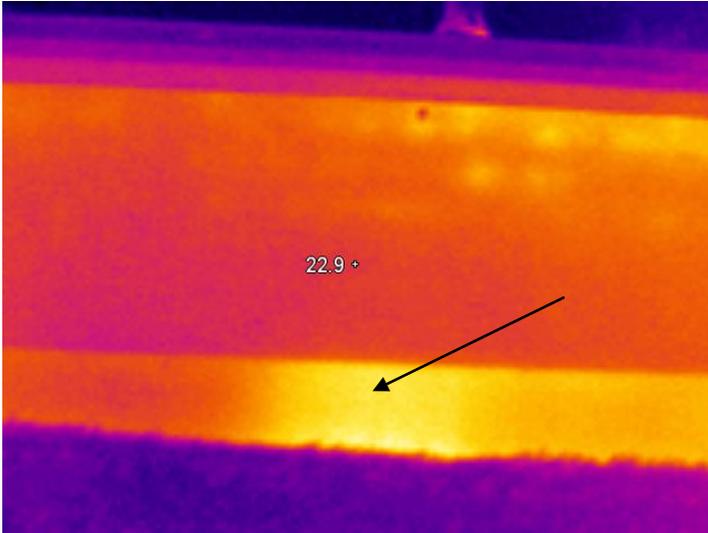
a. IR014259.IS2

The change in temperature is where the inside of the boiler room starts and the heat is escaping through the foundation.

1. From outside dig down into the soil around the foundation and expose 12 to 18” of the foundation wall. Wash off the soil and allow the walls to dry completely.
2. Glue at least 2” thickness of rigid expanded polystyrene (XPS) foam board (blue or pink board) to the wall by setting it in the bottom of the trench and going up to the top of the foundation. 3 or 4 inch thickness will save more but the largest payback will come from the first 2” of foam. Be cautious about the glue you select, get a construction adhesive that is formulated for XPS insulation, the other types will eat the foam.
3. Cover the above grade XPS insulation with metal sheeting (break metal), vinyl coil stock, or stucco. You can also get protective coated XPS that can be attached with masonry anchors for a higher price but a faster install.
4. Backfill the trenches in the soil.

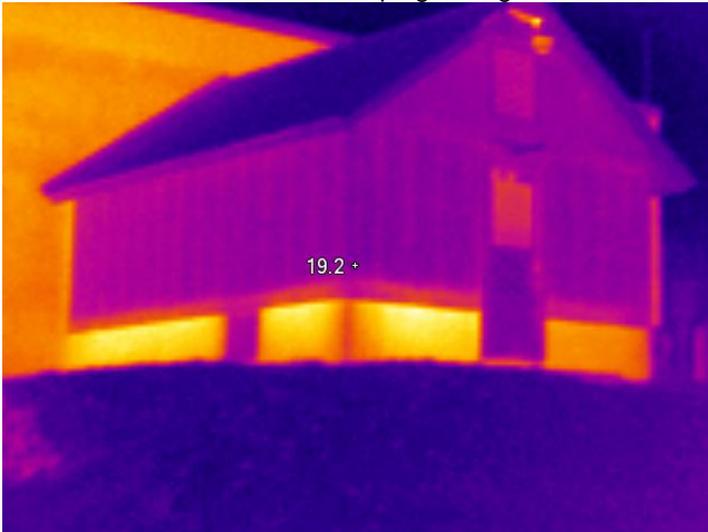
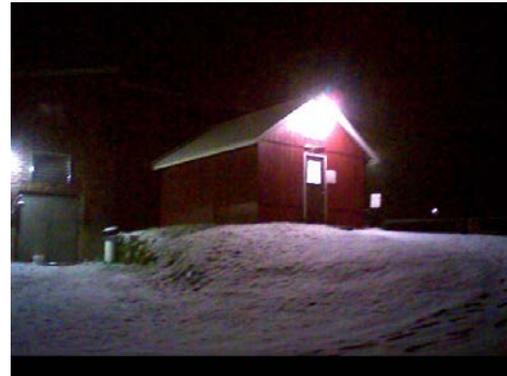
b. IR014267.IS2

Heat loss through the foundation. One side appears warmer than the other because that is the side with the radiant heaters. Note also the glowing shop walls beyond.

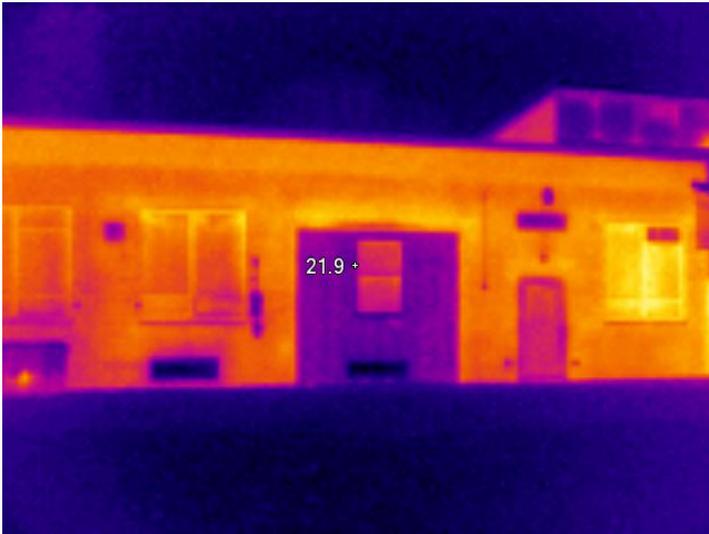
c. IR014278.IS2

The shop walls are in sharp contrast to the framed wall that infills the overhead door opening. Note also the gable end of the vented roof beyond. It probably needs insulation.

Insulate shop walls from outside:

3. Insulate the rest of the wall with at least 2” of polyisocyanurate board (Tuff- R or equivalent). Thicker insulation is recommended but the majority of the payback comes from the first 2” of insulation. Tape the seams of the rigid insulation.

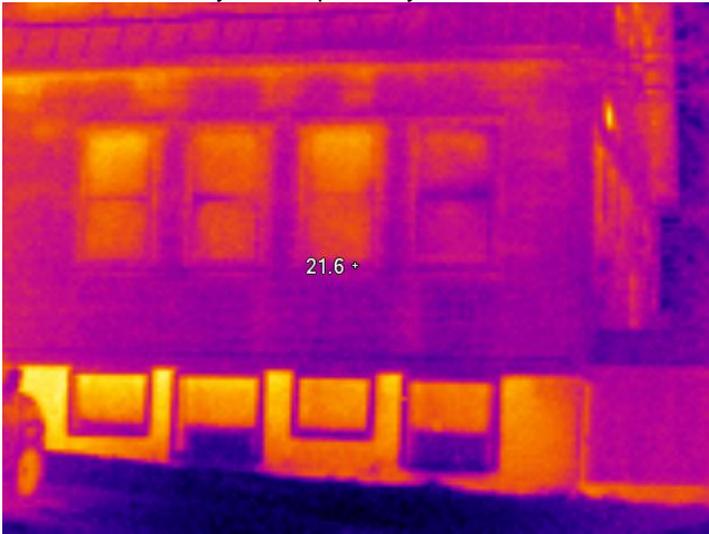
d. IR014328.IS2

The foundation walls of the 1912 building.

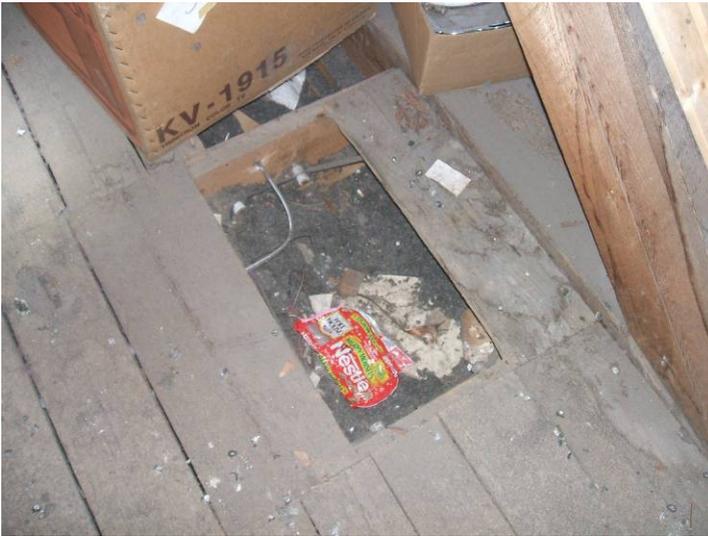
e.

Looking under the floor boards of the attic.

Although the financial case for the foundation and concrete block wall insulation is better there is no reason not to consider the attic of the 1912 building as long as low interest funding can be obtained. If the project can be cash positive over the term of the loan then it is worth serious consideration.

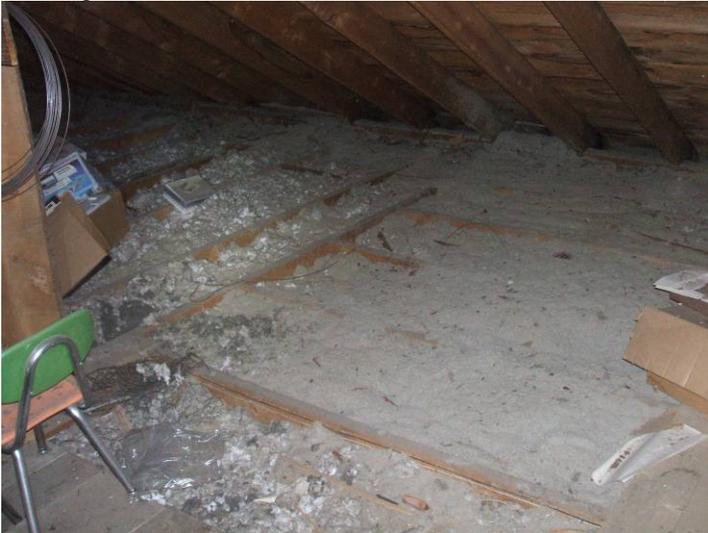
f.

The attic where there are no floor boards.

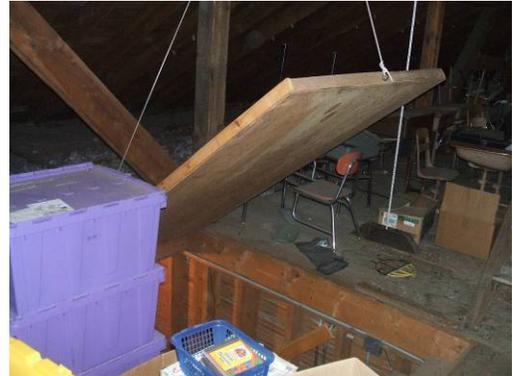
The uninsulated attic hatch

parts from the original manufacturer if available. When the door is closed you should not be able to see daylight light at the perimeter. Door thresholds also need to be added/replaced if they can be, if not, door sweeps should be added. *Focus* weather stripping efforts on doors that are used rarely and emergency exits since they have to perform more like walls most of the time. Don't forget to weather strip "interior" doors that open into cold spaces such as the attic. The attic hatch will be discussed in more detail later.

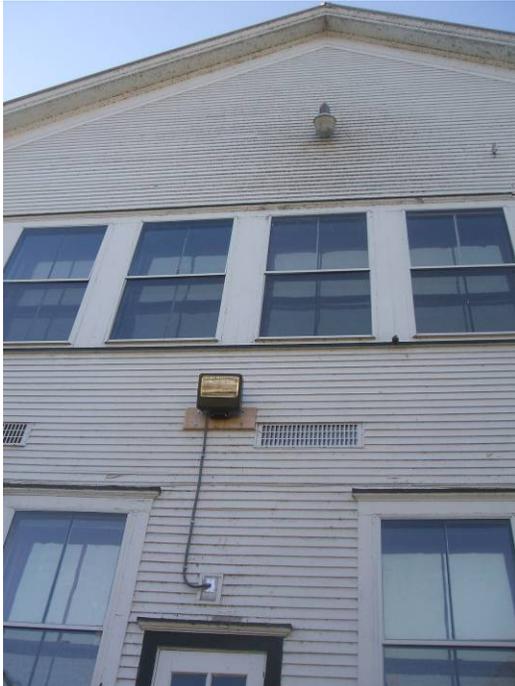
A metal halide light with a HP sodium light above it.

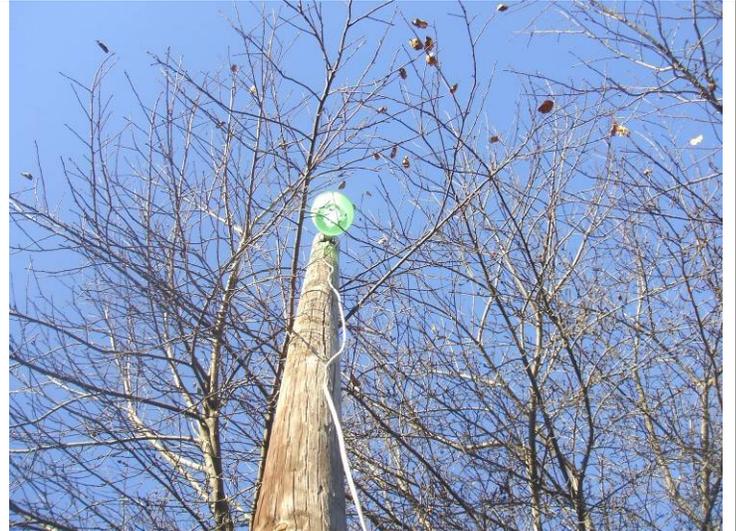
The bus light on in the middle of the day. In addition to fixing the photo cell this bulb could be replaced with a CFL as has been done on other similar lights.

I counted 13 outside building lights on at night and I understand all are needed for building security. They are controlled by a timer switch which is set to turn on from 5:00 pm to 7:15 am. The timer could be replaced with a photo sensor that would adjust seasonally for a small savings. Most of the lights are efficient and do not warrant immediate replacement however, the large metal halide light should probably be replaced with a comparable light level LED fixture. Because LED lights are “instant on” this light could be on a motion sensor to further increase energy savings. Also replace the HP sodium bulbs with CFLs in the remaining streetlamp style lights that have not already been changed. Finally, the photo sensor cell needs to be replaced on the pole light by the busses. It was on all day both times I was there.

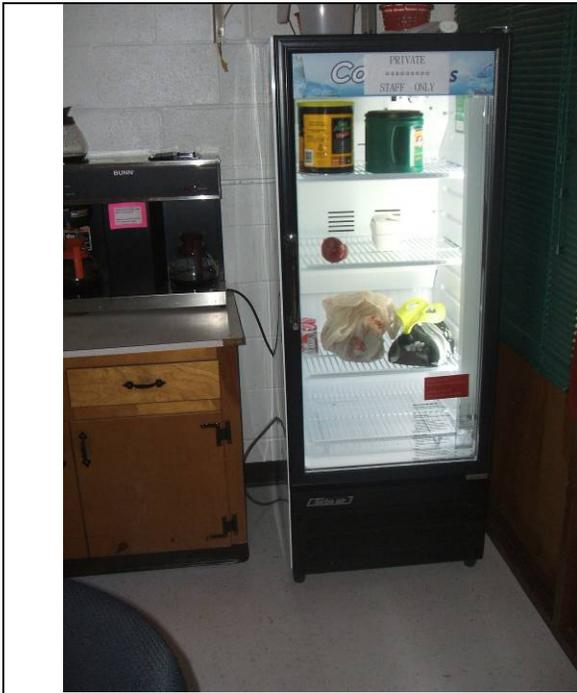
The fridge in the staff lounge has a glass door.

The fridge in the staff lounge should be replaced with a similar sized energy star fridge. The glass door has very little R-value so the fridge runs longer than it needs to. At the minimum, turn off the light that is always on inside the fridge, it is generating heat the fridge has to remove as well as wasting electricity.

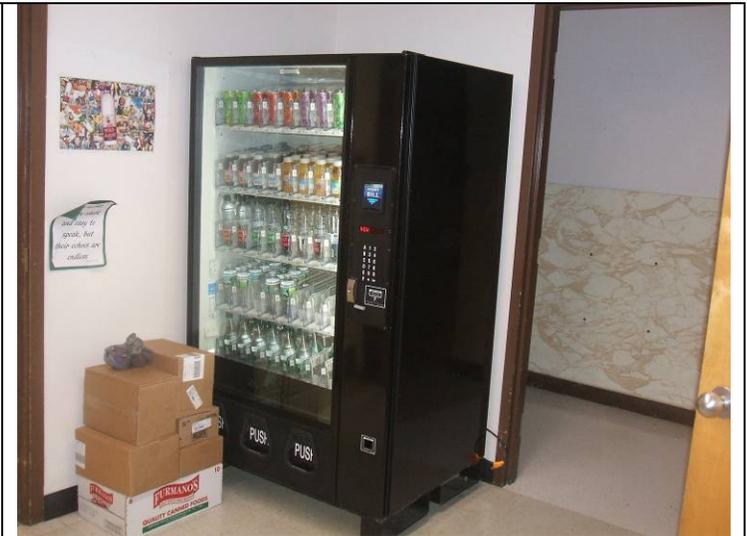
This vending machine does not need to be on at night.

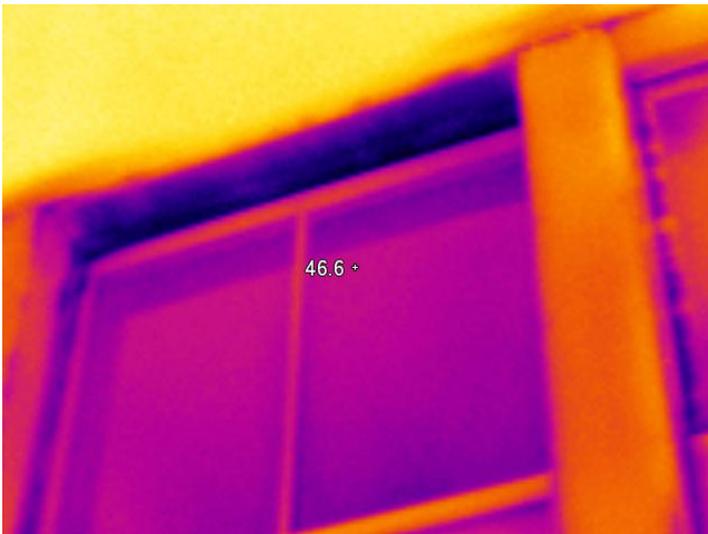
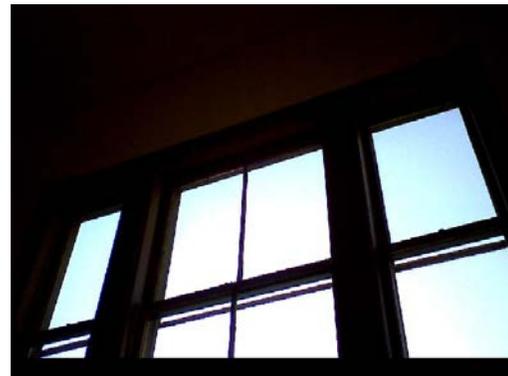
b. IR014092.IS2

This top sash is not fully closed and cold air is pouring in.

I recommend interior storm windows similar the one shown below for all windows to increase R-value and decrease air leakage especially on the rattly 1912 windows. On the 1912 windows I further recommend making the upper sash a fixed pane window and caulking it in place.

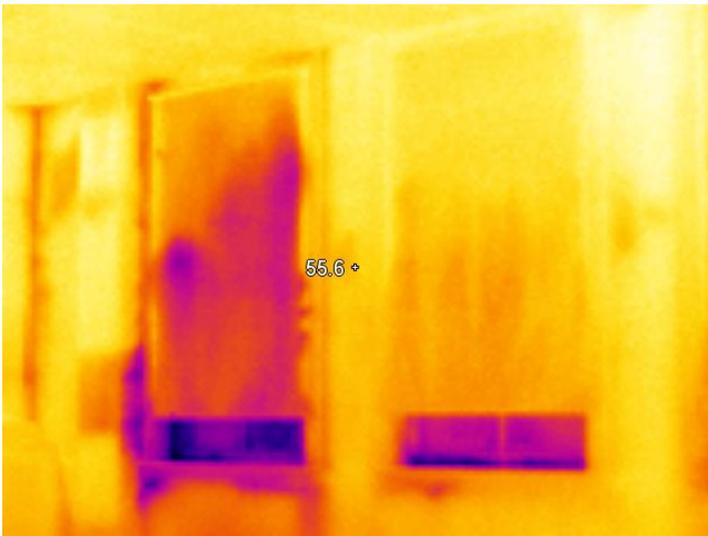
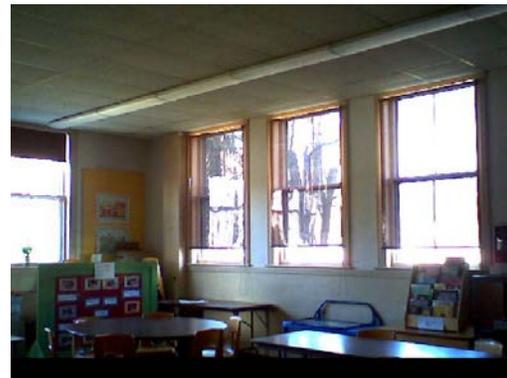
c. IR014062.IS2

This image shows that not all windows are equally leaky, some are much worse.

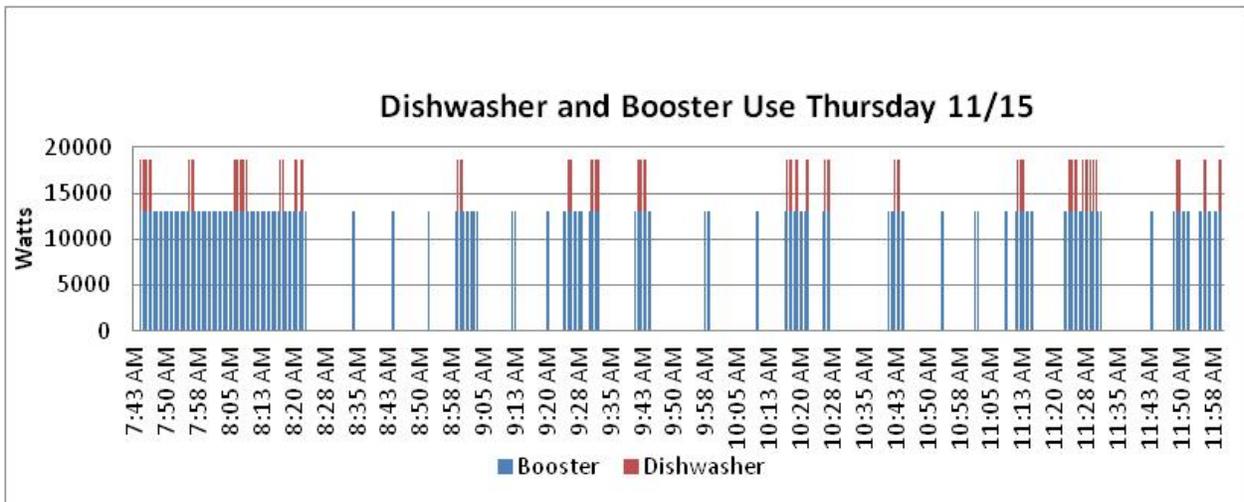
The 13 kW booster heater for the dishwasher cycles with the dishwasher and sometimes just heat its small storage tank. As noted in Norm Etkind's SEMP site assessment, the energy it uses is five times more expensive than that used by lighting and other appliances because it adds between 4 and 5 kW to the monthly 15 minute peak electrical demand. This cost, around \$1 per kWh, makes conversion to LP gas an attractive opportunity.

The cycling seen between dishwasher uses would continue through unoccupied times if the kitchen crew did not throw the disconnect every day.

The capacity of the booster is about 44 MBH (thousand Btu per hour) and can be met by a heater such as the Hatco PMG-60 3 Gal Booster Water Heater which costs \$4,500, can be installed by ARC, and should fit under the counter.

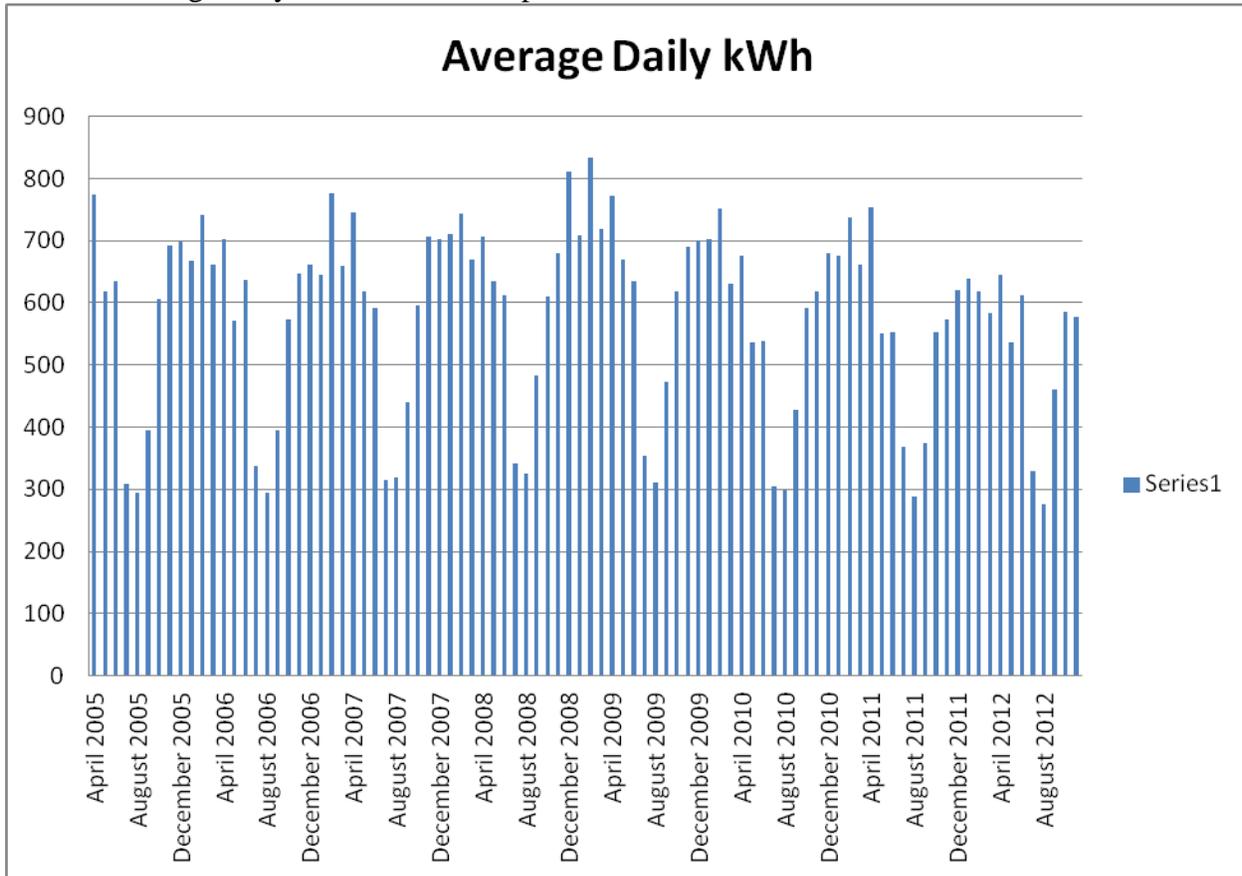
Electric power consumption spikes every February and April which was a mystery. I asked around to try to find possible reasons, heavy cleaning equipment during vacation, use of the kiln? Andrew Doyle came up with the best suggestion, when the students are gone for a week the boilers have to work harder to heat

the building. All the more reason for central temperature controls so the school can be setback on vacation weeks.
