## Town of Corinth Road Erosion Inventory Report

Prepared by:  
**TRORC**  
Two Rivers-Ottawaquechee  
REGIONAL COMMISSION

### Road Inventory and Evaluation Form for High Priority Project Sites

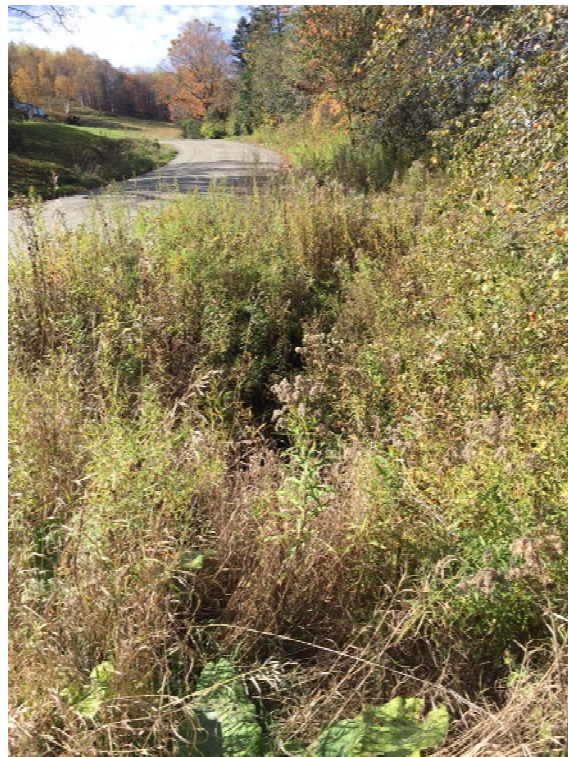
Road Segment Name & Segment ID Number:	Road Type:	Average Road Grade:	Site Number:
Cookeville Rd 21832	Gravel	1.49%	1

**Overall Segment Score:** Does Not Meet

**Notes:** Header erosion at stream culvert

- Add more ditch stone (4 ft already good)
- 18" culvert is undersized and rip rap on outlet: Will replace with 36" culvert
- To Threshold Way, 18" from house to culvert

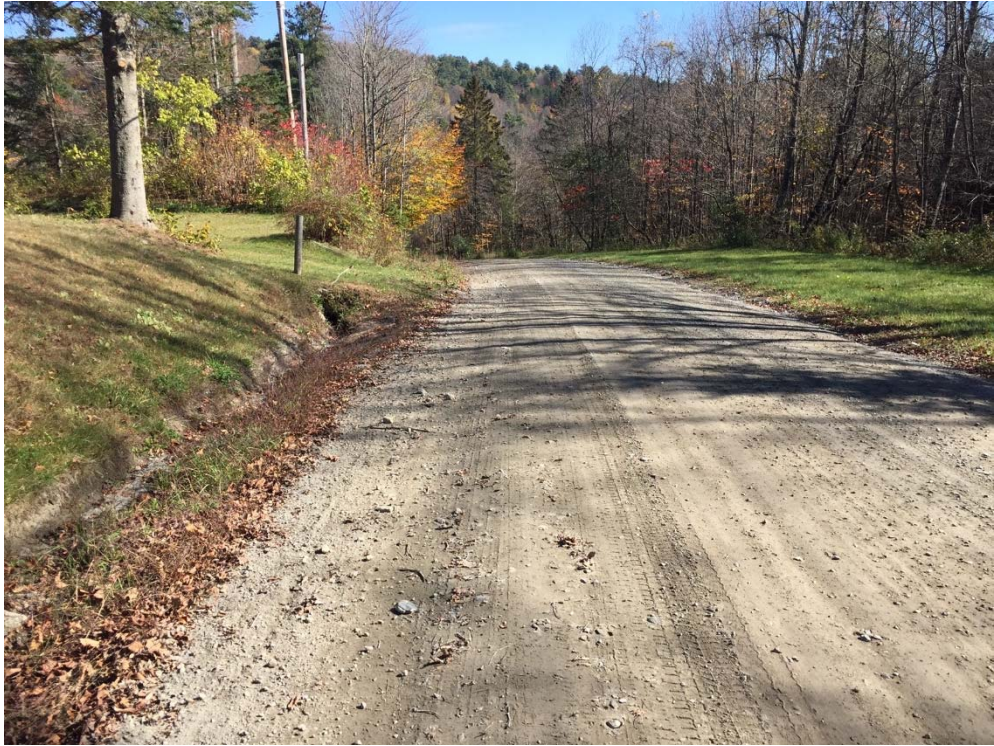
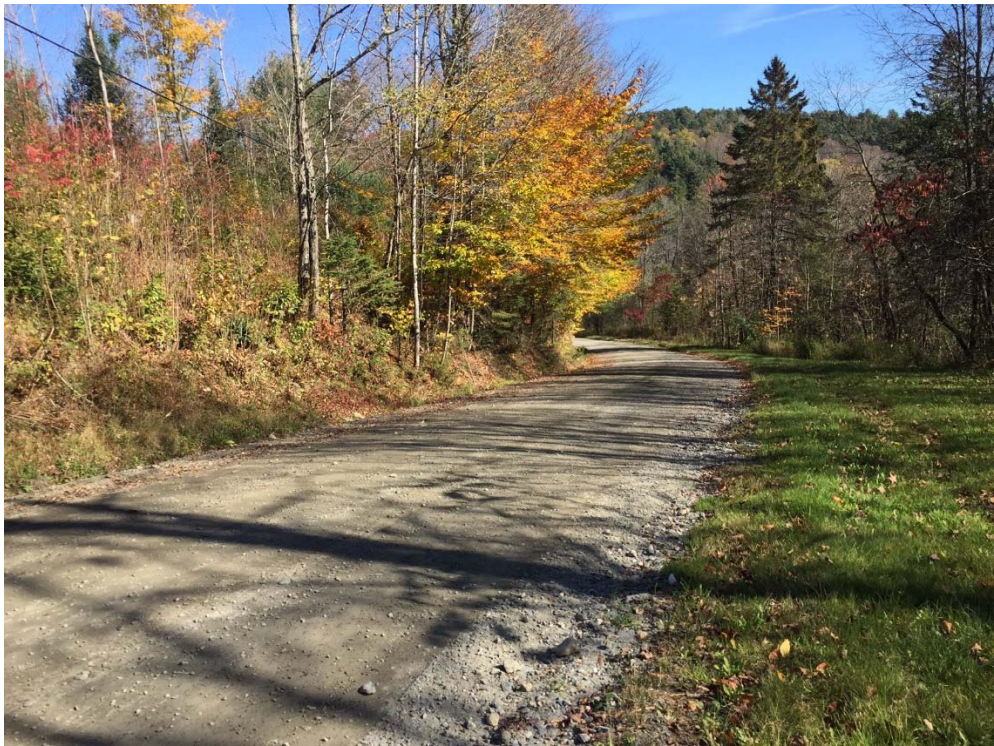
Road Segment Name & Segment ID Number:	Road Type:	Average Road Grade:	Site Number:
Center Rd 20034	Gravel	5.79%	2

**Overall Segment Score:** Does Not Meet

**Notes:** Steep and narrow still

- Stone-line ditch on left side (start above driveway)
- Stone both sides below driveway to brook
- Upsize driveway culvert from 15" to 18"

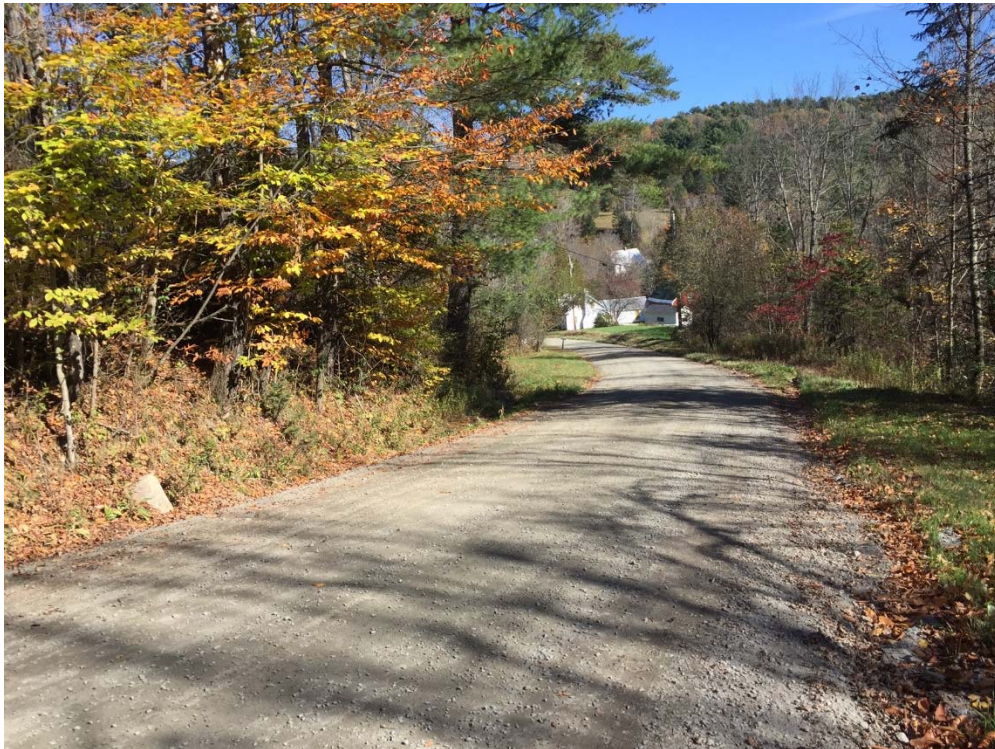
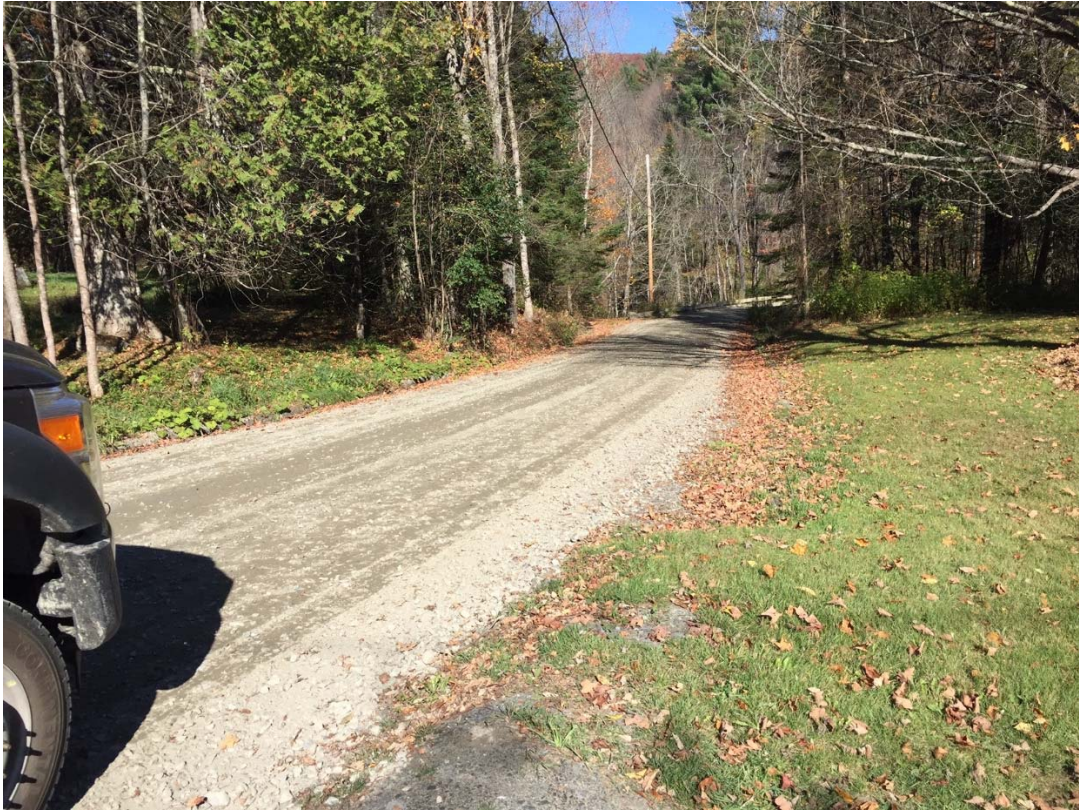
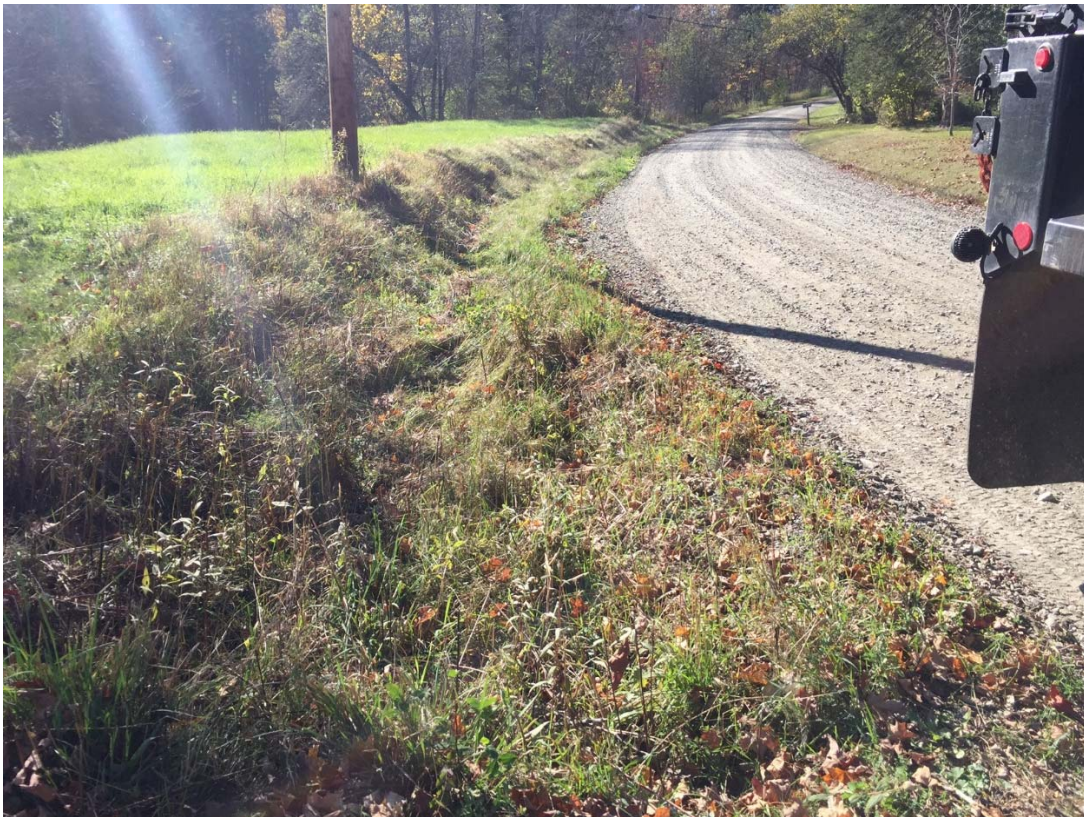
Road Segment Name & Segment ID Number:	Road Type:	Average Road Grade:	Site Number:
Center Rd 20035	Gravel	18.1%	3

**Overall Segment Score:** Does Not Meet

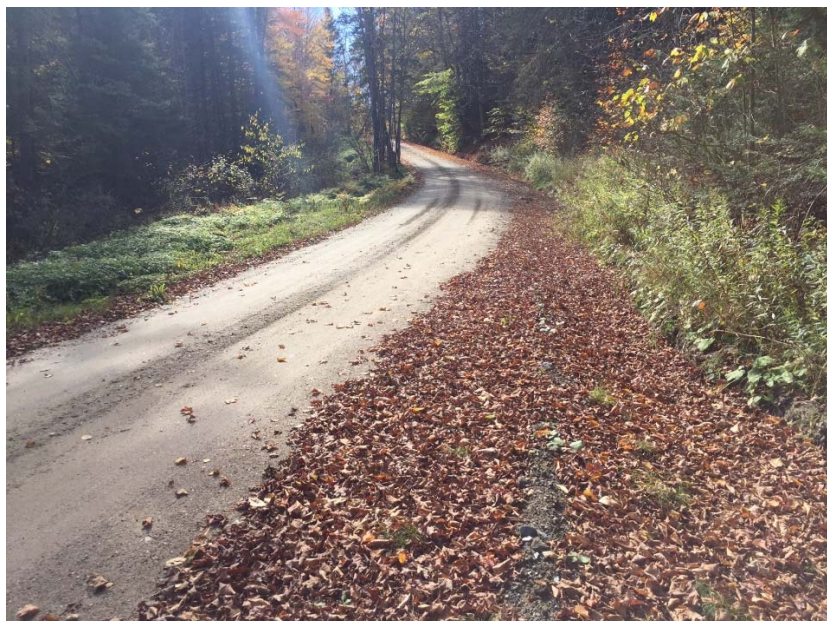
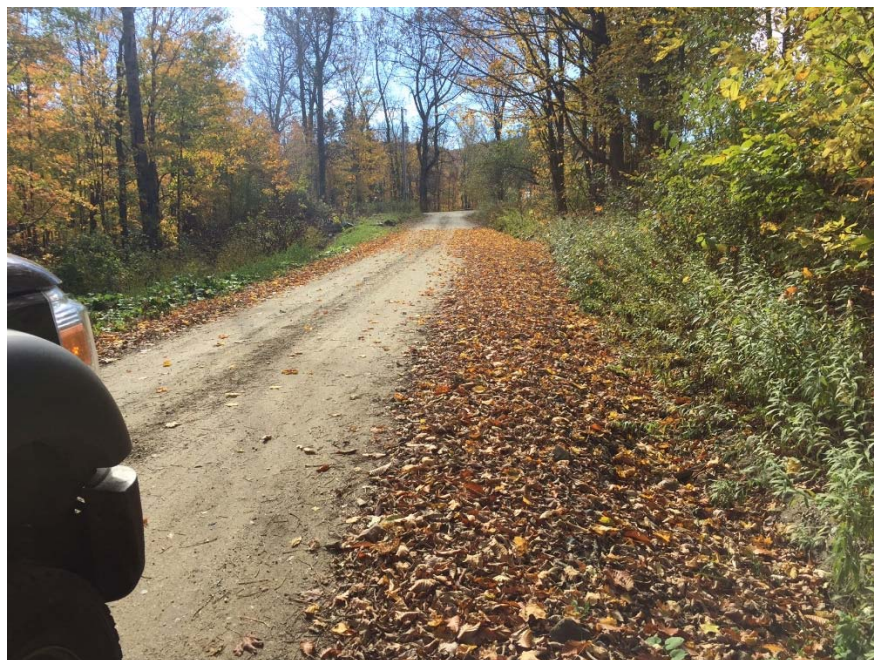
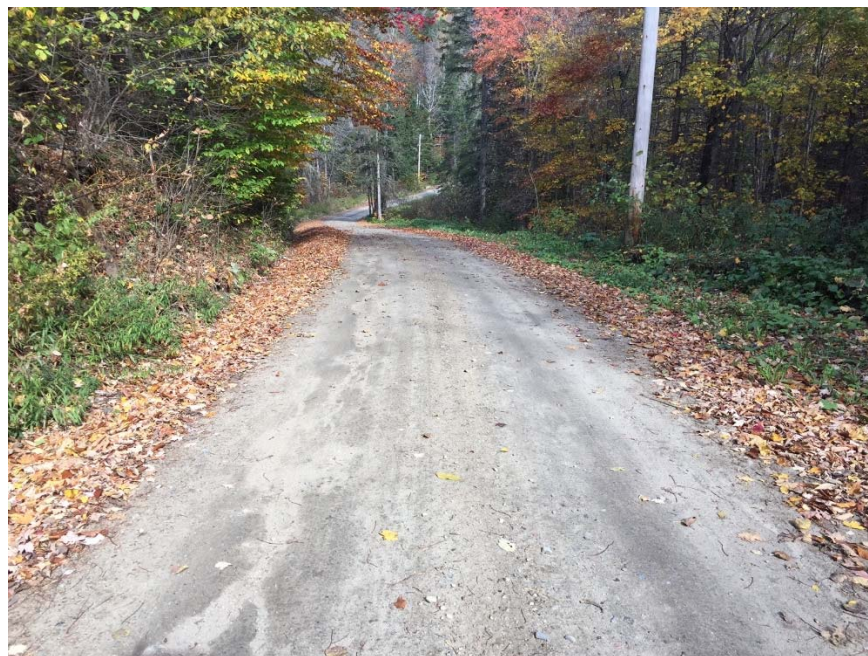
Road Segment Name & Segment ID Number:	Road Type:	Average Road Grade:	Site Number:
Threshold Wy 185389	Gravel	10.26%	4

**Overall Segment Score:** Does Not Meet

**Notes:** Conveyance goes directly into stream with not much filtration for sediment. Bank by stream culvert falling away

- Stone-line from top on left to brook
- Add 18" cross culvert at top of hill
- Add 18" above brook

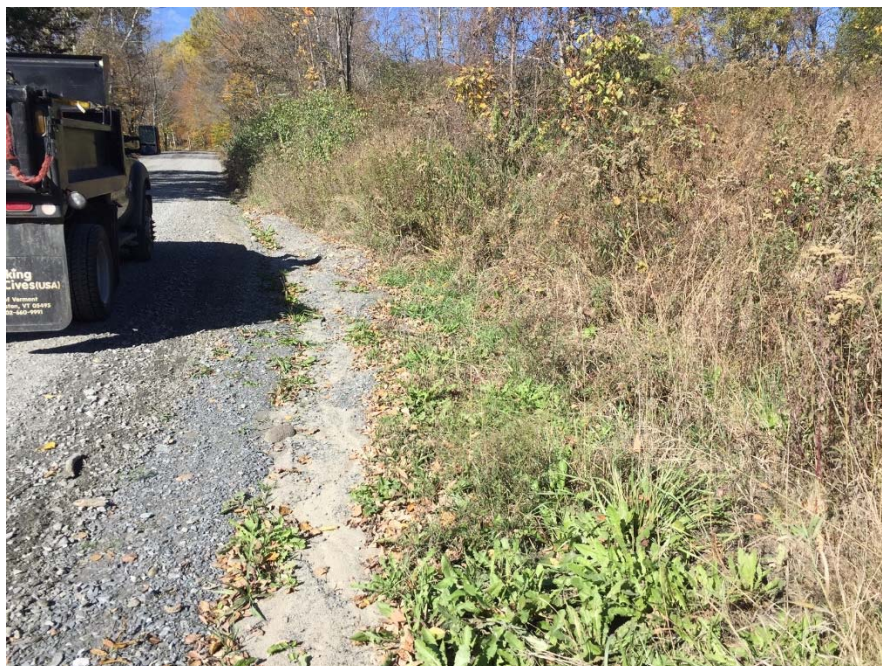
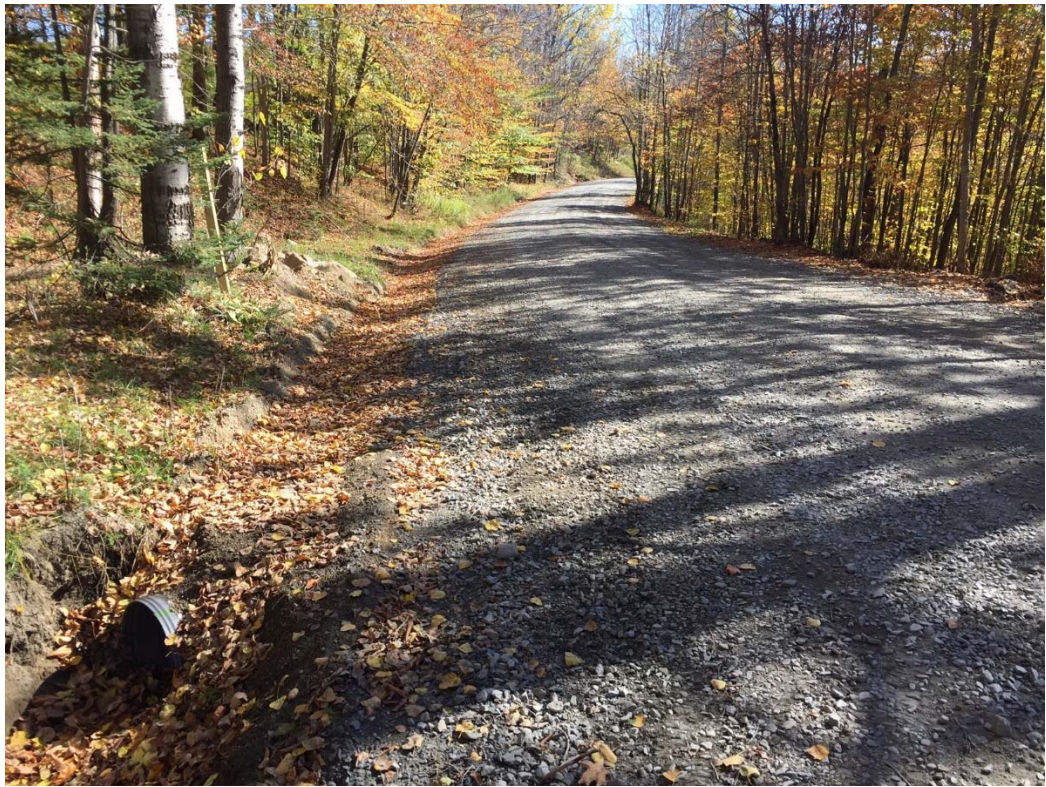
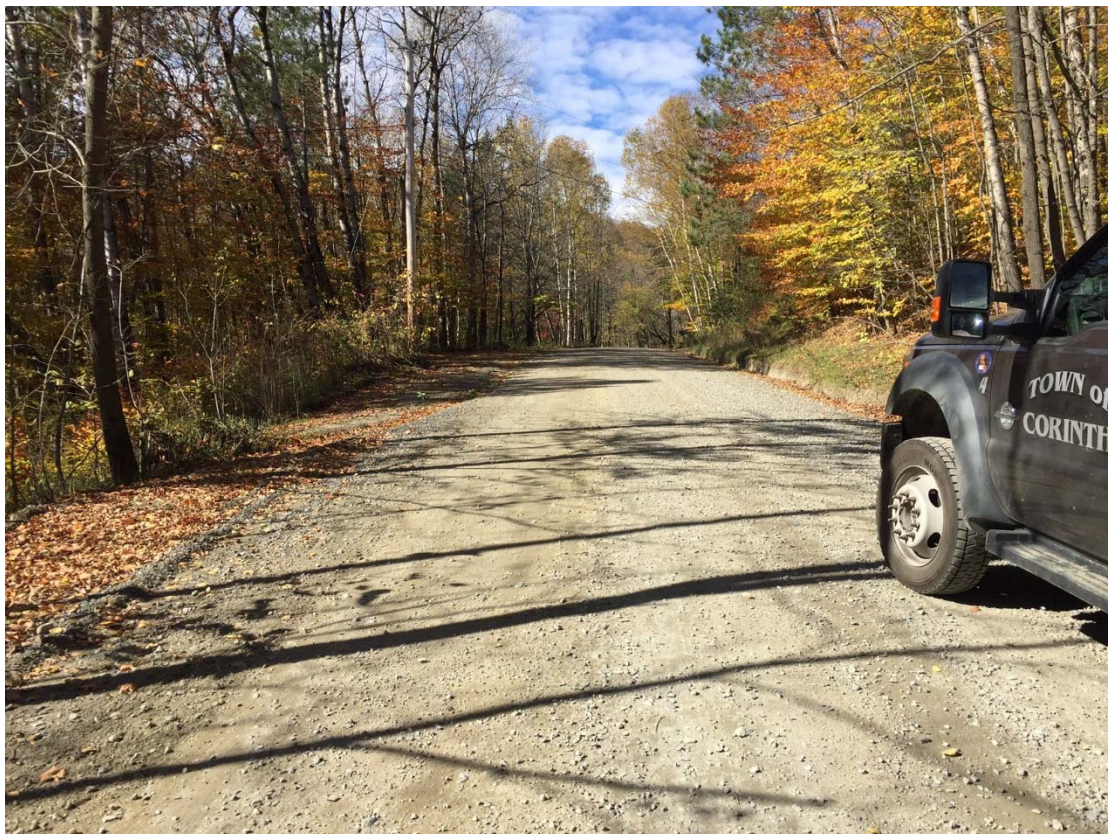
Road Segment Name & Segment ID Number:	Road Type:	Average Road Grade:	Site Number:
Cookeville Rd 25704	Gravel	4.22%	5

**Overall Segment Score:** Does Not Meet

**Notes:** Conveyance could be built better, eroding road away

- Stone-line from culvert/beaver pad to top of hill
- Upsize driveway culvert to 30"
- Stone-line above cross culvert

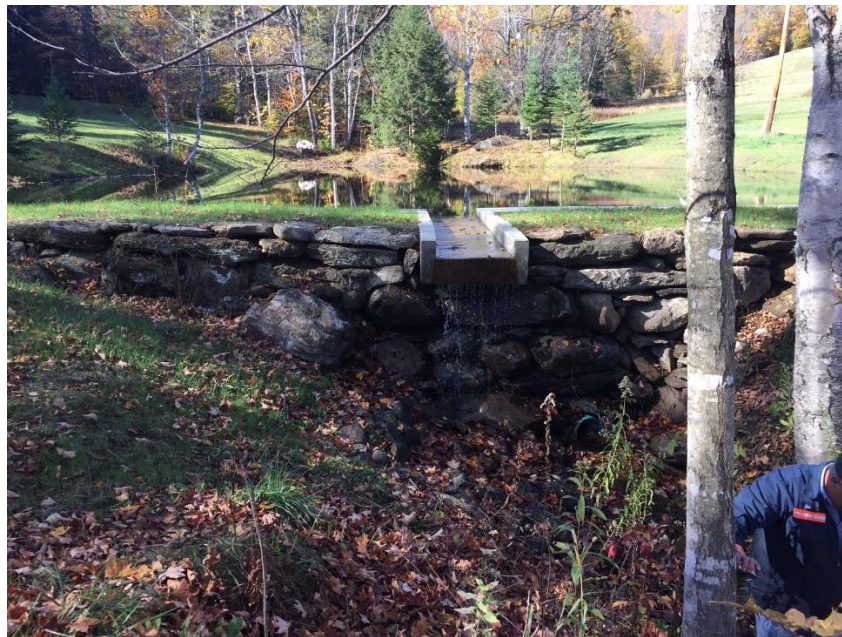
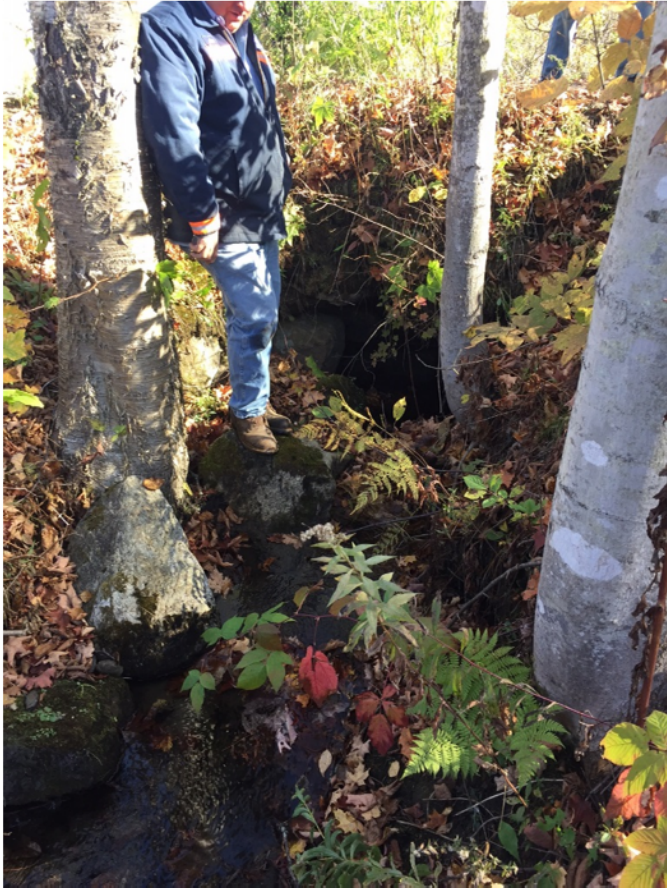
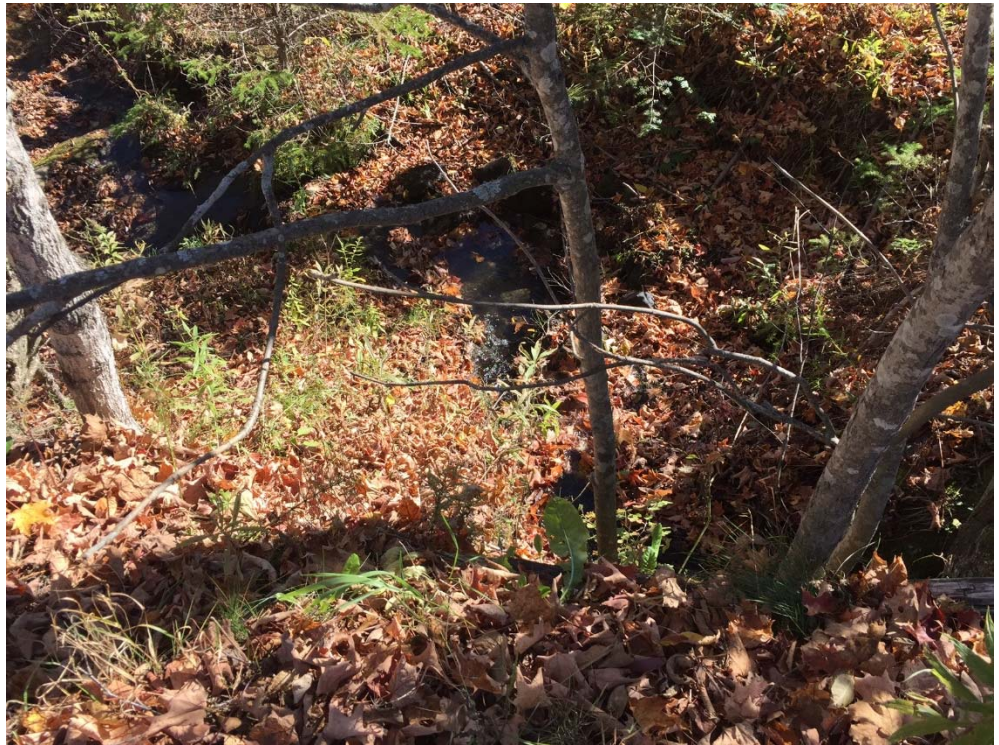
Road Segment Name & Segment ID Number:	Road Type:	Average Road Grade:	Site Number:
Richardson Rd 156847	Gravel	9.19%	6

**Overall Segment Score:** Does Not Meet

**Notes:** Should be class 4

- Site 6: replace 3x3 stone culvert
- Site 7: realign

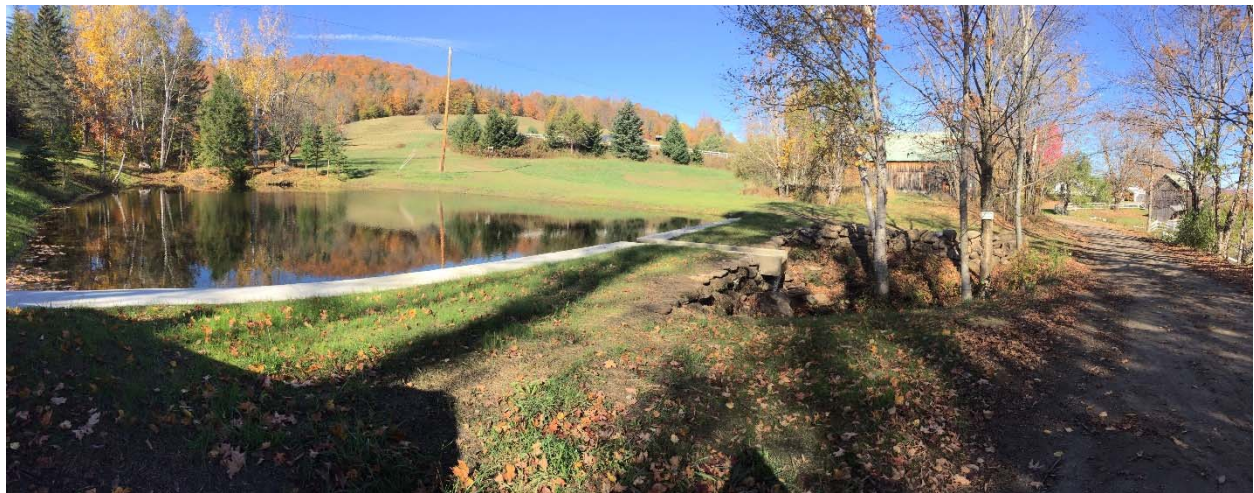
Road Segment Name & Segment ID Number:	Road Type:	Average Road Grade:	Site Number:
Richardson Rd 156895	Gravel	10.33%	7

**Overall Segment Score:** Does Not Meet

**Notes:** Road very steep and has rocks, seems like it should be class 4

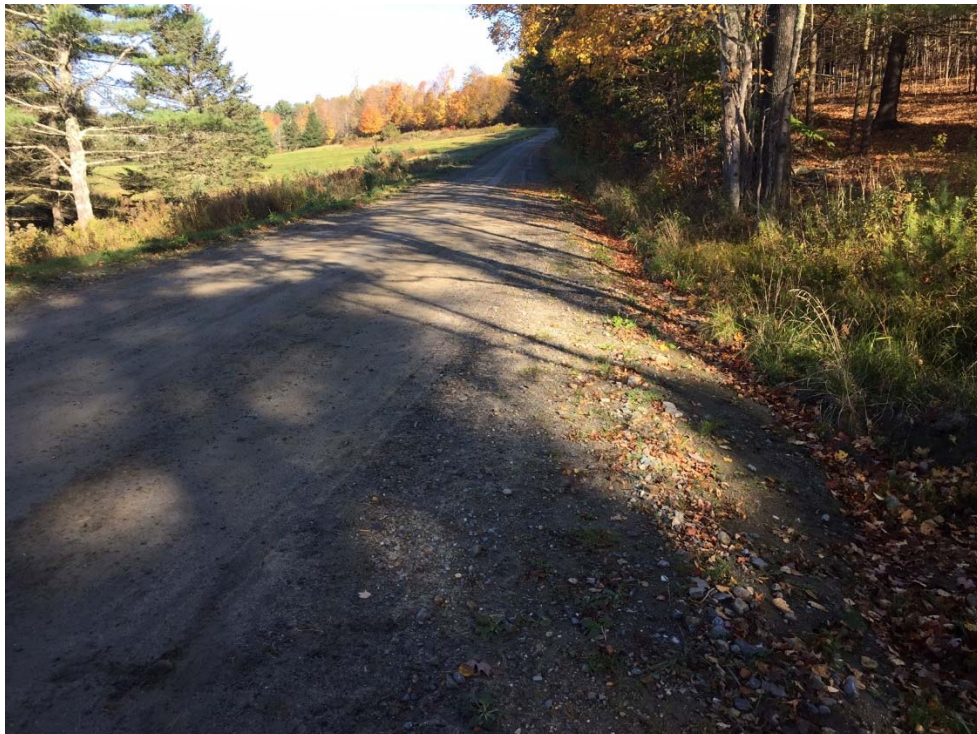
Road Segment Name & Segment ID Number:	Road Type:	Average Road Grade:	Site Number:
White Rd 197561	Gravel	6.13%	8

**Overall Segment Score:** Does Not Meet

5. DRIVEWAY CULVERT:	5. DRAINAGE CULVERT:	Type of Erosion
None Present	Does Not Meet	Gully

**Notes:** 12% slope

- At intersection of White and Hayward: stone-line right to culvert
- Upsize culvert from 18" to 24"

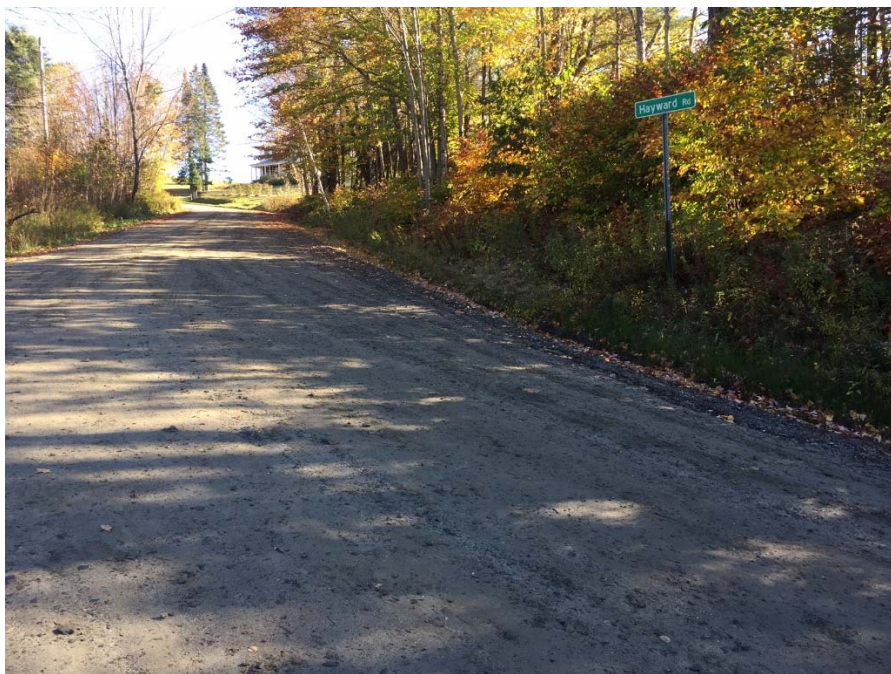
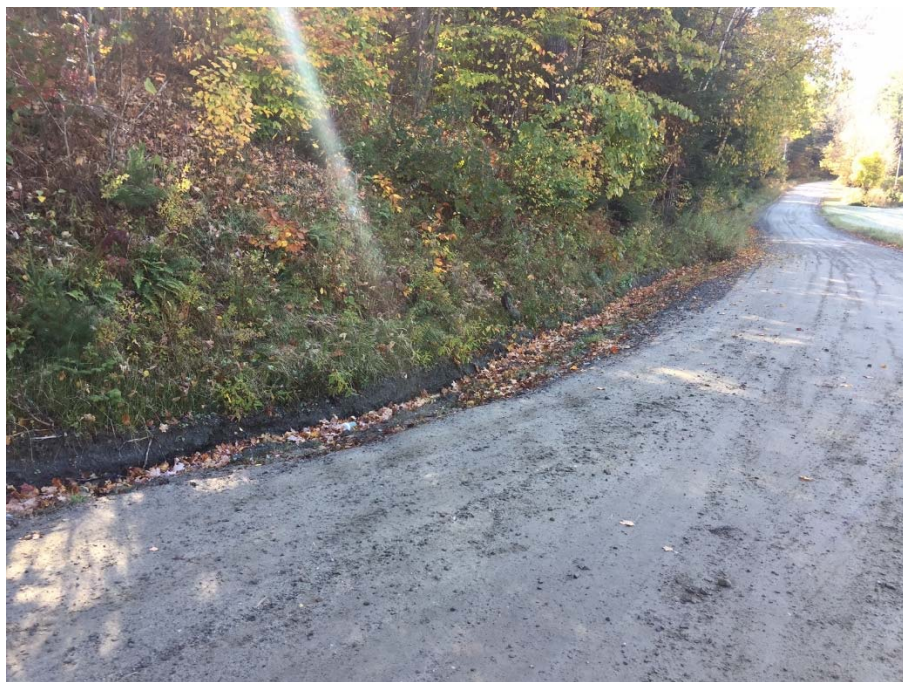
Road Segment Name & Segment ID Number:	Road Type:	Average Road Grade:	Site Number:
Hayward Rd 110189	Gravel	13.03%	N/A

**Notes:** Needs to be classified as hydrologically-connected segment as it meets criteria.

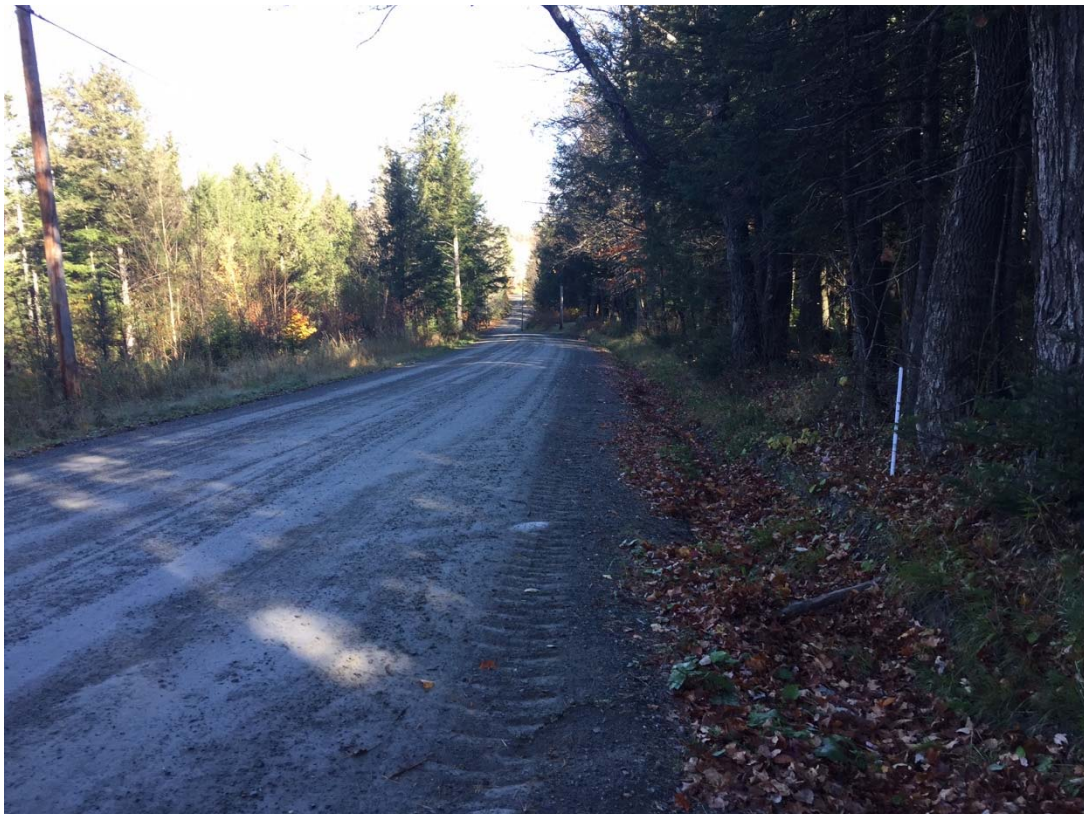
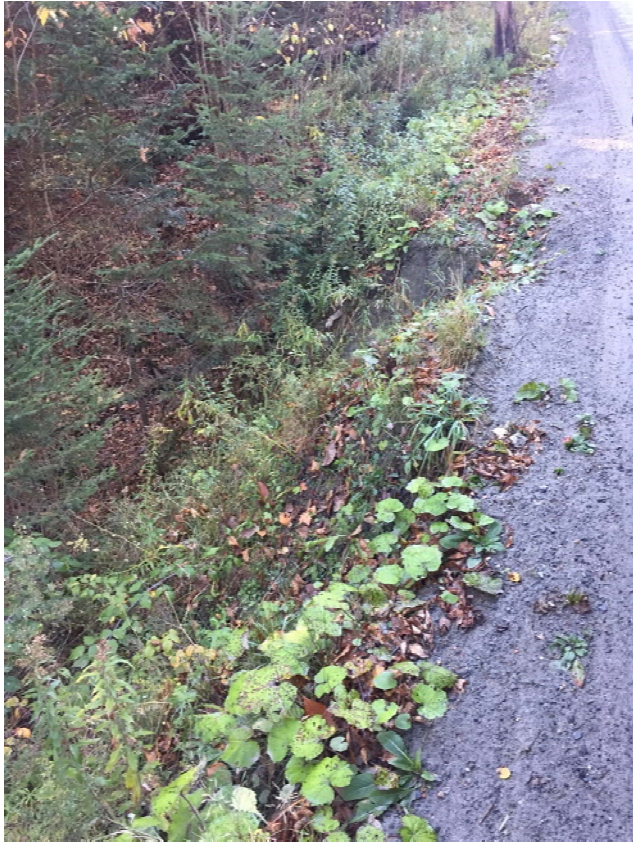
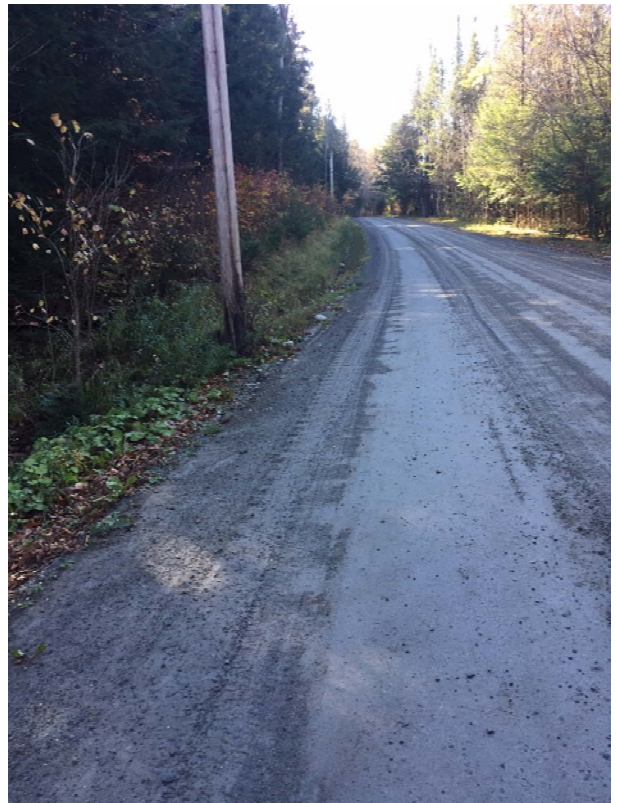
Road Segment Name & Segment ID Number:	Road Type:	Average Road Grade:	Site Number:
Fairground Rd 96161	Gravel	5.80%	9

**Overall Segment Score:** Does Not Meet

**Notes:** Ditch incising, turning into gully

- Stone-line from white post/tree right to brook
- Upsize driveway from 15" to 18"

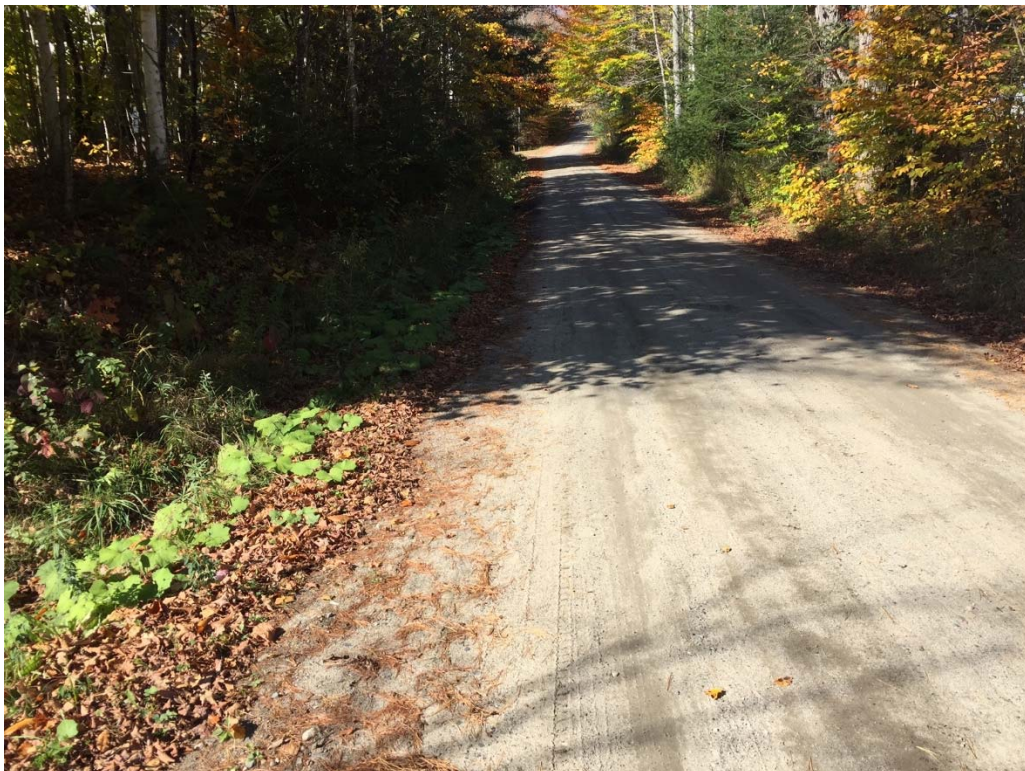
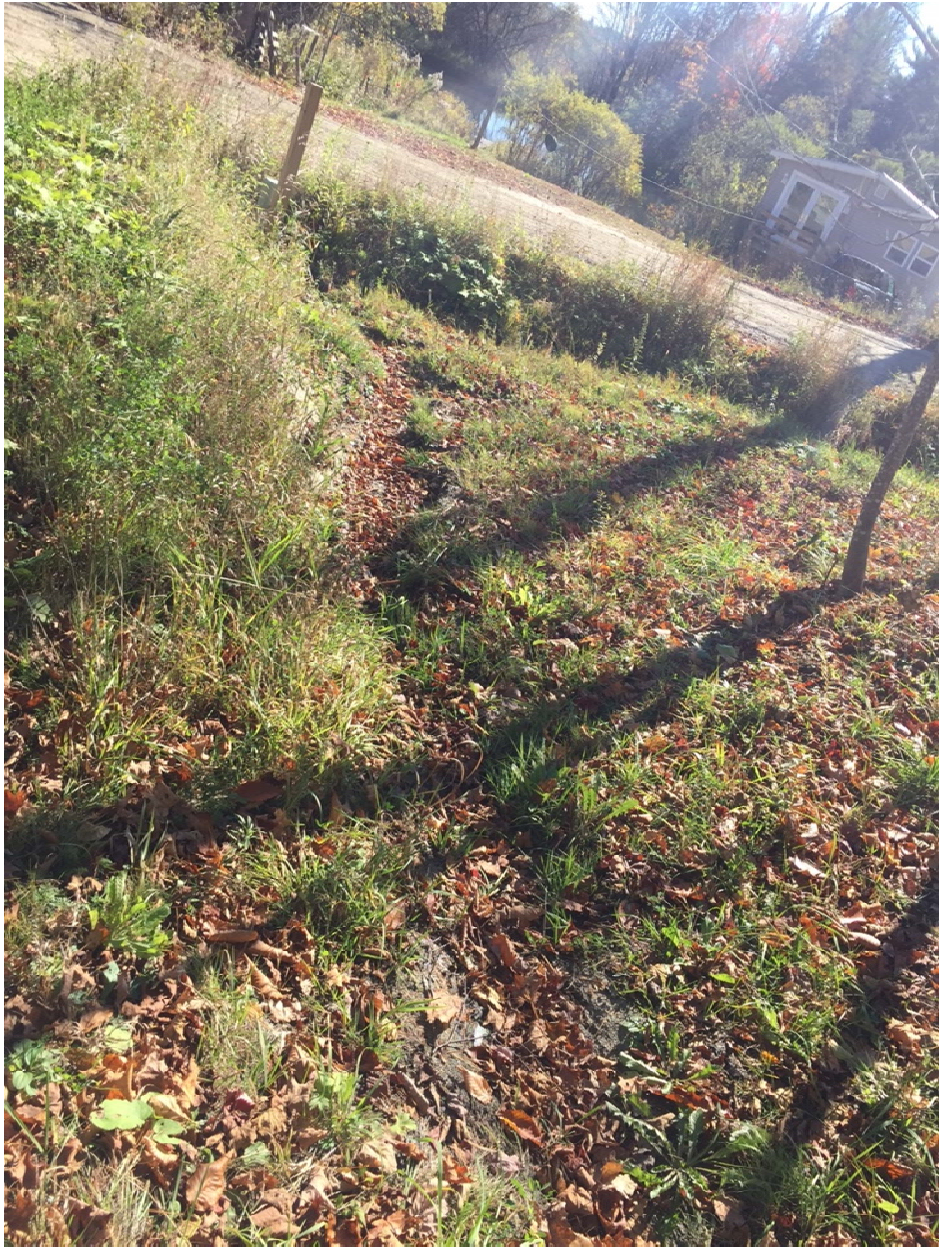
Road Segment Name & Segment ID Number:	Road Type:	Average Road Grade:	Site Number:
Hoots PI 113980	Gravel	10.11%	10

**Overall Segment Score:** Does Not Meet

- Site 10: Stone-line ditch
- Site 11: Stone-line ditch from driveway second right side

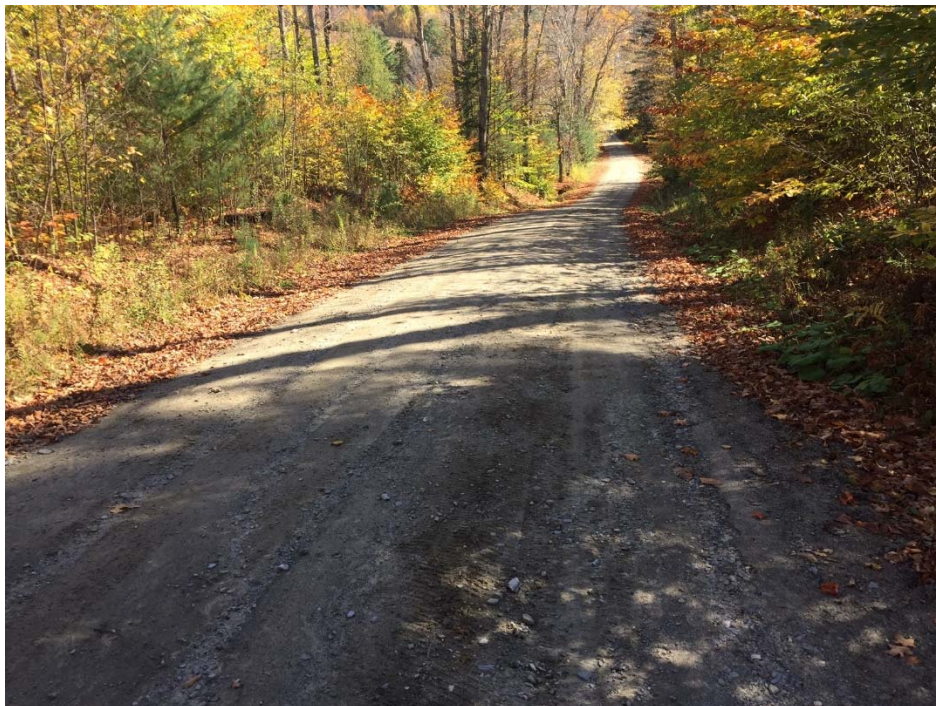
Road Segment Name & Segment ID Number:	Road Type:	Average Road Grade:	Site Number:
Hoots PI 113985	Gravel	13.18%	11

**Overall Segment Score:** Does Not Meet

**Notes:** Sediment spewing off turnouts and culvert outlets but not a problem for water quality in stream. Still needs stone lined ditching

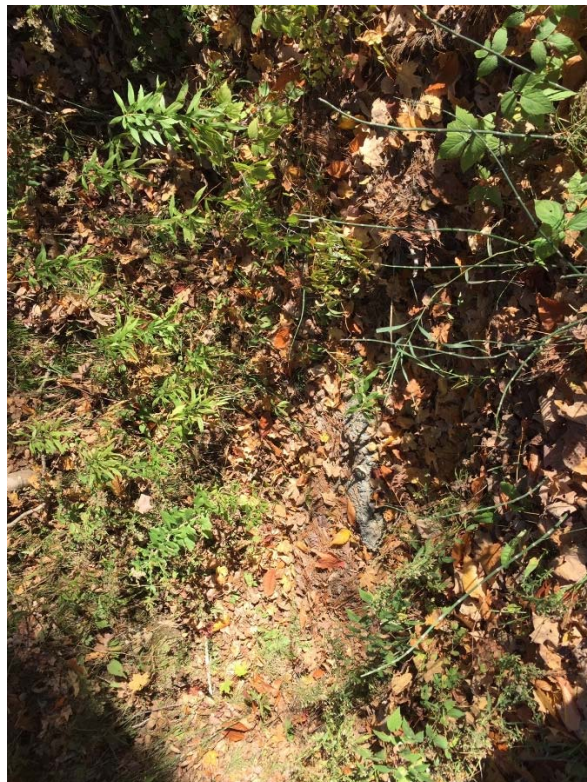
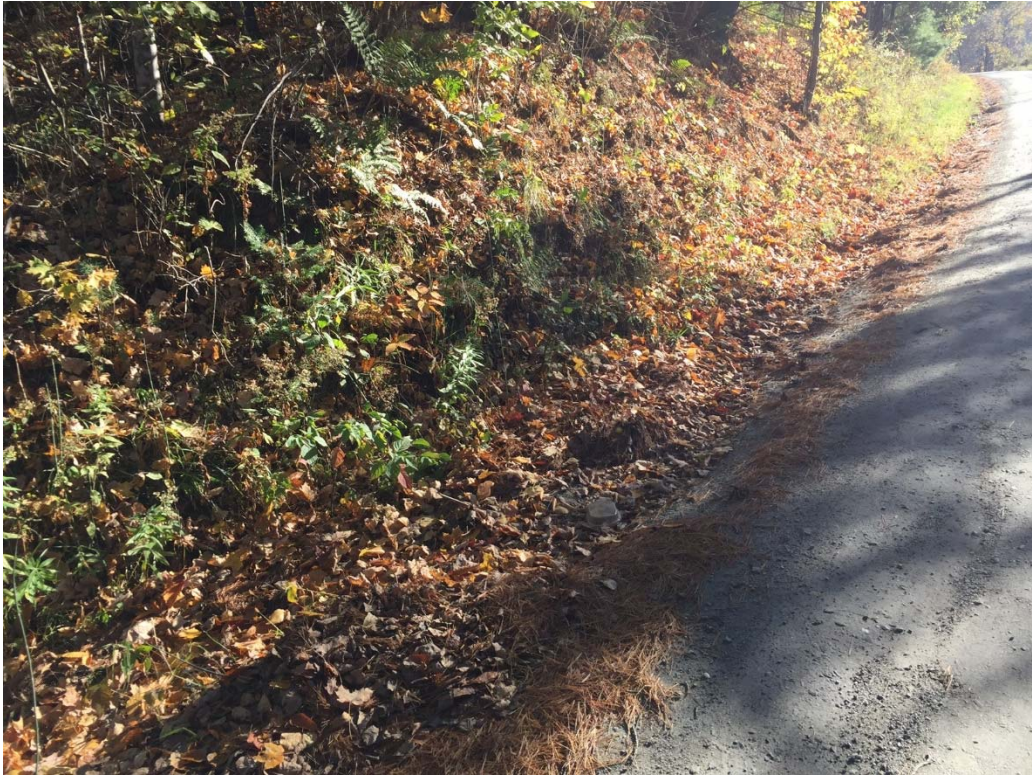
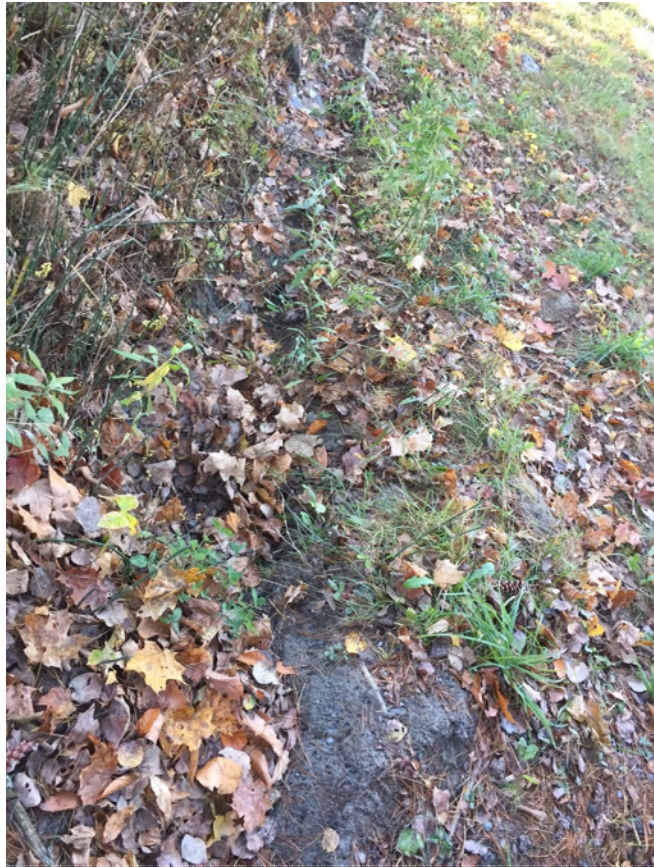
Road Segment Name & Segment ID Number:	Road Type:	Average Road Grade:	Site Number:
Page Hill Rd 146937	Gravel	8.48%	12

**Overall Segment Score:** Does Not Meet

**Notes:** Clogged culvert header, broken off outlet, culvert needs replacing

- Upsize 15" culvert to 18"
- Stone-line ditch 100ft from inlet, stone outlet, clean bank and trees

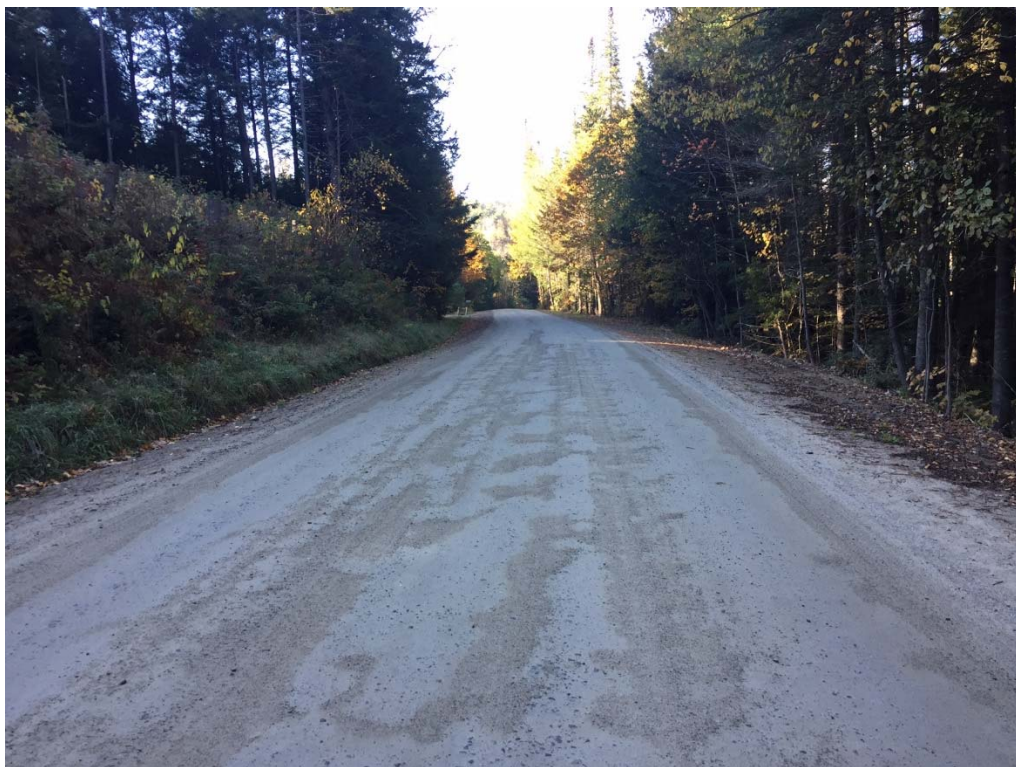
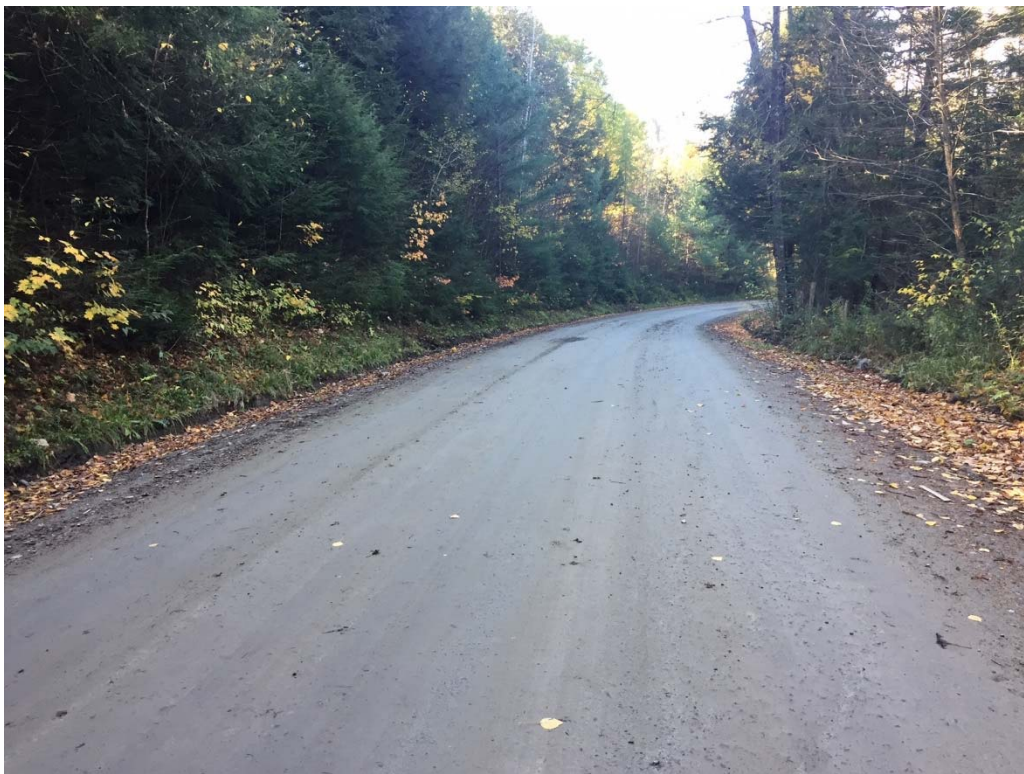
Road Segment Name & Segment ID Number:	Road Type:	Average Road Grade:	Site Number:
Young Rd 201314	Gravel	8.31%	14

**Overall Segment Score:** Does Not Meet

**Notes:** Ditch on opposite side of river not big enough, header collapsed, sediment entering stream

- Stone-line left side
- Replace driveway culvert at Spruce to stream
- Upsize 18" metal to 24" and stone outlet to brook
