## Town of Corinth Road Erosion Inventory Report

Prepared by:  
**TRORC**  
Two Rivers-Ottawaquechee  
REGIONAL COMMISSION

### Road Inventory and Evaluation Form for High Priority Project Sites

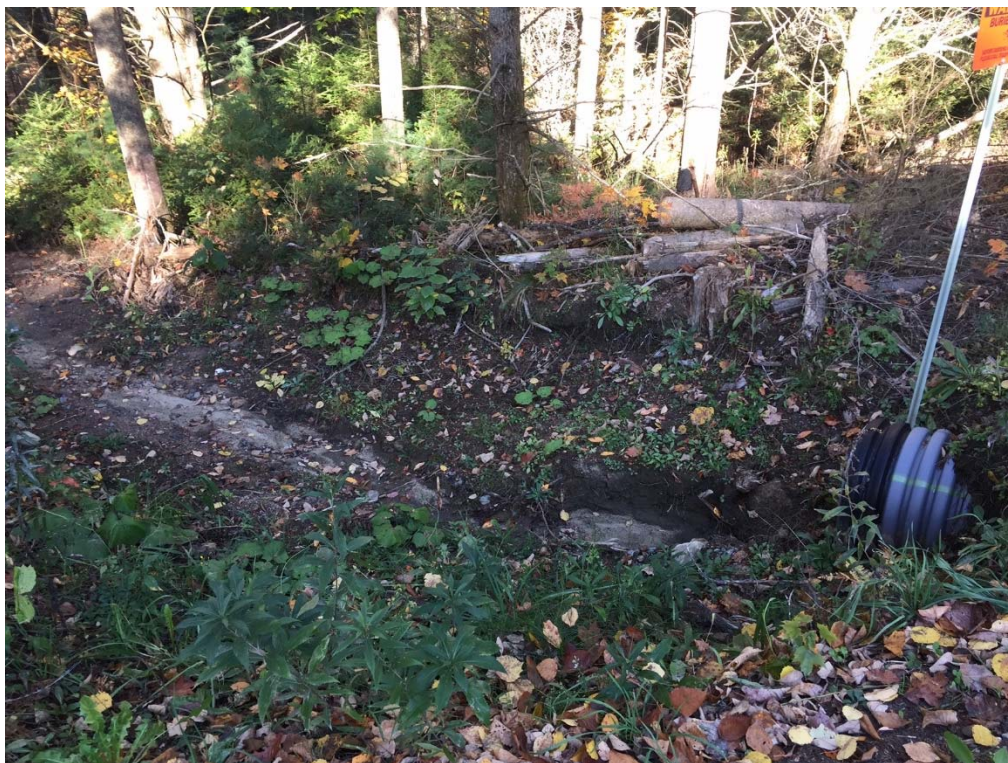
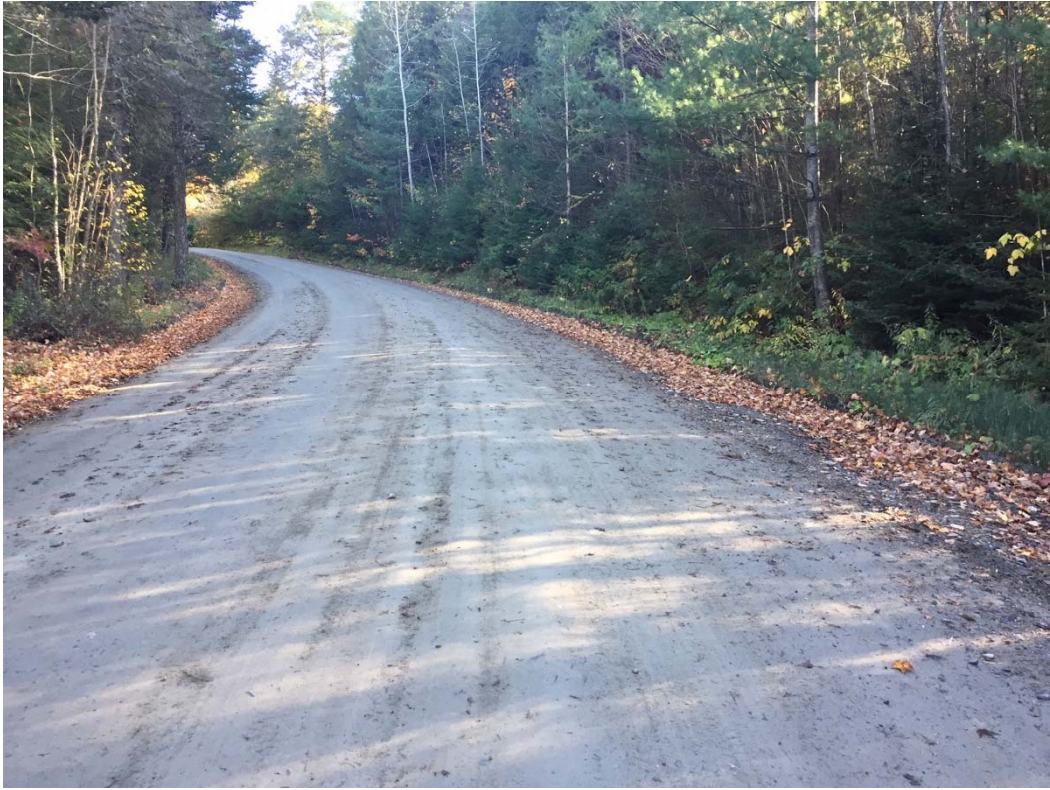
Road Segment Name & Segment ID Number:	Road Type:	Average Road Grade:	Site Number:
Young Rd 201310	Gravel	6.28%	15

**Overall Segment Score:** Does Not Meet

**Notes:** Driveway culvert turning into conveyance into stream with not much sediment filtration

- Stone-line left side
- Replace driveway culvert at Spruce to stream
- Upsize 18" metal to 24" and stone outlet to brook

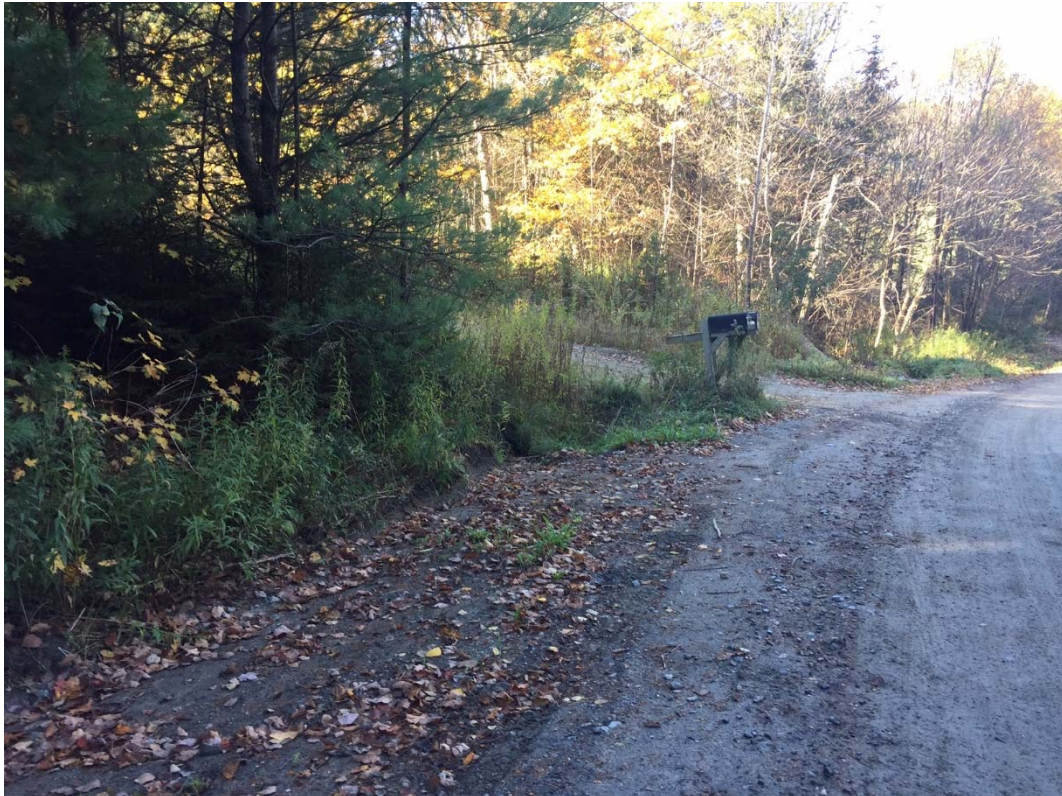
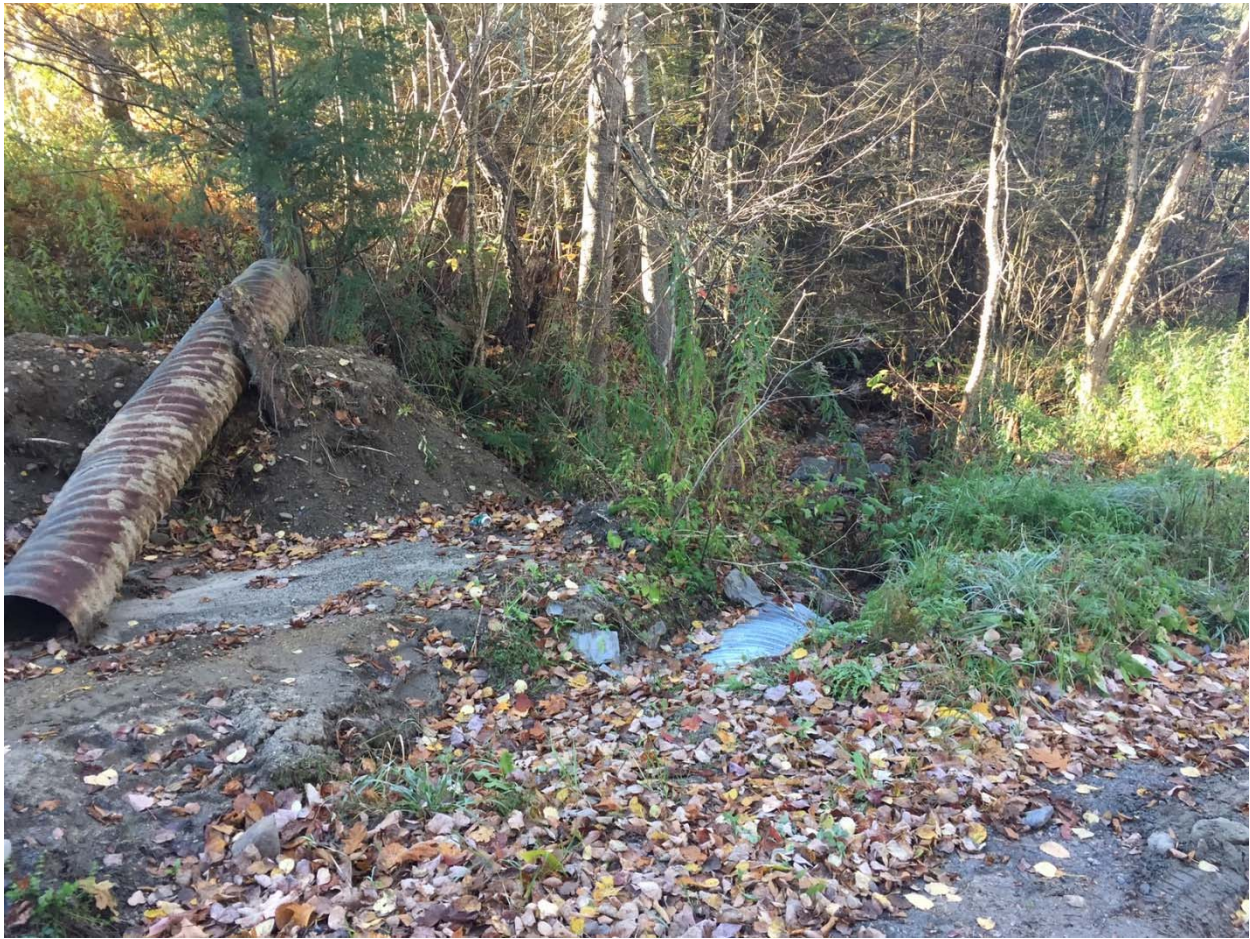
Road Segment Name & Segment ID Number:	Road Type:	Average Road Grade:	Site Number:
Chicken Farm Rd 21832	Gravel	9.75%	16

**Overall Segment Score:** Does Not Meet

**Notes:** Header filled with sediment, not draining/filtering well, 10.5% slope

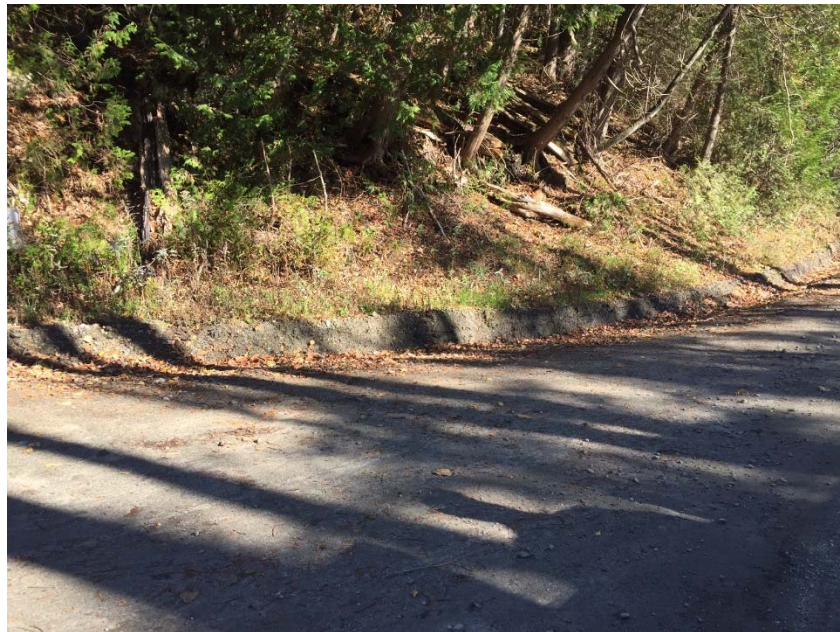
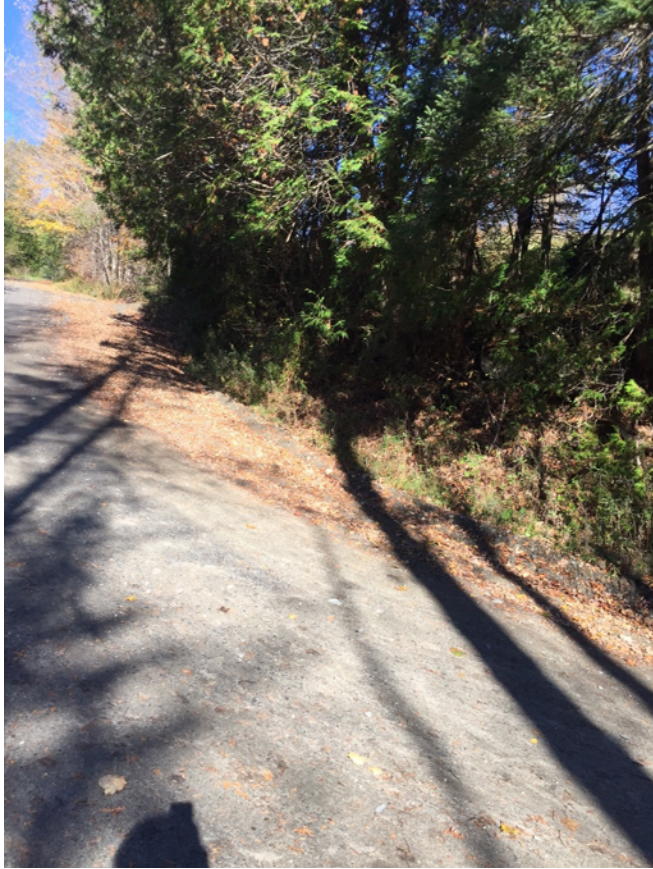
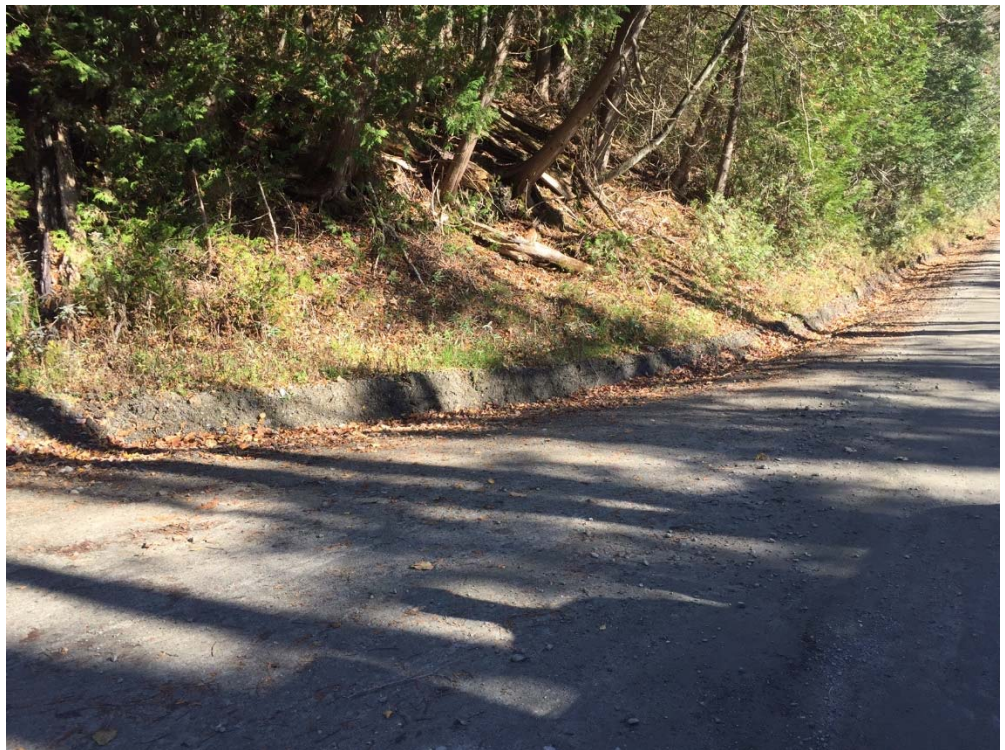
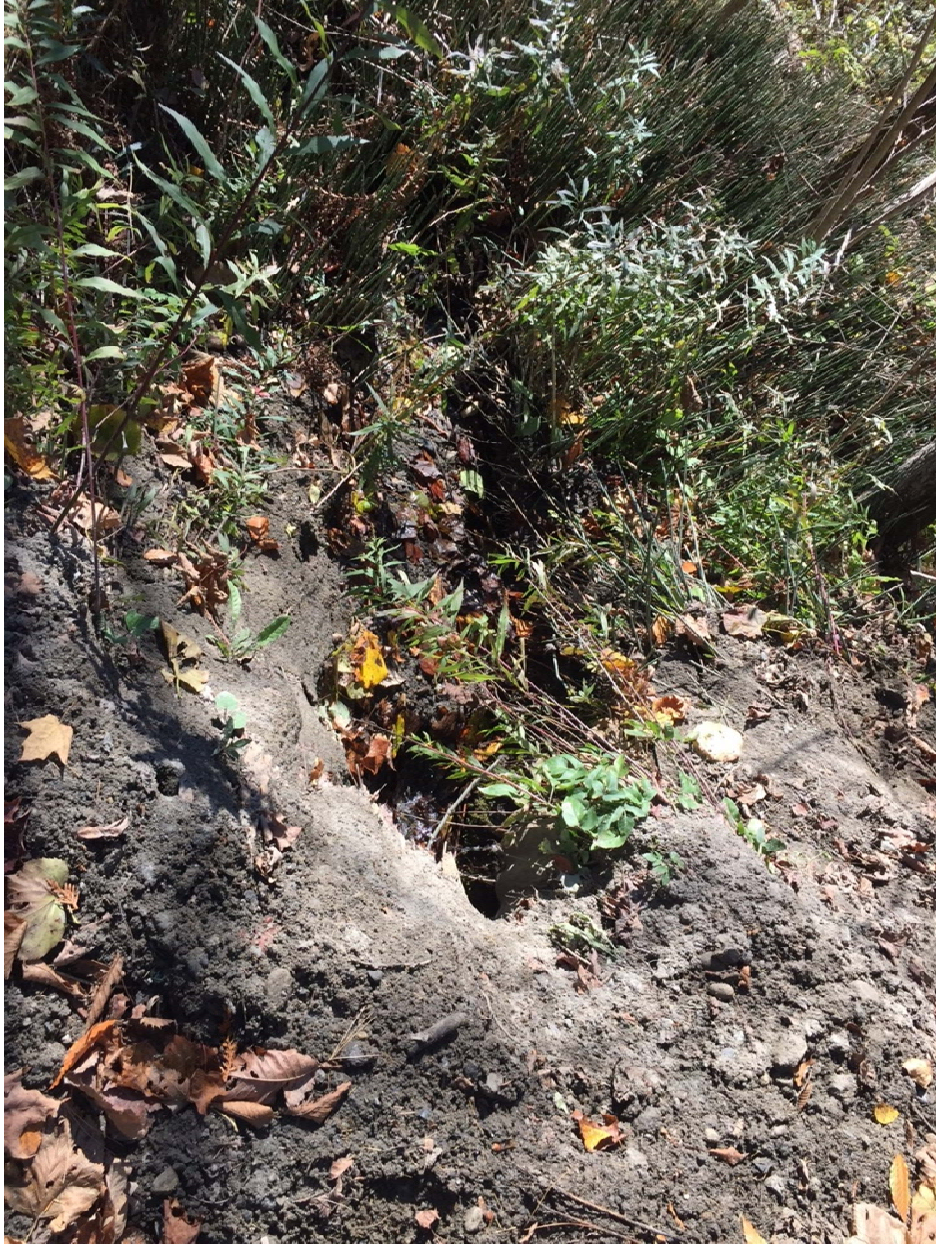
Road Segment Name & Segment ID Number:	Road Type:	Average Road Grade:	Site Number:
Notch End Rd 142022	Gravel	13.38%	20

**Overall Segment Score:** Does Not Meet

**Notes:** Very bad gully erosion, culvert taking a lot of the road.

Culvert outlet

- Stone-line ditch curve
- Add new 18"
- Upsize 15" to 18" culvert

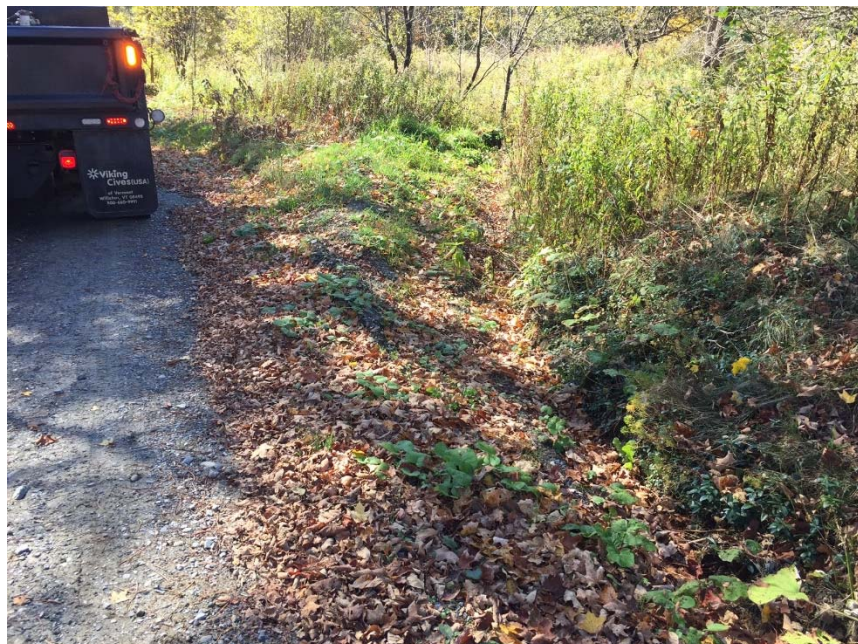
Road Segment Name & Segment ID Number:	Road Type:	Average Road Grade:	Site Number:
Carpenter PI 18649	Gravel	9.76%	21

**Notes:** Recently "fixed" but at first rain too much sediment will wash into river because not enough filtration BMPs.

- Clean turnout
- Take out small trees on right side
- Stone-line ditch

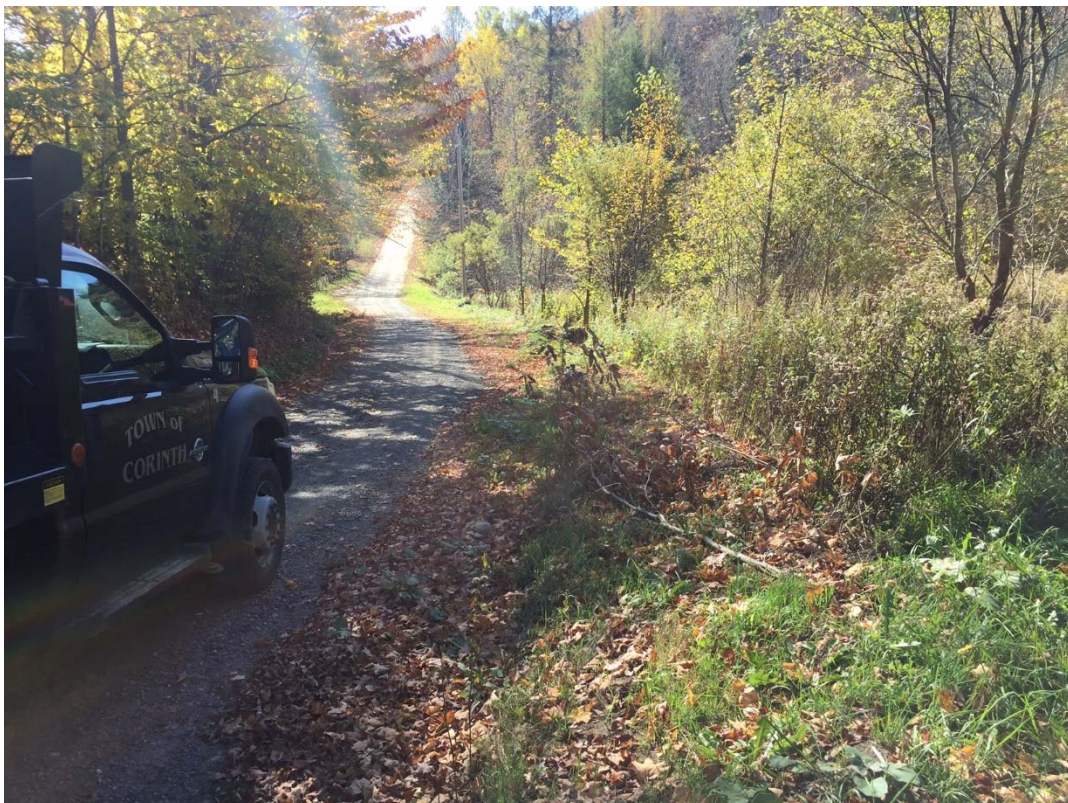
Road Segment Name & Segment ID Number:	Road Type:	Average Road Grade:	Site Number:
Carpenter PI 18652	Gravel	16.99%	22

**Overall Segment Score:** Does Not Meet

**Notes:** Not enough vegetation to hold newly fixed road in place, big piles of sediment next to turnouts.

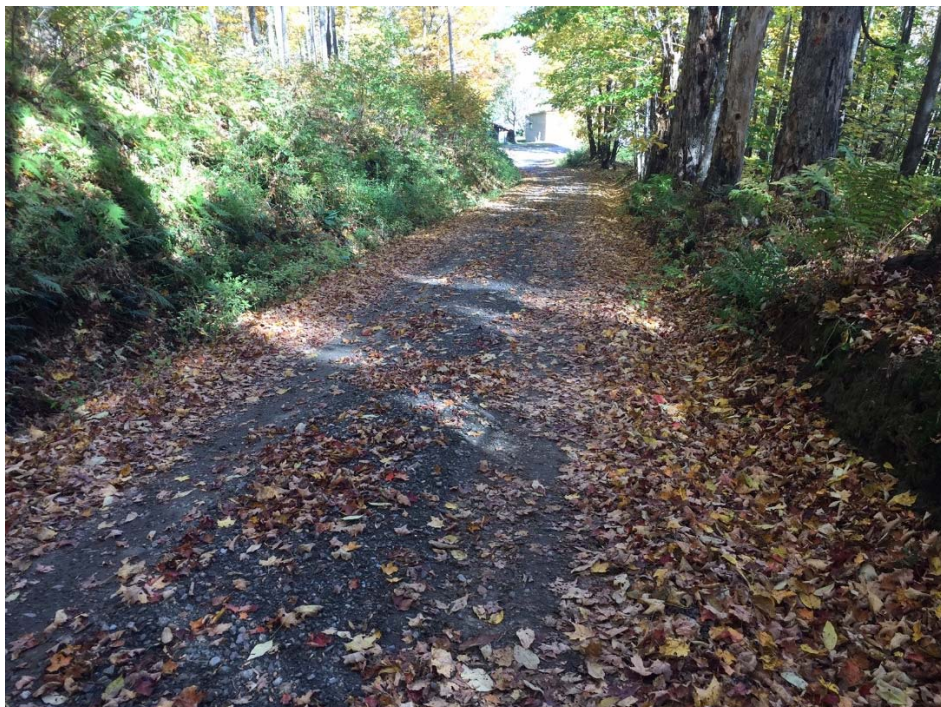
Road Segment Name & Segment ID Number:	Road Type:	Average Road Grade:	Site Number:
Carpenter PI 18651	Gravel	11.13%	23

**Overall Segment Score:** Does Not Meet

**Notes:** Could use new culvert and better conveyance system. Road between here and main rd should be looked at - close to stream and bad conveyance spewing sediment right into stream and bad rill in ditches most of way down.
