## Baxter Library Building Energy Plan

## Building Energy Plan

December 20, 2012

***RE: Energy Audit Conducted November 16&28, 2012 on the Baxter Library.***

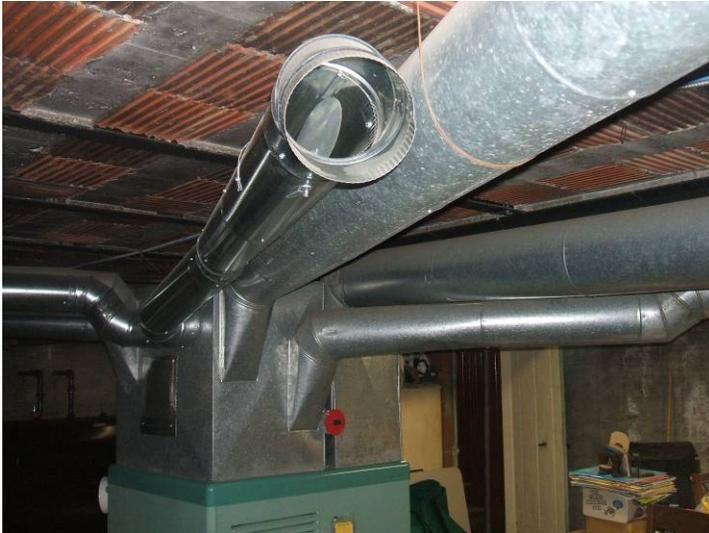
This duct is providing warm air to the unused basement and it could easily be dampered shut.

There is one duct dedicated to the basement that probably does not need to be. Given that the foundation walls are mostly below grade this basement probably stays around 55 degrees even on the coldest winter days. In addition, the basement gains radiant heat energy from the furnace and ductwork itself. This duct has an in line damper that can be closed and it should be done immediately. Over time you may find that duct is not needed so it can be removed and capped permanently. The only reason to keep it long term is to provide heat to the basement in the unlikely event that the fallout shelter has to be used. Even then, with many people down there heating will not be the prime concern.

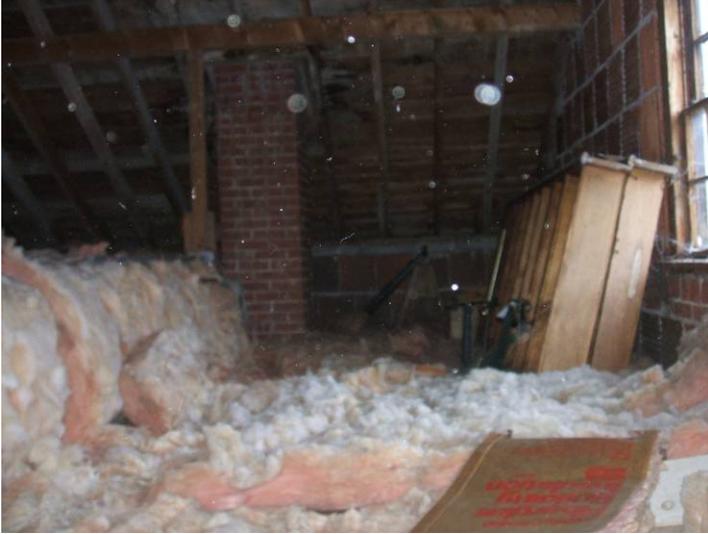
**a.**  
The attic has a single layer of R19 fiberglass that is probably performing at a level of R15 or less because it has been packed down.

The images detail the state of the attic insulation, in a phase, it needs more. The existing fiberglass is in decent shape and most of it can remain in place as long as it remains flat. Below the fiberboard there is a framing space for the plaster ceiling. Ideally the fiberboard would be removed so new insulation could

be in direct contact with the whole plaster ceiling but this would make the project cost more for a minimal gain in performance. As a compromise, the fiberboard should be removed at the ceiling perimeter so new cellulose insulation can be blown all the way down to the plaster ceiling at the perimeter of the attic. After that, blow another 10” to 12” layer of cellulose over the top of the existing fiberglass making sure the fiberglass is completely flat at the time.

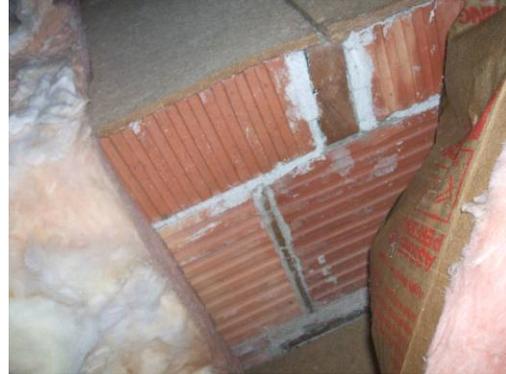
Looking under the fiberglass there is "step" wall that needs rigid insulation attached to it.

Before installing cellulose glue 2” rigid polyisocyanurate foam board (Dow Tuff-R) to the masonry step walls in the attic.

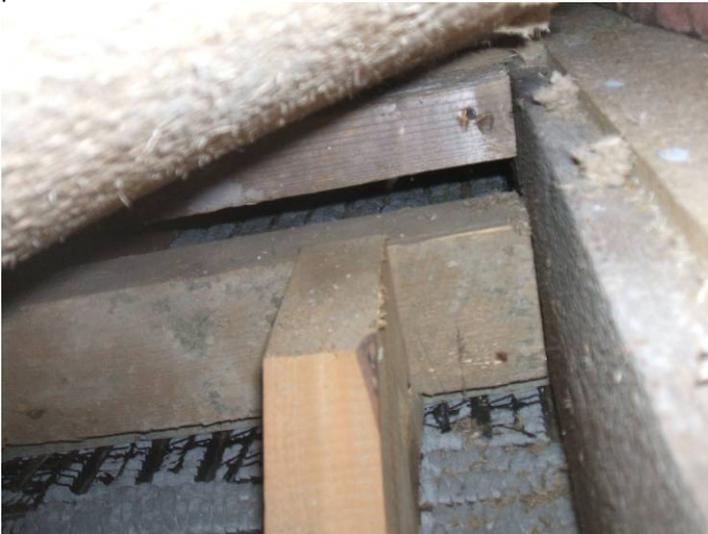
**b.**  
Under the fiberglass there is a layer of fiberboard that covers the framing space over the plaster ceiling. Ideally the insulation would be in contact with the plaster ceiling.

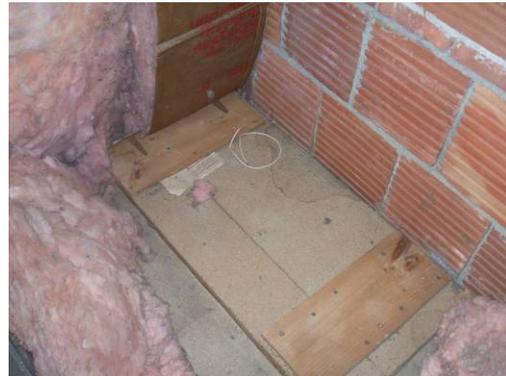
Looking at the attic hatch it needs a layer of insulation affixed to it. Note also another step wall, this one has no insulation.

Finally, Weather-strip the hatch so it seals tightly to the trim when closed. The attic hatch needs 6” of rigid polyisocyanurate insulation glued to it. Use wide foil tape to cover and protect the edges of the insulation.

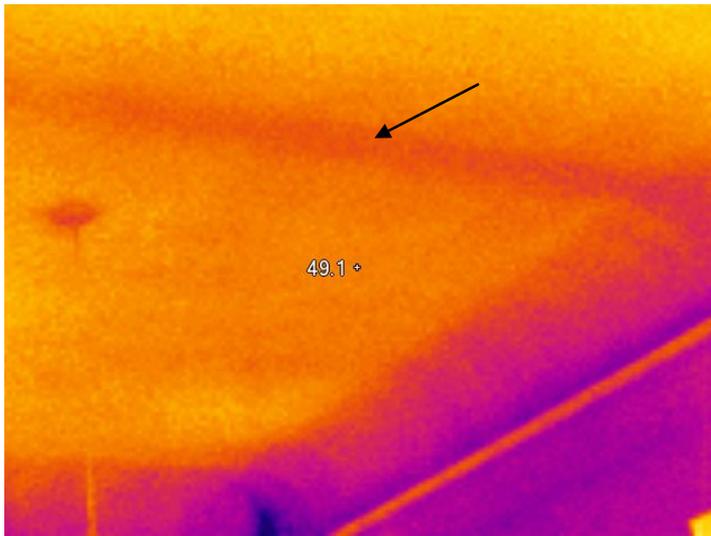
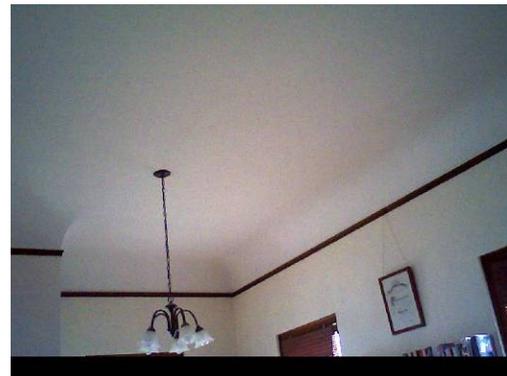
**c. IR014172.IS2**

The plaster ceiling gets cooler as it curves down to meet the wall. Cellulose should be blown in from above at the ceiling perimeter so it will fill that curved space. The line indicated is a steel beam that should also get insulated over.

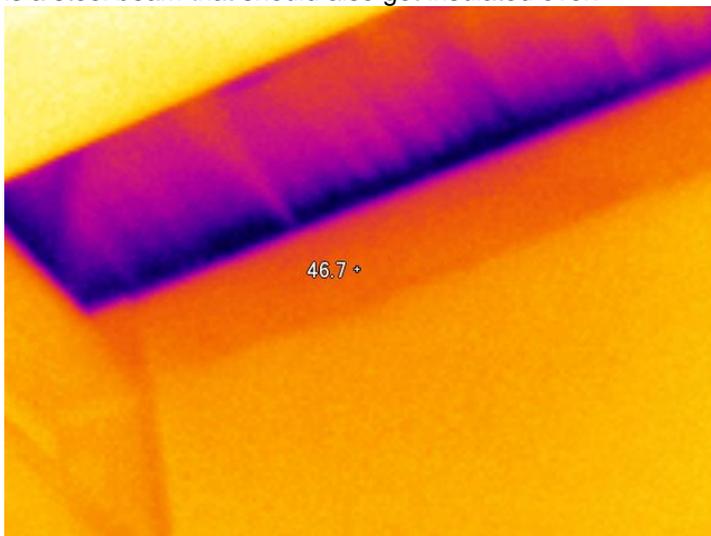
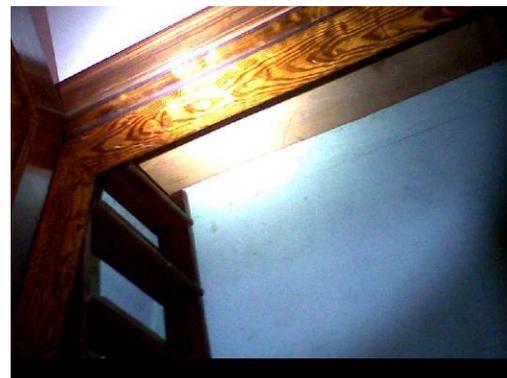
**d. IR014198.IS2**

The attic hatch from below with cold air streaming by it.

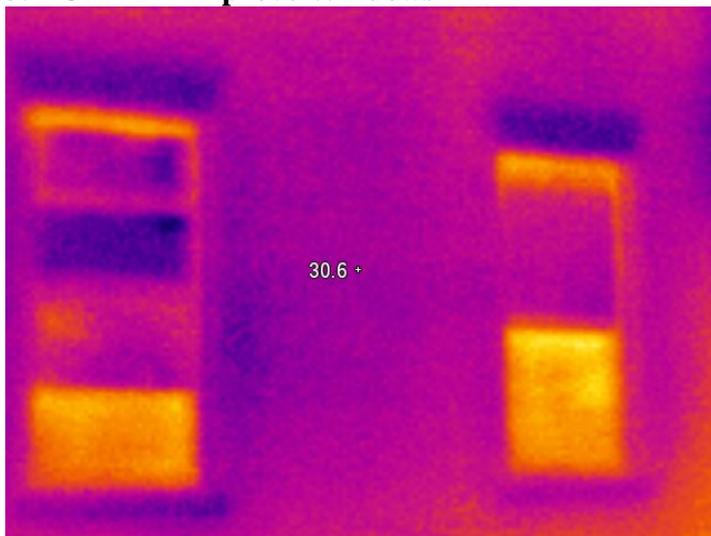
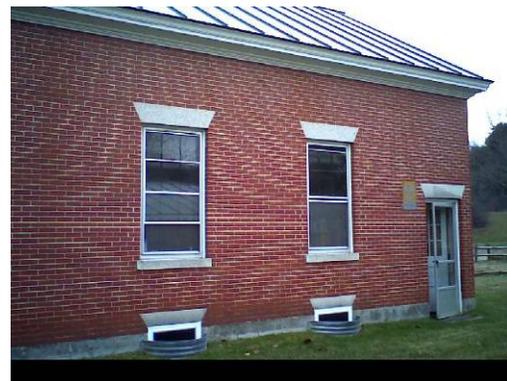
#### a. IR014152.IS2

Most of the storm windows have not been closed for winter yet. Note the difference in heat loss where the storm is partially closed.

The windows are single pane wood framed windows with exterior aluminum framed storm windows. The exterior storms do not add much in terms of air tightness but when closed they double the R-value of the window. Close all the storm windows every fall.

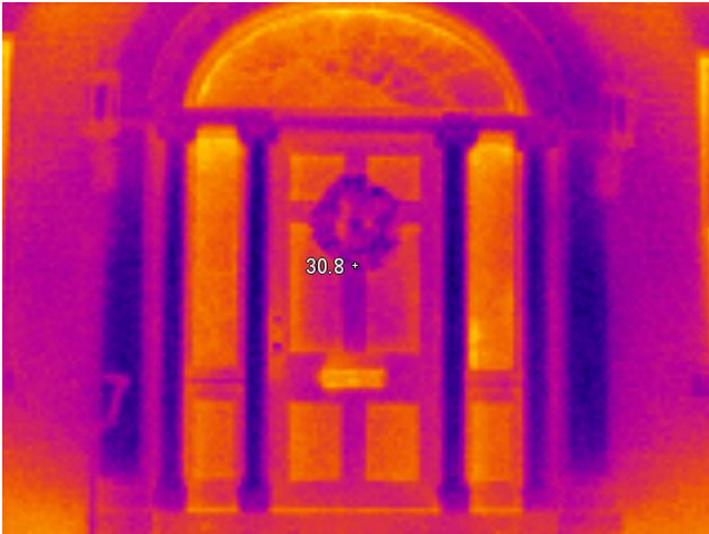
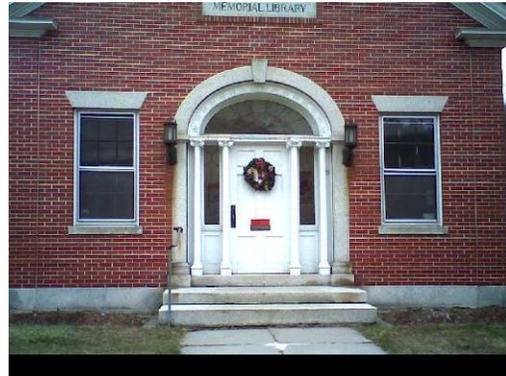
**b. IR014159.IS2**

The windows above and to the sides of this door are single pane windows with no storms. Note also that the wood portions of the door aren't much better than the windows.

Either before or after the windows have been tightened I further recommend installing interior storm windows on all windows including the top and side windows at the front entrance. Interior storm windows cost much less than a replacement window and will not harm the historical natural of the original window. In rooms with many and/or large windows they do double duty to reduce energy costs: 1- In many cases they double the R-value of the window and, 2- they decrease radiant losses from the human body to the windows. People feel warmer when in the room so they leave the thermostat at a lower setting.

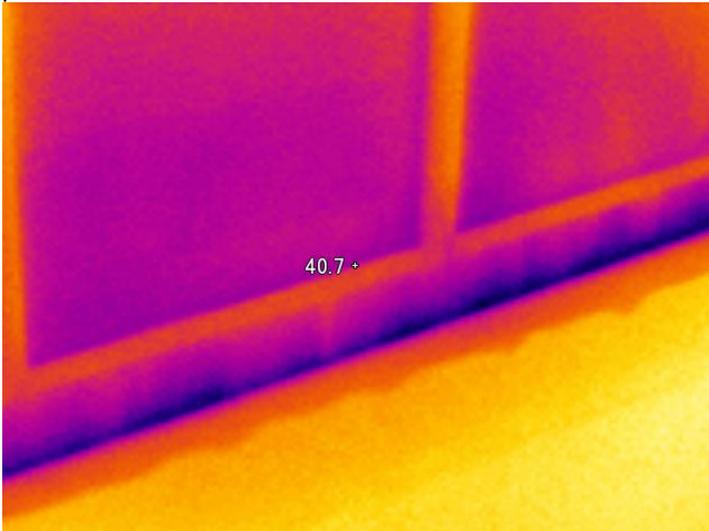
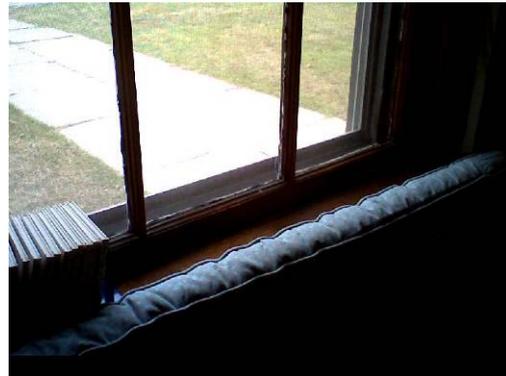
**c. IR014193.IS2**

The air sweeping up under this window sash is typical of all the windows even with the storms closed.

All of the windows, with and without storm windows down, are air leaky at all sides of each sash. Make the upper sash a fixed sash and caulk it in place with clear silicone caulk. Weather strip the lower sash and the storm windows based on the recommendations below\*:

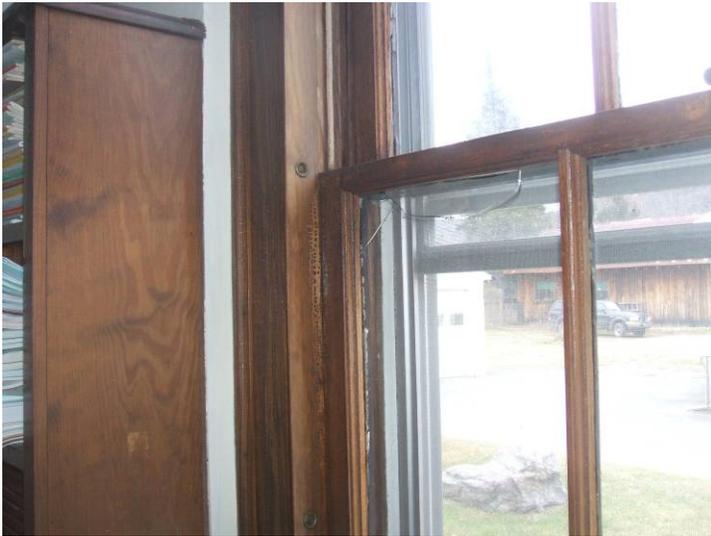
**d.**

This window needs to have the broken pane replaced.

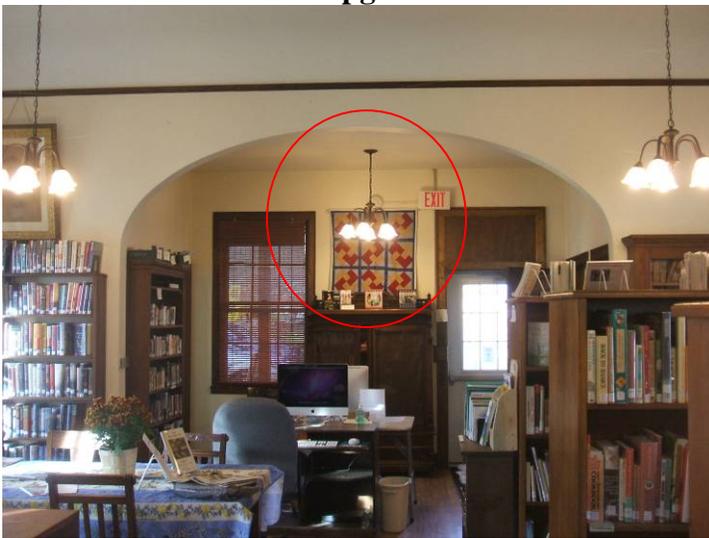
This back light needs to be isolated on a separate switch.

The back entrance photo sensor appears not to be working and should be easy to replace. At the same time have an electrician rewire the chandeliers in the library so the back chandelier can be switched independently from the rest. With the high number of windows the room often has enough light without the lights being on except for the back of the library. As a result the lights are all on so the back can be properly lit. A separate switch for the back light would solve this problem. Access in the attic is very good for rewiring (make this change before the insulation measure above). Unfortunately the cost of an electrician makes this relatively simple task have a long payback.

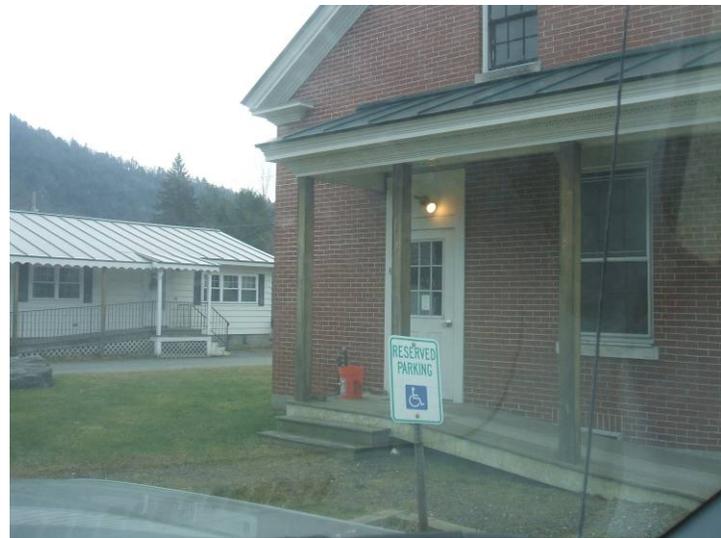
The outside light on at 11am.

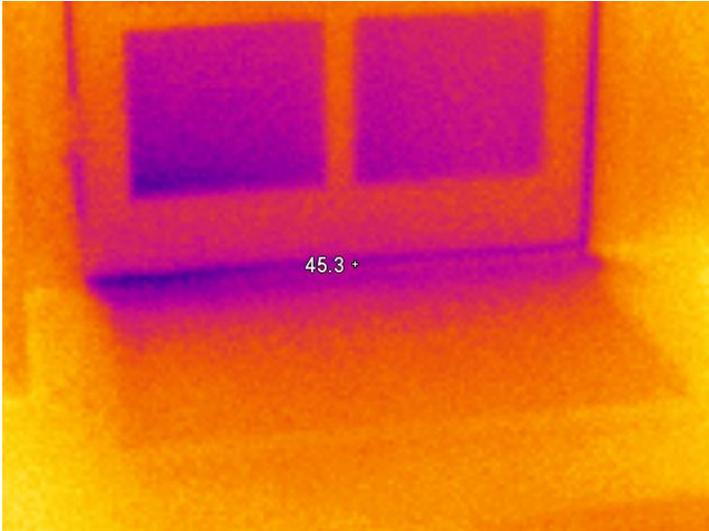
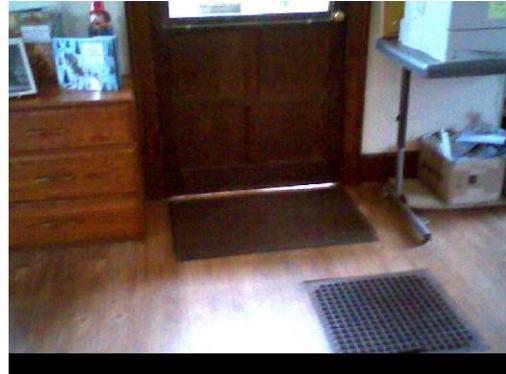
### a. IR014173.IS2

The interior vestibule door is a thin interior door that borders an unheated space. There is no weather-stripping on the door.

The interior vestibule should be replaced with an insulated exterior door to separate the heated room from the cold vestibule.

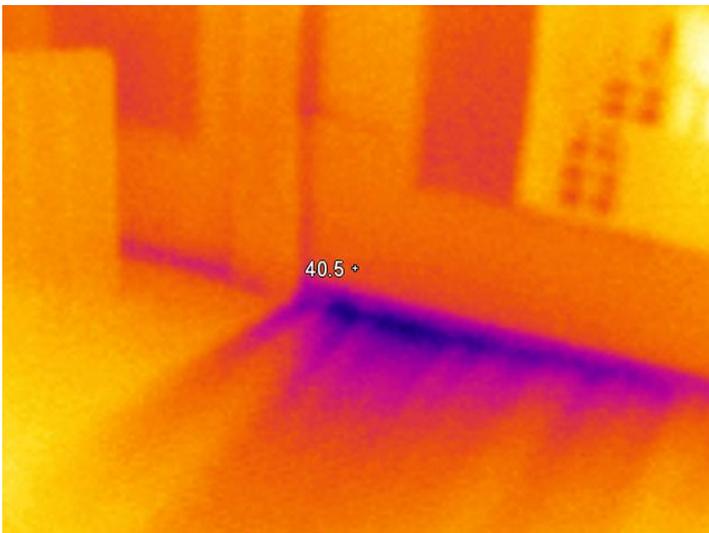
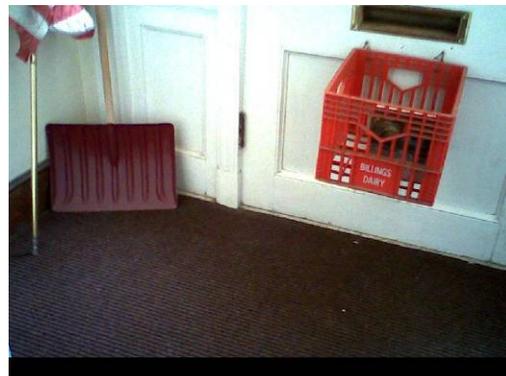
### b. IR014178.IS2

The front door needs new sweeps.

The back door is in pretty good shape but the other 2 doors need attention. Weather-strip the exterior doors at the head, jambs, and especially at the threshold with commercial grade weather-stripping ([www.draftseal.com](http://www.draftseal.com) or Q-lon available through The Energy Federation ([www.efi.org](http://www.efi.org)). When the door is closed you should not be able to see daylight light at the perimeter. Door thresholds also need to be added/replaced if they can be, if not, door sweeps should be added. Focus weather stripping efforts on doors that are used rarely like the back basement door since it has to perform more like a wall most of the time. Consider also weather-stripping the interior door that goes to the basement that is consistently at a lower set temperature.

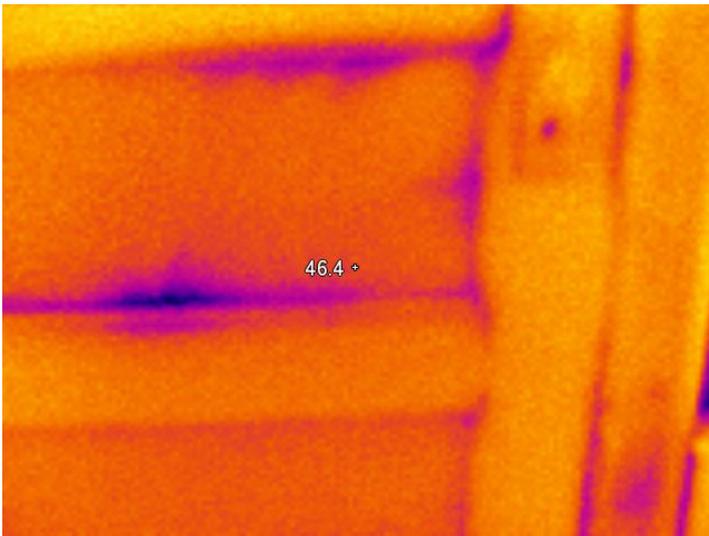
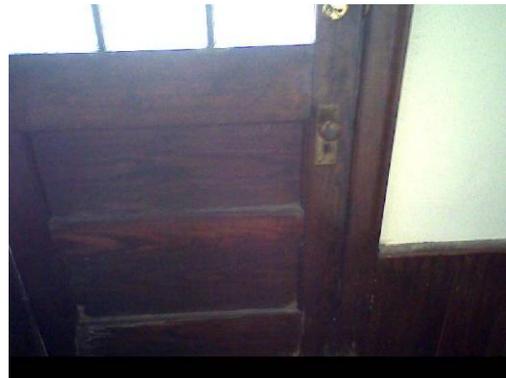
**c. IR014202.IS2**

The back basement door is very leaky with daylight visible in many places.

If the back basement door is not used most of the winter install a 2” thick sheet of rigid foam insulation between the door and the storm door. The rigid insulation should be covered with ¼” plywood painted white (or decorated in any way) to protect the foam from sunlight. This is low cost way to make the door triple in R-value.
