Braintree Town Office Building Energy Plan

Building Energy Plan

December 4, 2010

RE: Energy Audit Conducted October 2, 2010 on the Braintree Town Offices and Garage

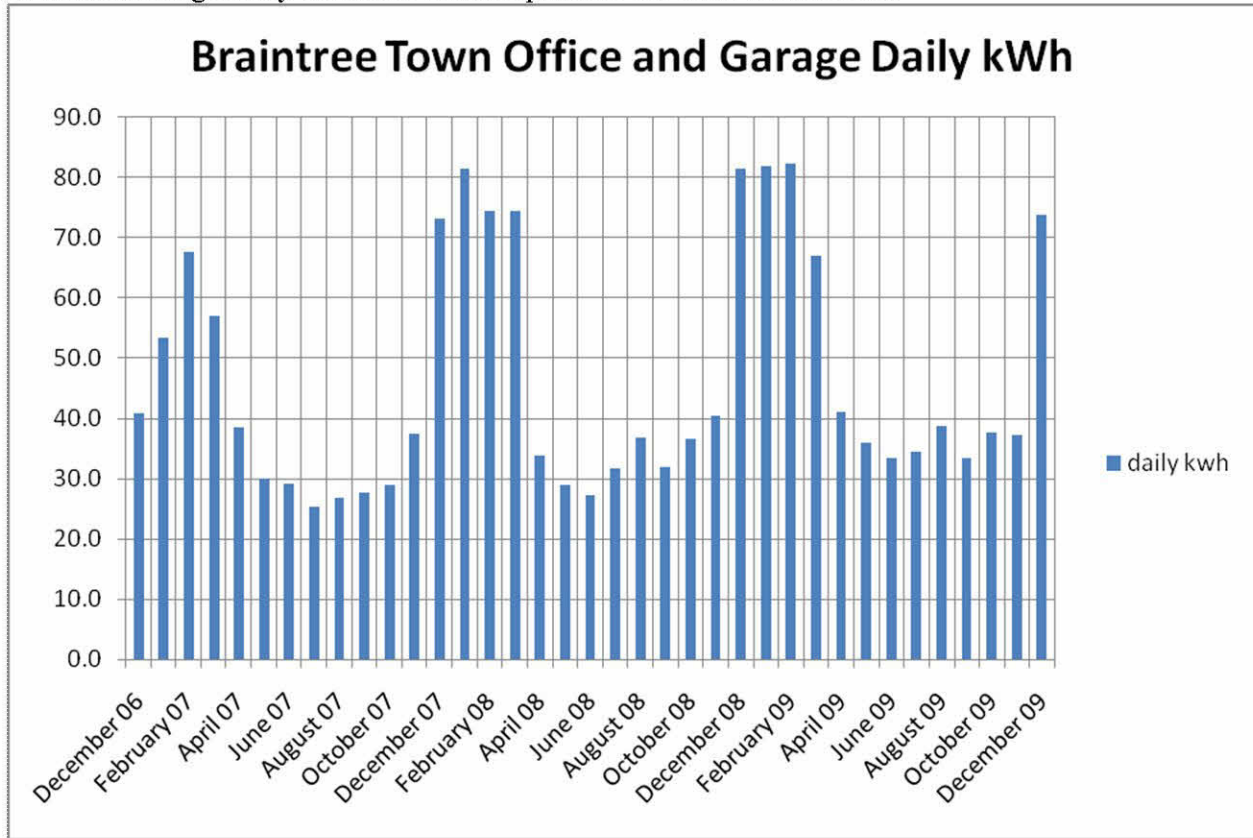
As can be seen in the chart above, the daily electrical load doubles in the winter season. There are many small contributors that increase electrical use in the winter: furnace/boiler run time, additional lighting in the winter, (especially use of the halogen lights in the unheated part of the garage), and the small electric hot water heater in the town hall may be running more in winter because it is near the cold air intake for the boiler. All of these loads combined are not enough to explain the jump in daily kWh. The jump is caused by the block heaters for the 2 school buses in the winter.
