Town of Bridgewater Road Erosion Inventory Report

In the spring of 2017, the Two Rivers-Ottauquechee Regional Commission (TRORC) conducted a road erosion inventory (REI) to evaluate hydrologically connected segments in the town of Bridgewater. This report highlights the road sites with the most significant hydrological impact due to erosion within the municipality.

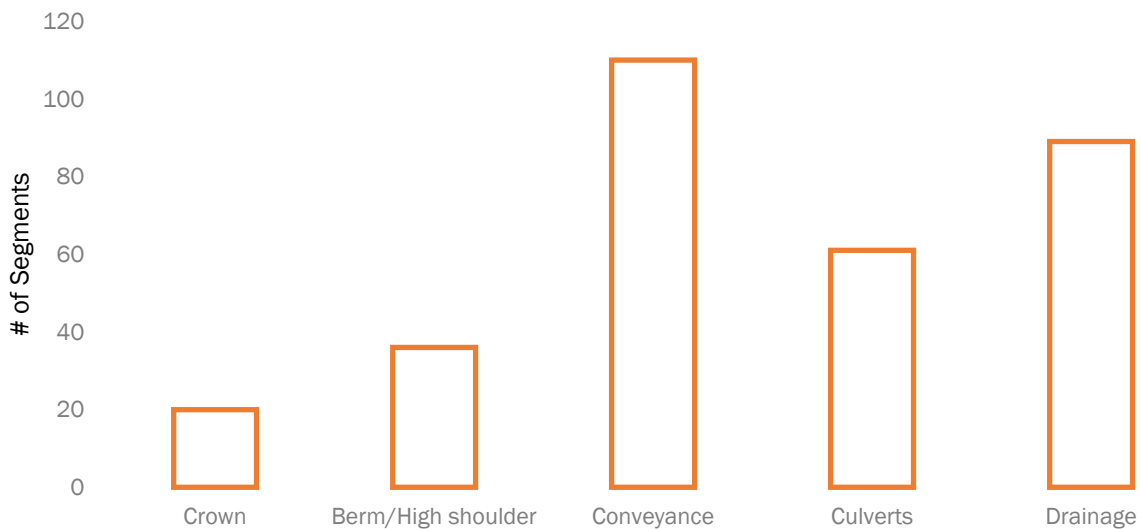
COMMON ISSUES AFFECTING SEGMENTS THAT DO NOT FULLY MEET

The three main issues in the high priority segments are:

- Poor Conveyance (100% Do Not Meet)
- Poor Drainage (88% have erosion present)
- Culverts (80% Do Not Meet)

- Inadequate infiltration and diversion practices
- Unstable banks separating roads from rivers
- Unstable ditches or no ditches at all where they are needed
- Lack of culvert headwalls, or culverts that are poorly placed, undersized, or in disrepair

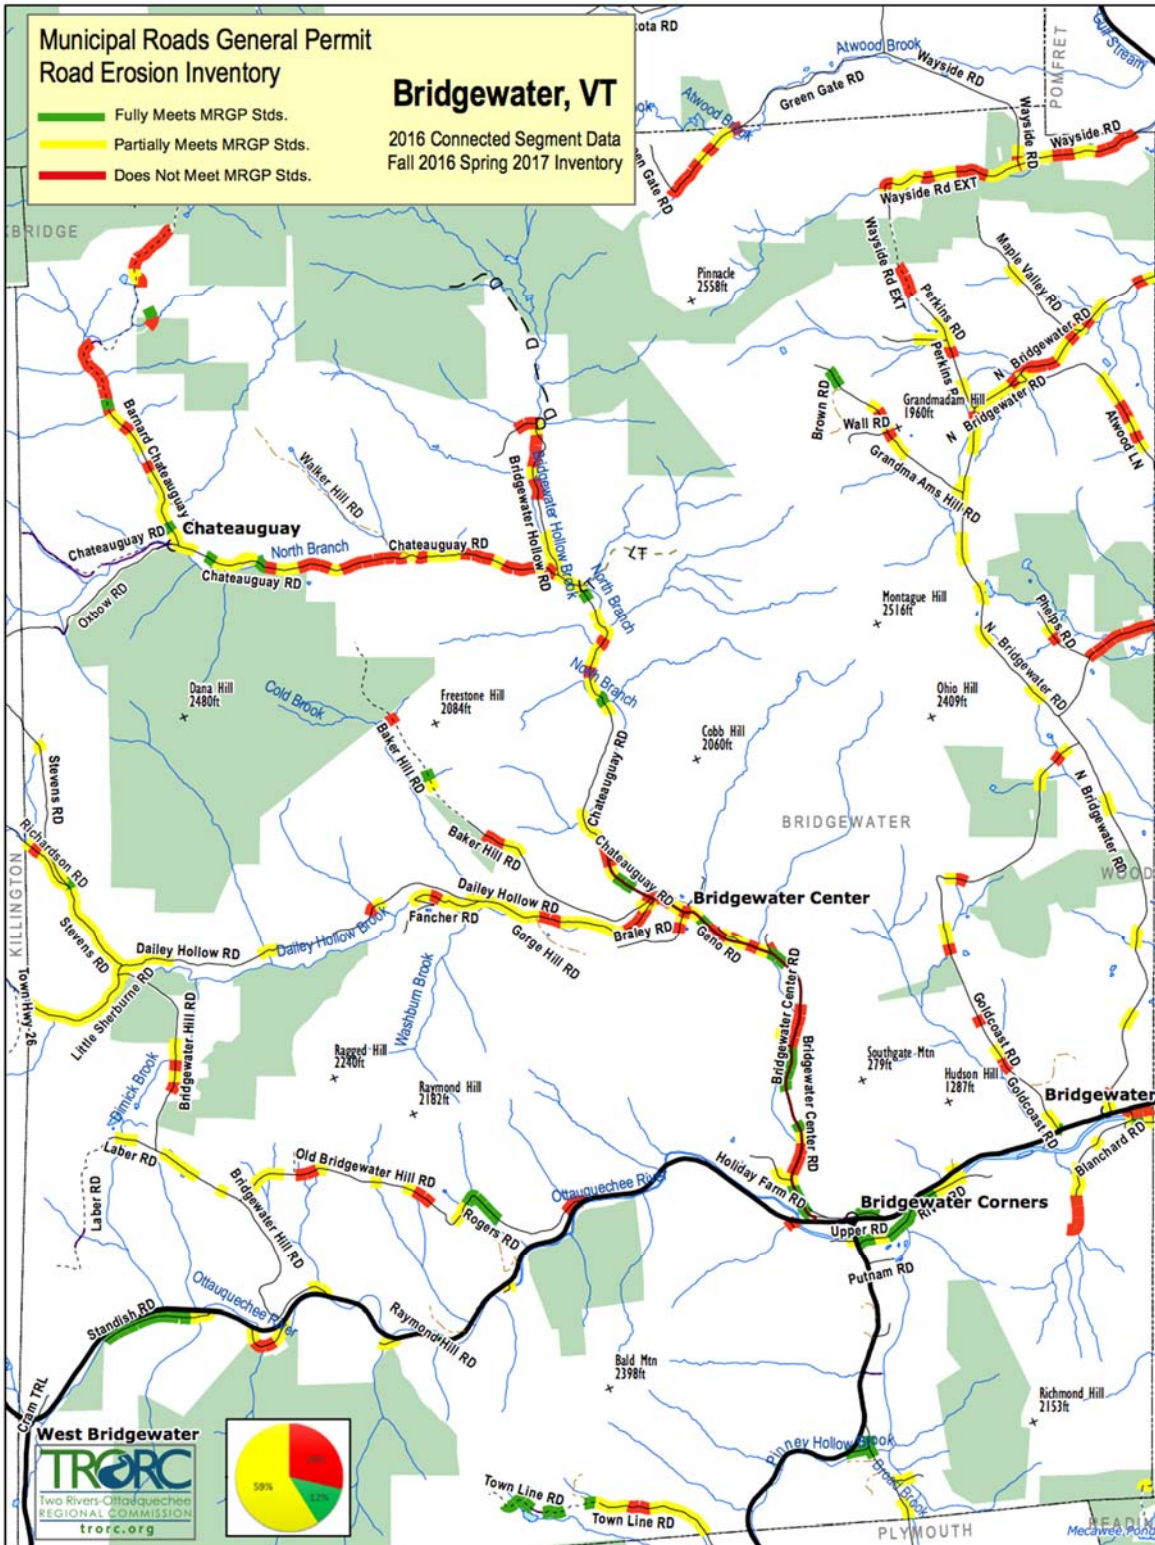
Figure 1- Depicts the Town with all hydro-connected segments and their scores, as well as the breakdown of how many segments Fully Meet, Partially Meet, and Do Not Meet.

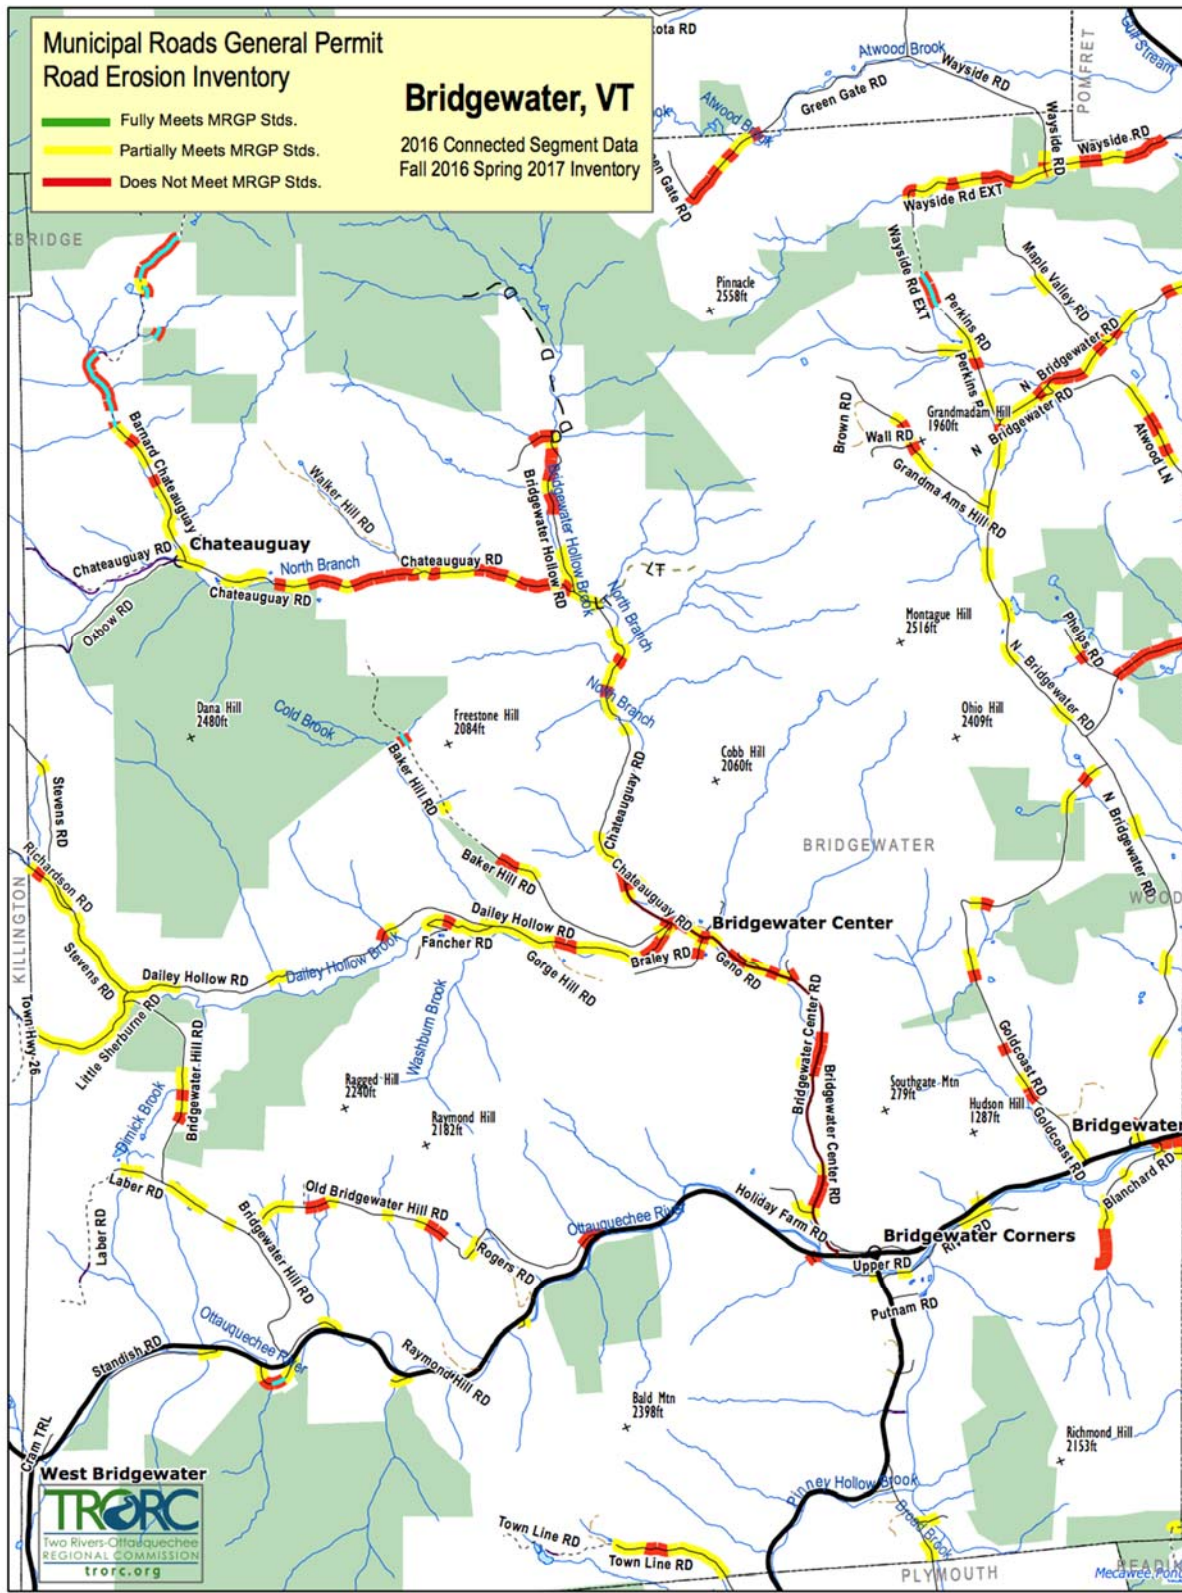
Figure 2- Displays the segments with a score of Partially Meet and Does Not Meet.

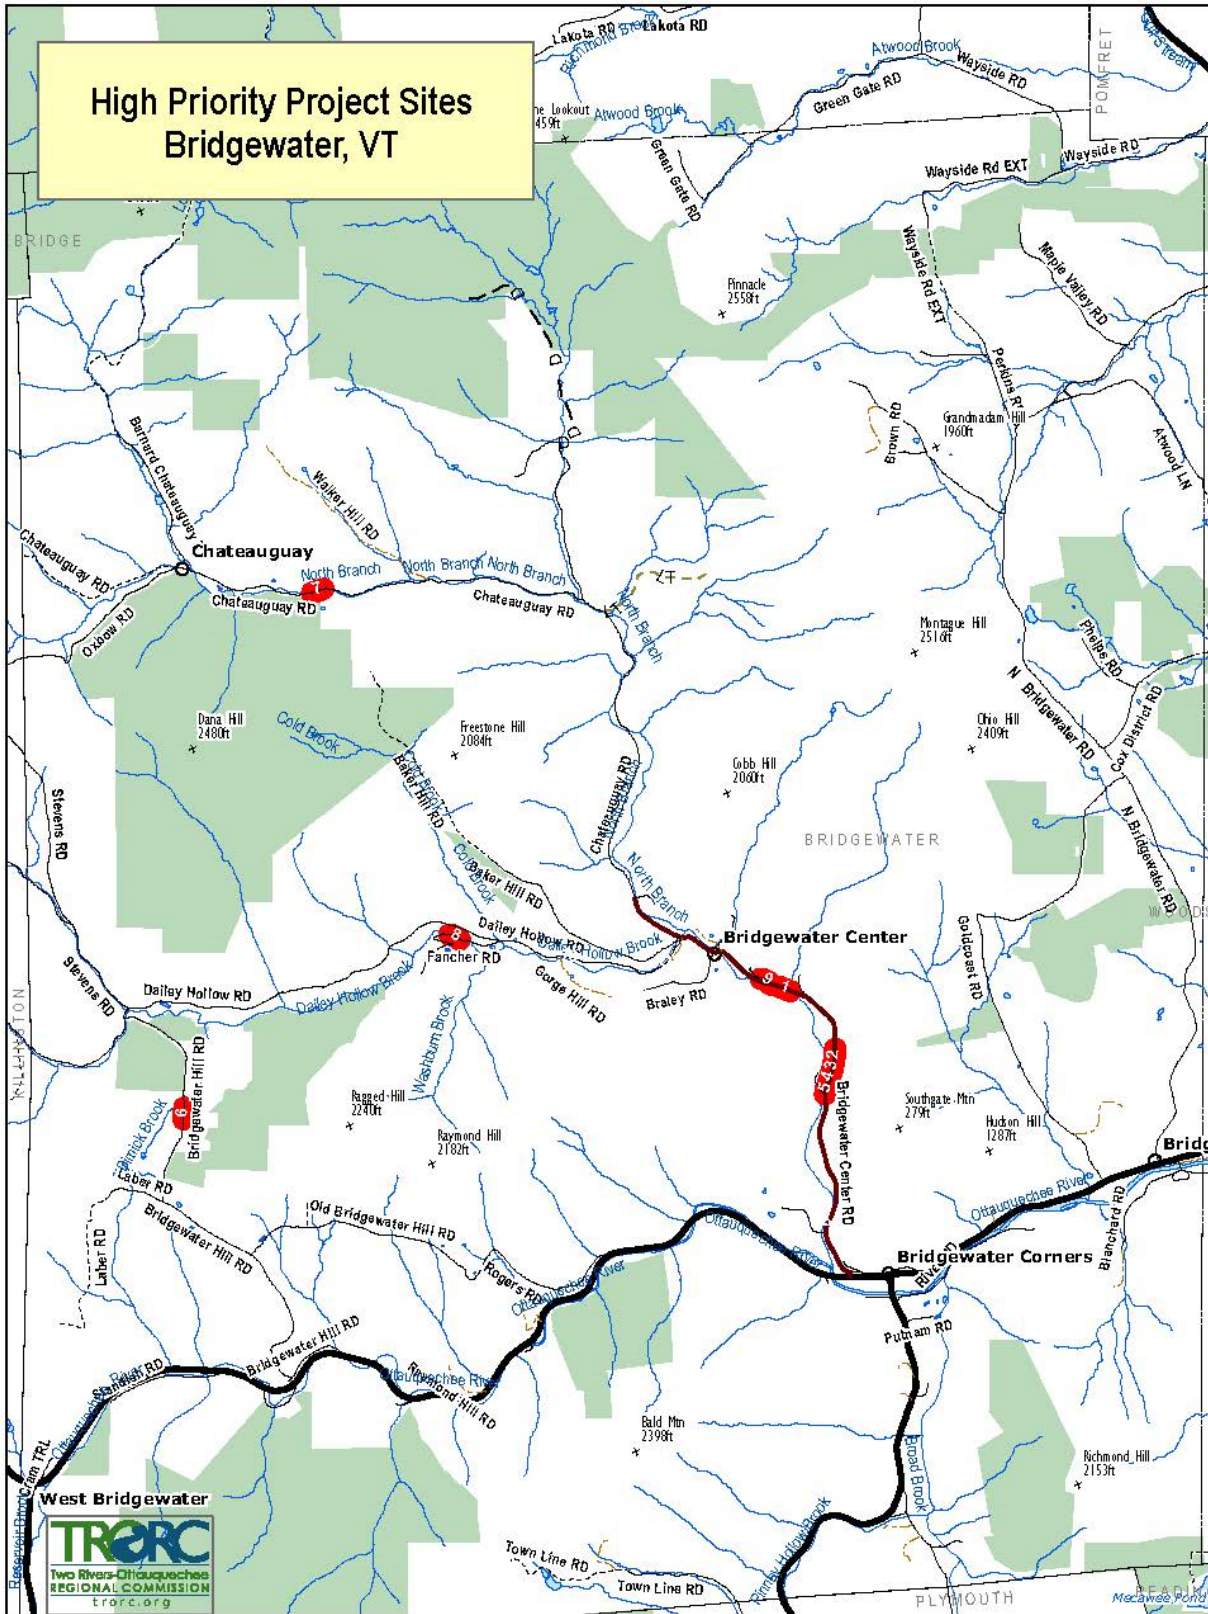
Twenty-five (25) segments have been identified as **High Priority**. High Priority indicates an overall score of Does Not Meet with a slope of 10% or greater. These are the segments which the town will focus on addressing in future grants. They are also a good example of issues facing the road network as a whole as other segments are likely to deteriorate in similar ways.

Figure 3- Displays high priority segments within the Town.

Very High Priority Road Segments are on slopes >10% that do not meet standards. These must be brought to MRGP standards by 12/31/2025.

- >10%: Stone-line ditch with 12" minus stone
- 18" drainage culvert minimum
- 15" drive culvert
