Stockbridge Town Garage Building Energy Plan

Building Energy Plan

December 17, 2010

RE: Energy Audit Conducted October 5, 2010 on the Stockbridge Town Garage and Fire Dept.

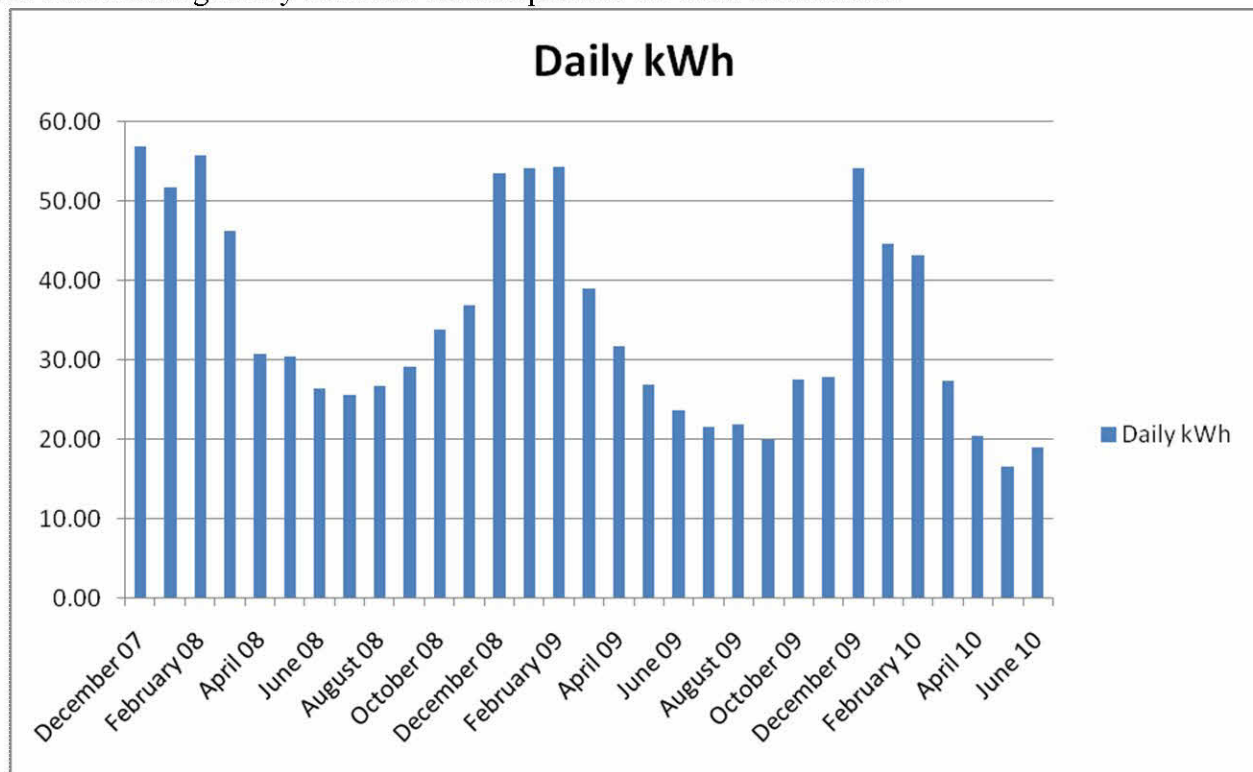
Below is the average daily electrical consumption in kWh for each month.

As can be seen in the chart above, the daily electrical load nearly doubles in the winter season. There are many contributors that increase electrical use in the winter: furnace/boiler run time, pump and modine running time, and longer lighting run time in the winter. All of these loads combined are enough to explain the jump in daily kWh.
