Vershire Town Garage Building Energy Plan

Building Energy Plan

November 16, 2010

RE: Energy Audit Conducted September 16, 2010 on the Vershire Town Garage

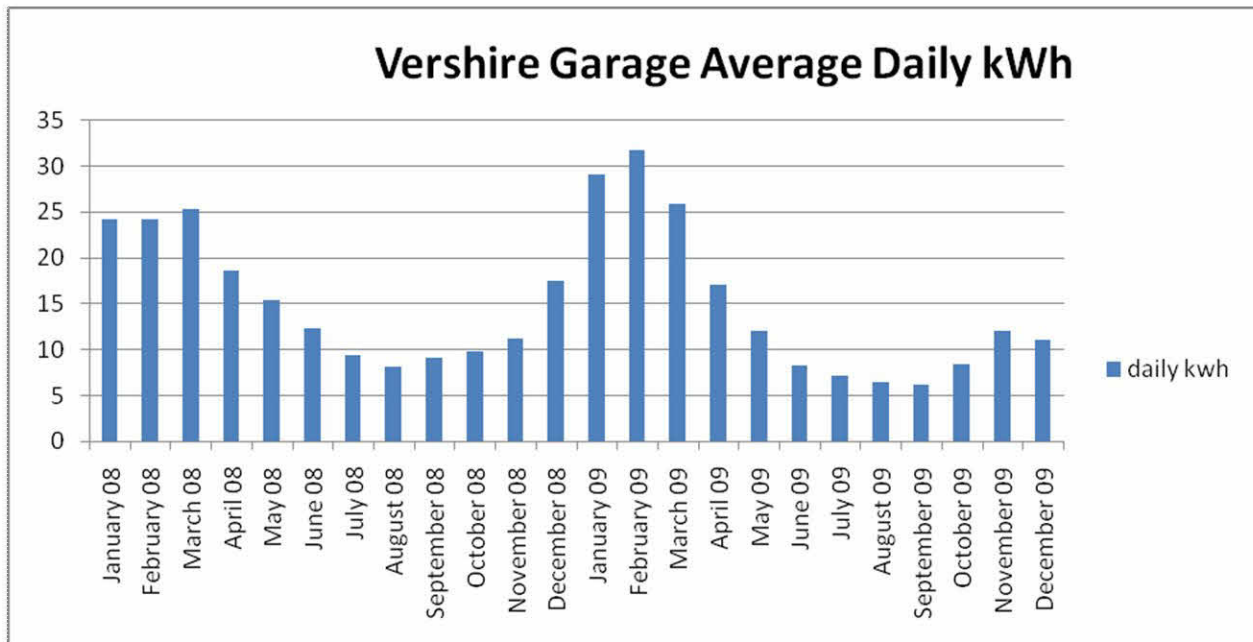
The average daily electrical consumption in kWh for each month.

The table and chart above show that the electrical base load for this building is not very high, about 44% of the total electrical load. This is indication that there are few opportunities to improve the electrical efficiency of the appliances that are used year round. As can be seen above, the electrical load increases significantly for the winter season. This is caused, in part, by the lights that have to be on for longer hours in the winter but I also believe this is a reflection of the constant cycling of the 2 Modine type heaters.
