Woodstock Town Hall Building Energy Plan

Building Energy Plan

January 17, 2011

RE: Energy Audit Conducted October 30, 2010 on the Woodstock Town Hall.

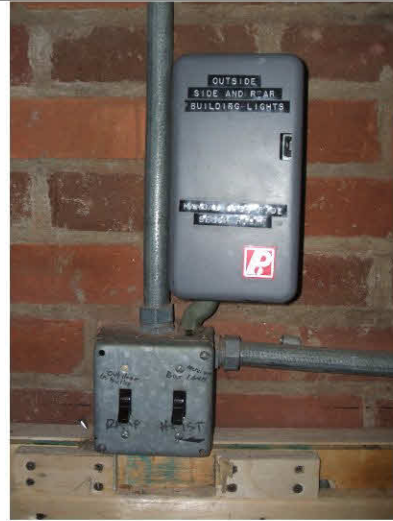
This light and the one around the corner both were on in the daytime.

There are 2 outside lights that I found on in the daytime both times I was on site. I found a timer that controls these lights and it appears to be set for 4pm to 11pm but the override switch may be working because the lights were on at 2:04 pm. Verify the switch and timer are working and adjust the timer seasonally so the lights do not stay on in the daytime.
