Chelsea Public School Building Energy Plan

Building Energy Plan

December 13, 2012

RE: Energy Audit Conducted November 21 & 29, 2012 on the Chelsea Public School

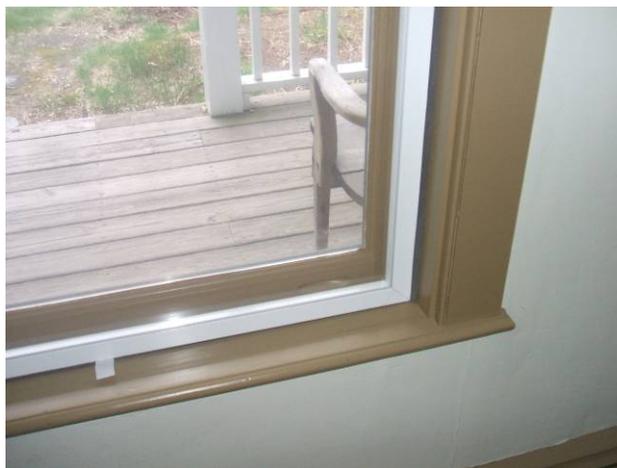
Most of the windows are single pane wood framed windows with shades. The above grade windows of the 1912 building have an exterior storm window. The shades are primarily to block solar gain but do provide some R-value when drawn.

I recommend interior storm windows similar the one shown below for all windows to increase R-value and decrease air leakage especially on the rattly 1912 windows. On the 1912 windows I further recommend making the upper sash a fixed pane window and caulking it in place.

These interior storms have 2 panes of vinyl film so they are not too expensive and they are gasketed for a tight fit.
