## Town of Corinth Road Erosion Inventory Report

Prepared by:  
**TRORC**  
Two Rivers-Ottawaquechee  
REGIONAL COMMISSION

### Road Inventory and Evaluation Form for High Priority Project Sites

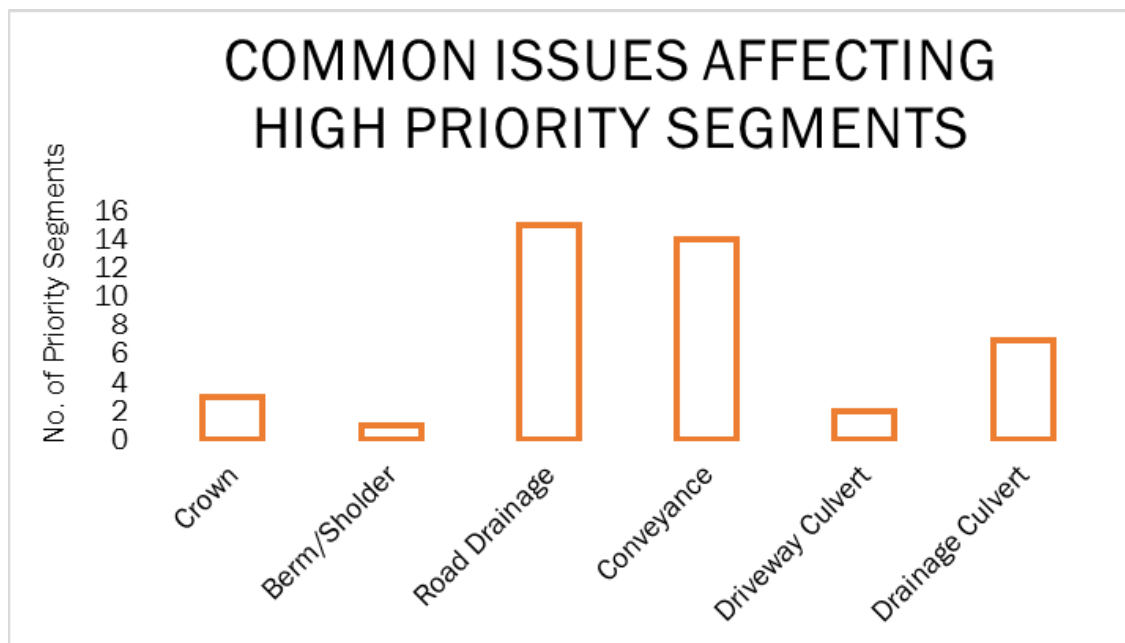
The three main issues in the high priority segments are:

- Poor Conveyance (58% Do Not Meet)
- Poor Drainage (100% have erosion present)
- Culverts (23% have inadequate or unstable culverts)

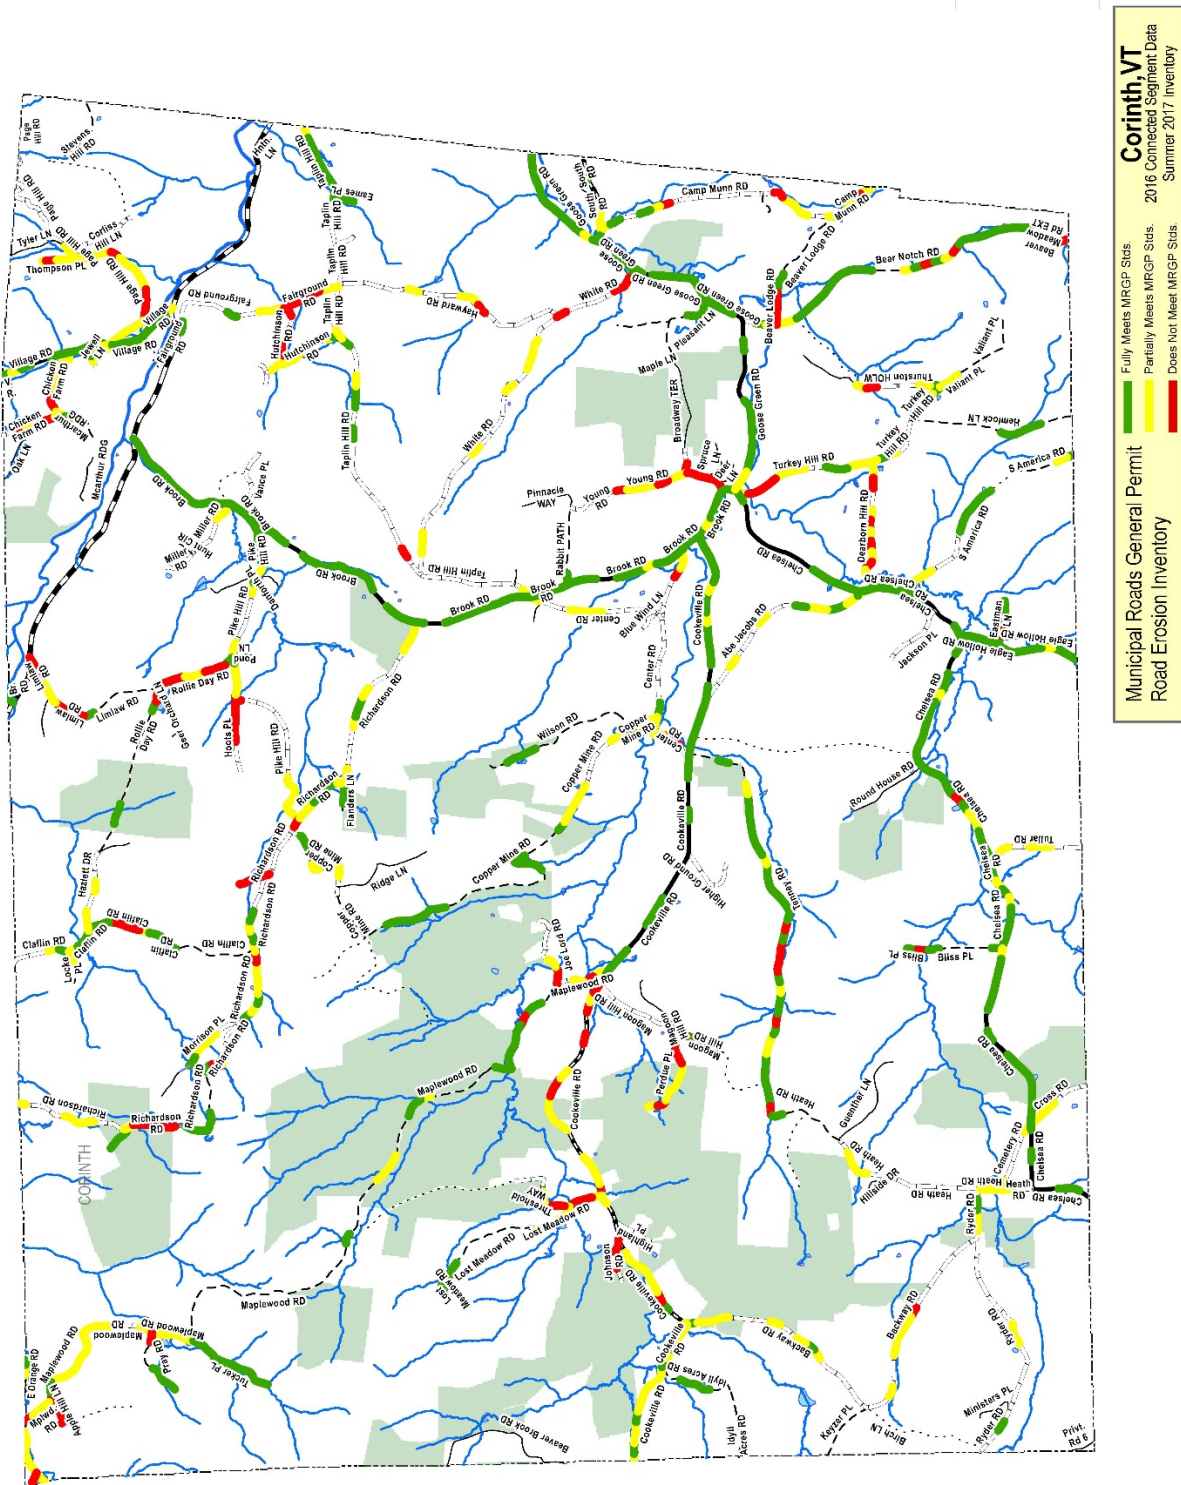
**Figure 1-** Depicts the Town with all hydro-connected segments and their scores, as well as the breakdown of how many segments Fully Meet, Partially Meet, and Do Not Meet.

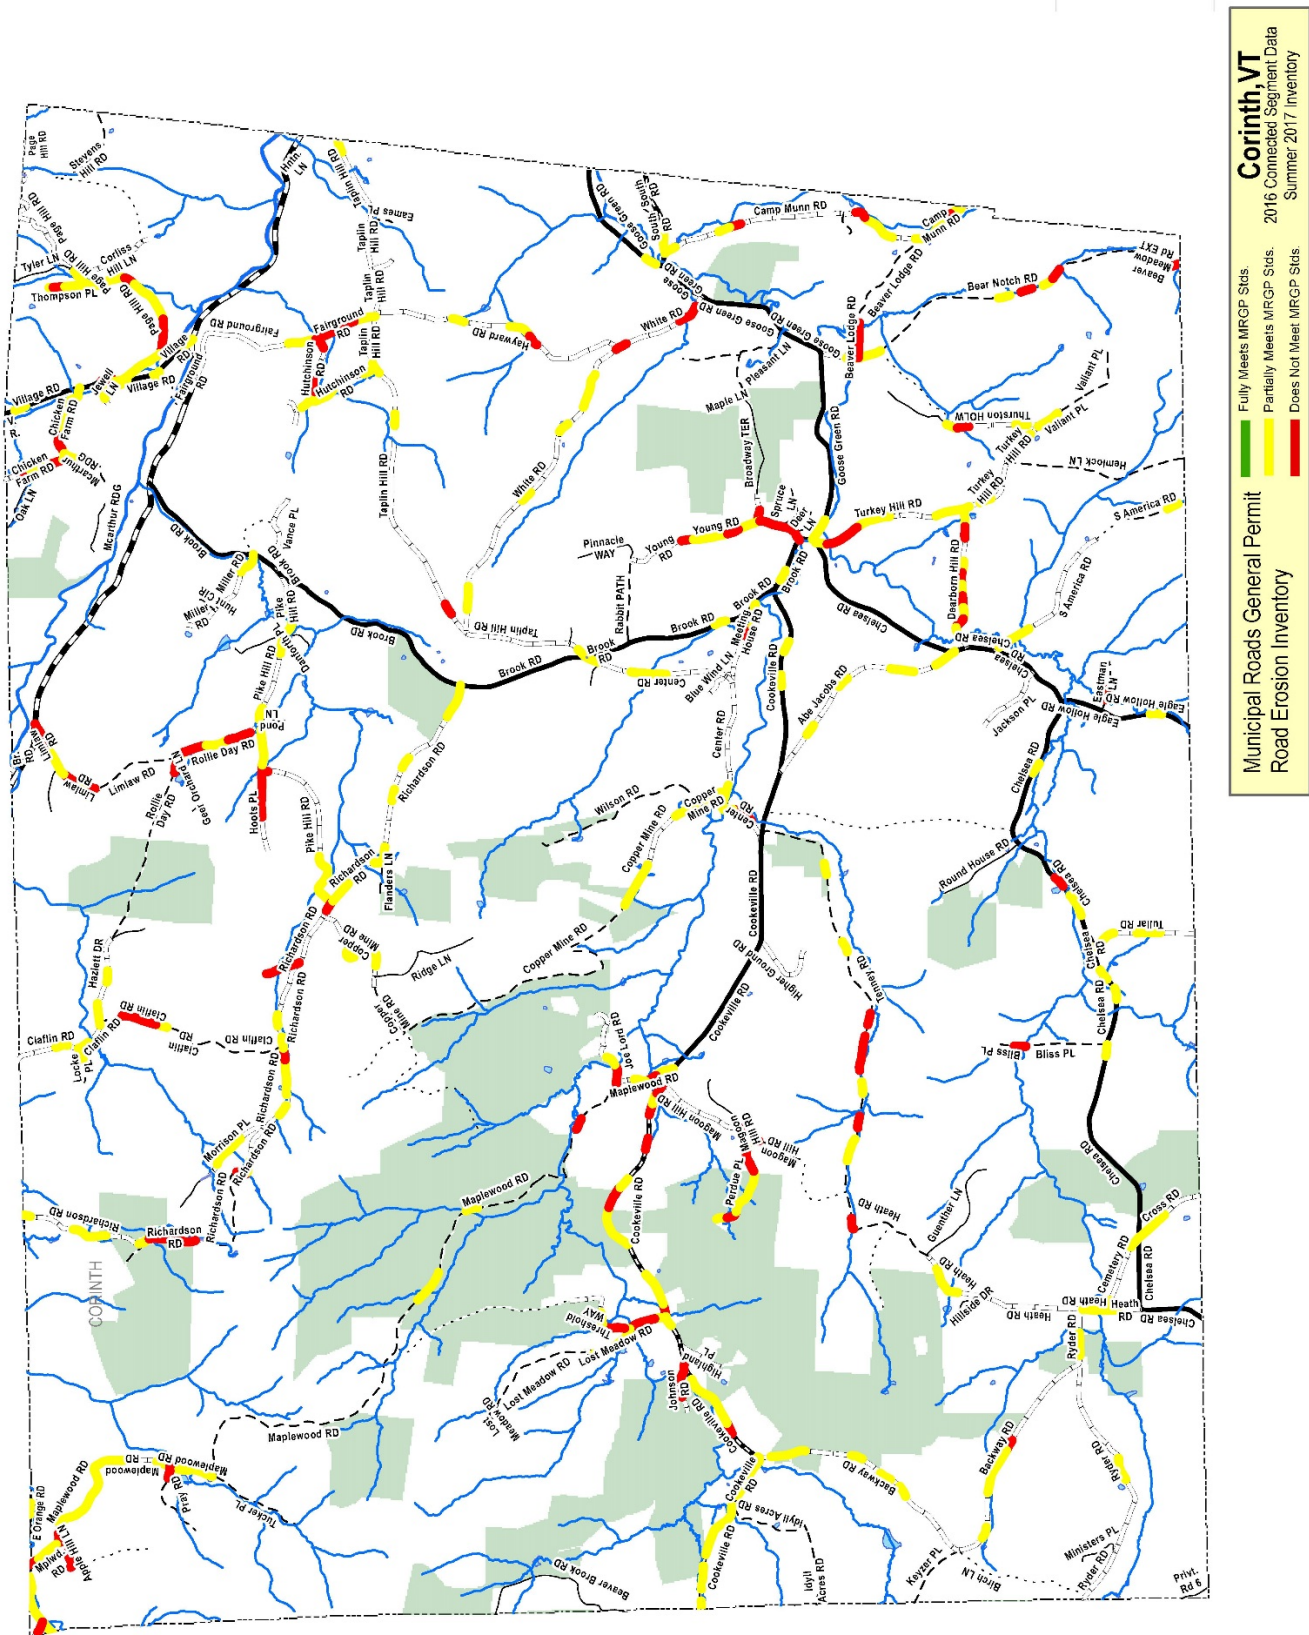
Figure 2- Displays the segments with a score of Partially Meet and Does Not Meet.

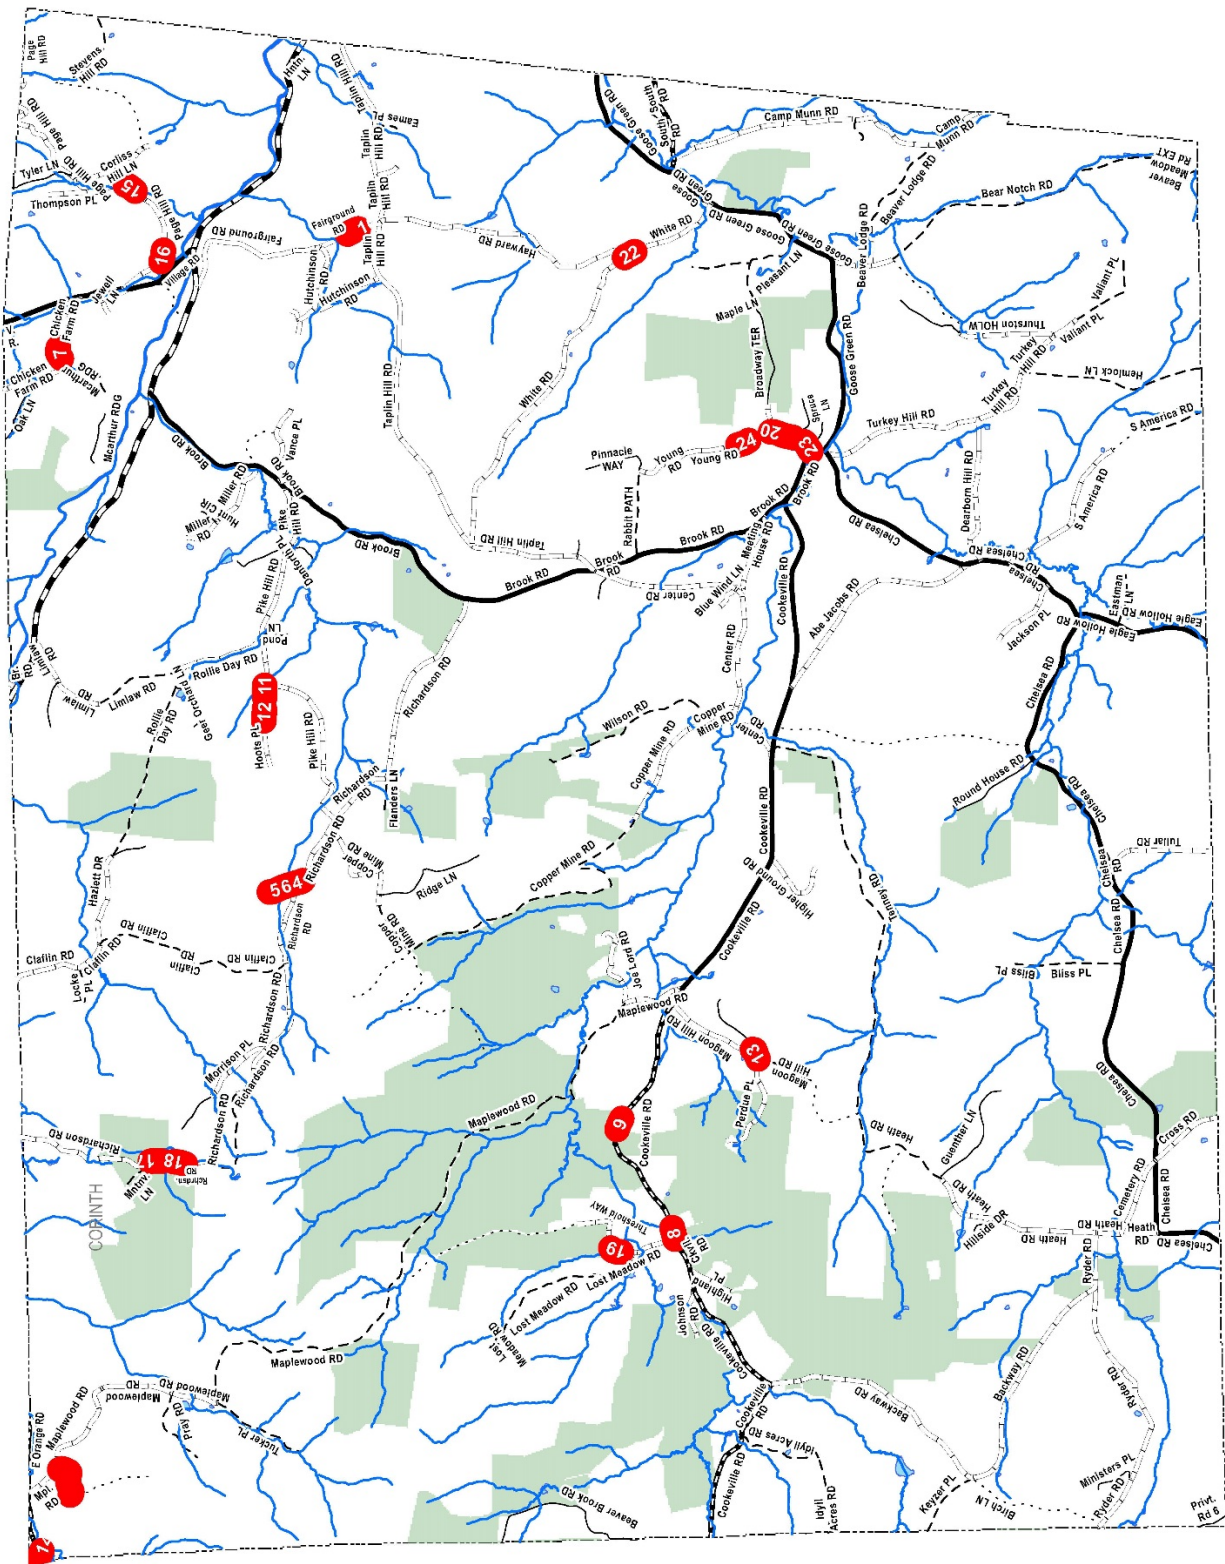
**Figure 3-** Displays high priority segments within the town.
