## Baxter Library Building Energy Plan

## Building Energy Plan

December 20, 2012

***RE: Energy Audit Conducted November 16&28, 2012 on the Baxter Library.***

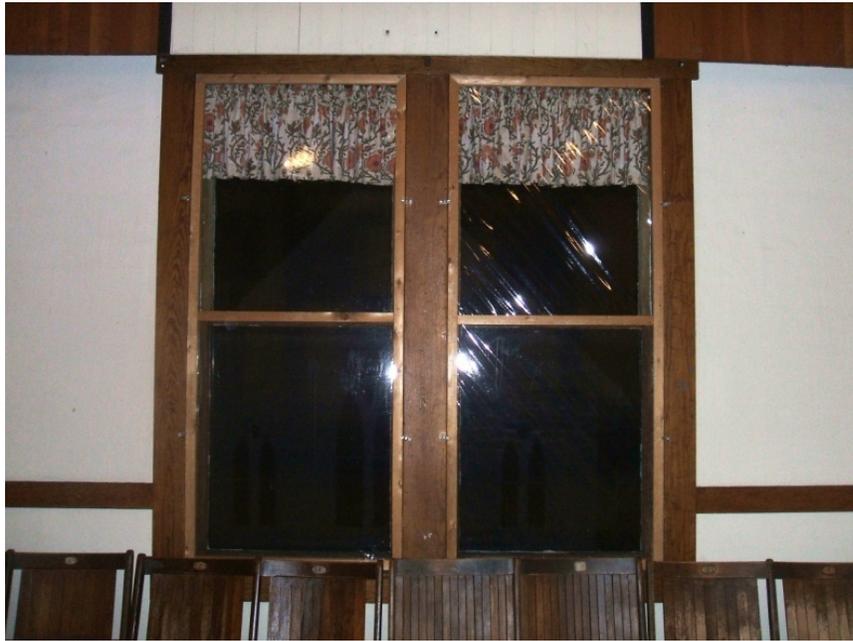
An example of a homemade interior storm window.

I carried the cost for Advanced Energy Panels, an interior storm window made in Orford, NH. These windows are reasonably priced and have good compression fit weather-stripping. It may be more cost effective to *make* carefully fit wooden window frames sheathed in low cost window film on both sides (both types of windows shown below).

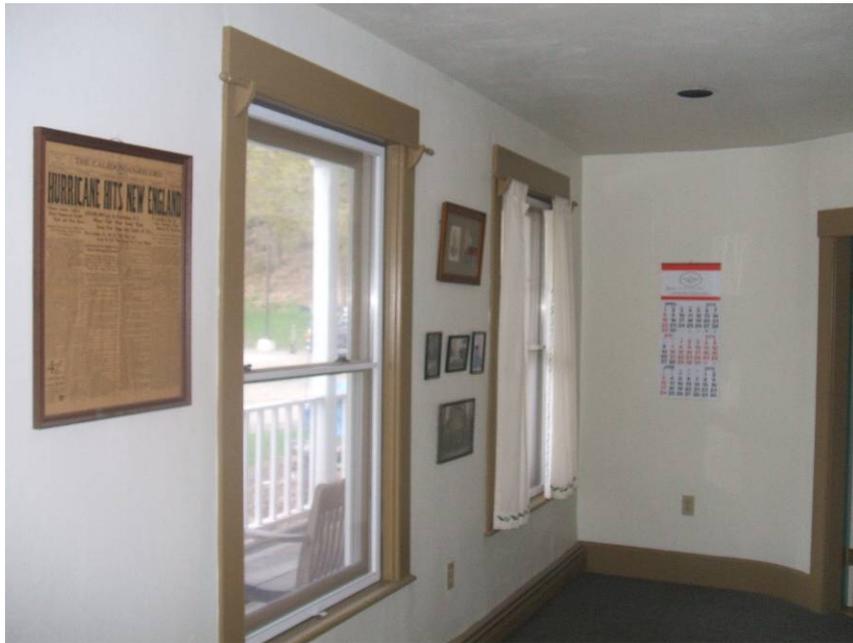
The white frame is an Advanced Energy Panel.
